Mariners' Alerting and Reporting Scheme

MARS Report No 348 October 2021

Engine crewmember dies during piston replacement

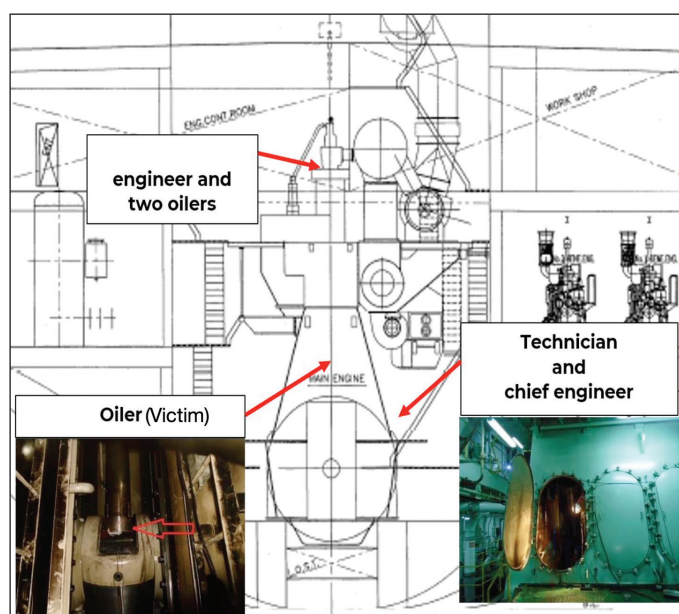
Soon after, the chief engineer instructed an engineer to turn the engine using the turning gear. The other engineer dropped the piston lifting tool. A loud noise was heard; the piston had dropped inside the crankcase. The oiler who had remained inside the crankcase was found unresponsive in the sump tank of the main engine. Emergency procedures were taken but the oiler was declared deceased before his arrival at the hospital.

- The existing risk assessment for this job indicated that crew should take the engine manufacturer's instruction manual into account while planning the operation. However, in this case the manual was not discussed beforehand and several steps mentioned by the manufacturer were not followed by the crew members during the operation.
- The chief engineer was the supervisor of the operation. However, he did not have a portable VHF radio with him while the task was being carried out. Furthermore, the communication between the two other engineers was in a language not understood by the chief engineer.

- Before carrying out any high-risk operation, such as overhauling and maintenance of the main engine, the manufacturer's instructions must be discussed and incorporated in the planning of the operation.
- A thorough review of the risk assessments for any high-risk operation must be carried out to identify the hazards and risks associated with every stage of the operation. Appropriate safeguards to eliminate those risks should be put in place.
- Effective communication should be established while carrying out any operation onboard. The supervisor of the operation and all involved crew members should be equipped with the appropriate communication devices and communicate in the vessel's working language throughout the operation.
