Mariners' Alerting and Reporting Scheme

MARS Report No 349 November 2021

MARS 202153

Allision with bridge support

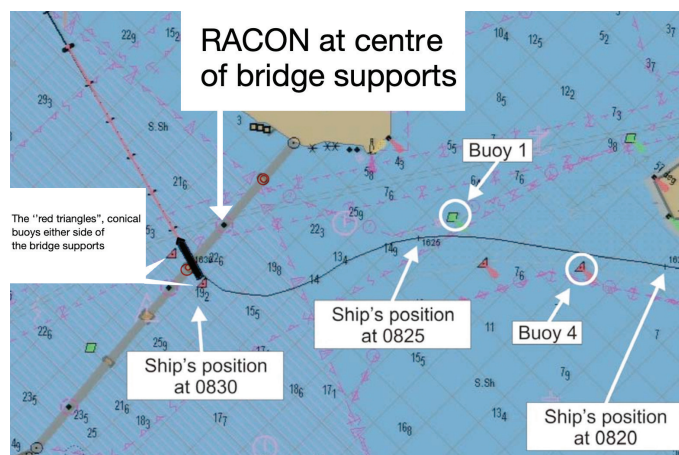
Over the next two minutes, the pilot gave rudder orders of hard starboard, mid-ships, starboard 20°, and hard starboard. At 08:29, the crew posted at the bow reported the bridge column close to port. About 10 seconds later, the pilot ordered the rudder midships and then hard port rudder. An allision was now inevitable and the pilot wanted to reduce the swing of the stern towards the bridge support.

The forward port side of the vessel struck the corner of the fendering system at the base of the bridge support at 08:30. The bridge support was unaffected due to the fendering and cement pier skirt but the vessel suffered a large gash. Fuel tanks were punctured, causing pollution. The vessel was subsequently brought to anchorage to allow time to assess the situation.

- A shared plan where everyone on the bridge is working from the same basis means there is a chance of catching and correcting an error, if it happens.

● In this case, the Master had some reservations about the departure, as his comment to the pilot testifies ('the fog is so heavy'). But he did not question the pilot's impetus to leave. If you are in charge, take charge.

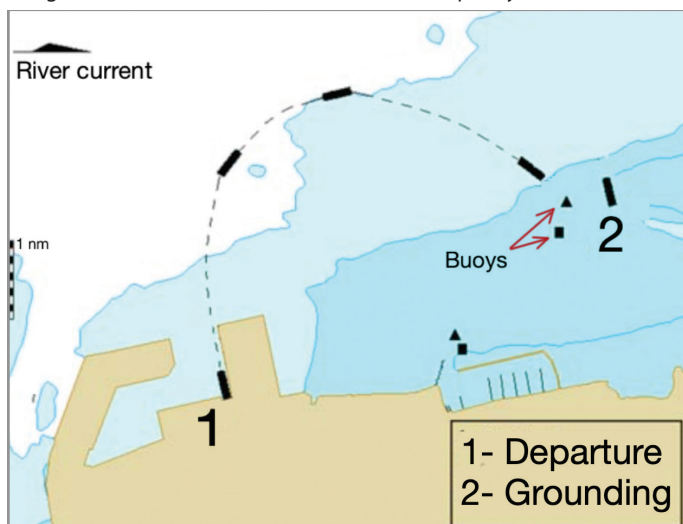
Once the vessel cleared the departure basin and passed the jetties, it quickly fell off to starboard into the river current setting approximately 075° at two knots (see below), but this was not visually apparent to the bridge team. However, the Master and mate both noticed that the gyrocompass repeater heading was rapidly turning to the east.

As the Master and mate monitored the radars, both set on the 1.5 nautical mile scale, they saw the echoes of the nearby landmass quickly shifting, creating a blurred image. This was to be expected since the radars were set on unstabilised, head-up presentation. Nonetheless, the bridge team were now flustered and unable to quickly determine the

vessel's position. Without visual cues or an understanding of the blurred radar image, the Master and mate looked to the GPS receiver to gain an appreciation of the vessel's speed. Soon, the lookout reported seeing buoys ahead. The Master manoeuvred to avoid the buoys and, shortly thereafter, some 10 minutes after departure, the vessel grounded.

- Blind pilotage not only requires proper training, but practice too. Practise your blind pilotage technique whenever possibly, especially in good weather.
- A north-up, stabilised radar setup is superior to an unstabilised setting when navigating in low visibility conditions.

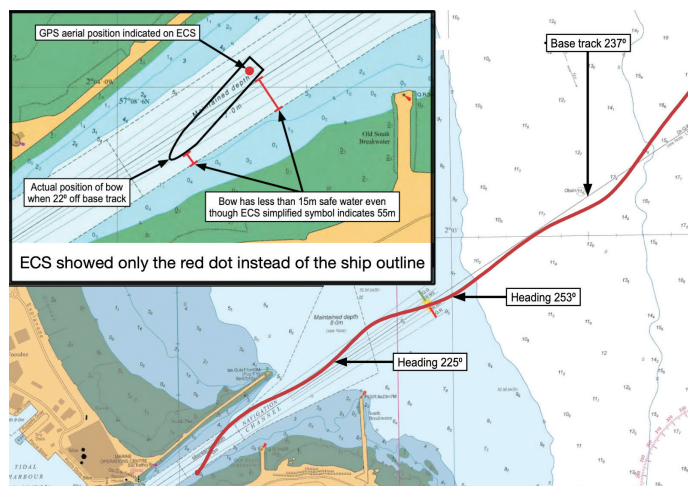
The PEC holder applied about 10° of port rudder to bring the ship back towards the planned track. In response to prompting from the Master, the PEC holder applied more port helm until there was 30°. The vessel rapidly crossed the narrow channel, and after 15 seconds, the PEC holder realised the new danger and applied maximum starboard

rudder, but this alteration was too late. The ferry grounded at 6.5kts, raking along its port bow and port side before coming to a stop on the southern edge of the 70 metre wide channel.

Hull, propellor and rudder damage on the port side required repairs that kept the ferry out of service for four weeks. The official investigation found, among other things, that the grounding was due to the bridge team losing situational awareness in thick fog.

Another finding was that the use of one parallel index (PI), as in this case, was insufficient for safe navigation in near zero visibility. Multiple PIs to display safety limits, effectively drawing a corridor down which the ship can be safely driven, would be more appropriate for such conditions. Additionally, by having only a symbol representing the ship on the ECS instead of a scale outline of the vessel, important safety information such as the swept breadth within the channel was not available to the bridge team.

- Commercial pressure or even personal overconfidence can contribute to our making wrong decisions. When it comes to conning a ship in restricted waters and visibility, taking a conservative approach is probably the best option.
