Mariners' Alerting and Reporting Scheme

MARS Report No 350 December 2021

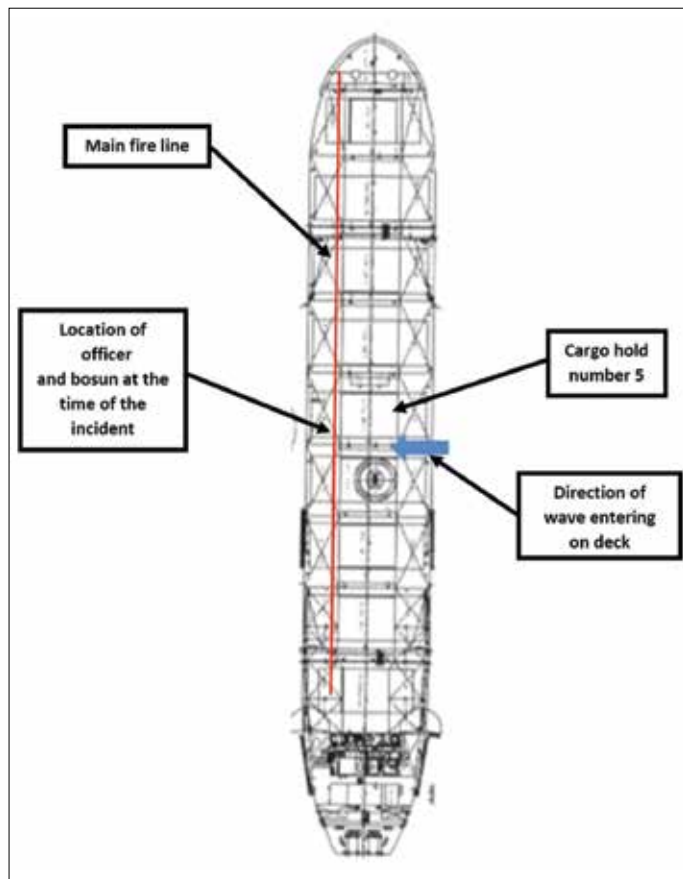
→ A loaded bulk carrier was under way at sea. A leak had been discovered in the main fire line on the main deck near hold five, and the bosun and an officer were tasked to fix it. The fire pump was stopped and the two men started working on replacing the flange gasket in the line. About an hour later, the OOW observed the wind speed and the height of waves increasing. The Master was informed of the deteriorating weather conditions, and contacted the chief officer and asked him to stop work on deck and secure the loose equipment.

By the time the chief officer told the men to stop work on the fire line the job was already completed. It only remained to collect the tools, which they proceeded to do after a rest break for coffee. As the men collected the tools, a heavy wave swept the deck from the starboard side. Both men were caught by the wave; the OOW held on to the railing, but the bosun was swept overboard by the force of the water. The alarm was raised and the crew began search sweeps of the area. Several hours later, with weather deteriorating further and darkness, the search was called off. The bosun was never found.

- Accessing the deck during heavy weather, even on a large vessel, can be very dangerous. Heavy winds and waves can result in a catastrophic outcome.
- No personnel should be allowed to access the deck in heavy weather unless it is necessary for the safety of the crew or ship. If the crew is required to go on deck during deteriorating weather conditions:
 - i) A thorough risk assessment should be performed and appropriate safeguards implemented to mitigate the risk of heavy weather and waves breaking on to the deck, such as taking the weather on the stern.
 - ii) Proper Personal Protective Equipment (PPE) such as a harness, safety line and a flotation device should be worn.

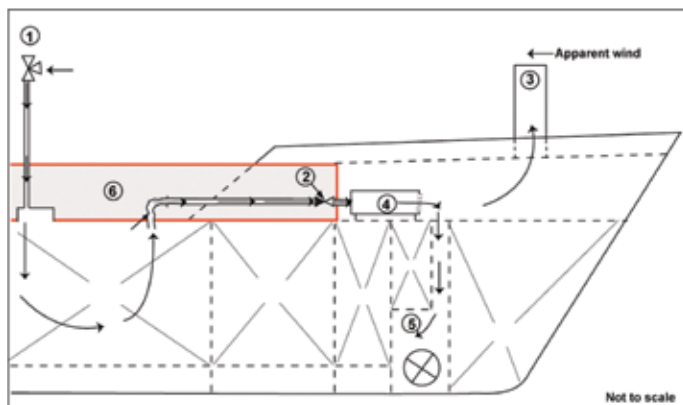
The analysis in the official report describes how, given that the forecandle door was open, the apparent wind across the vessel's bow had created an area of lower pressure in the forecandle. This, coupled with open PV valves, induced a flow of gasoline vapours from the cargo tank into the forecandle through the drying unit and the modified non-return valve, as shown in the diagram. The modifications to the non-return valve had not been approved. Once the heavier-than-air vapours passed through the tank-drying unit, they settled downward and into the bow thruster compartment. The vapours were probably ignited by an automatically controlled heating unit in the bow thruster compartment.

Migration of flammable vapours from cargo tank to bow thruster compartment

- The inappropriate practice of using the tank-drying equipment for cargo tank ventilation allowed the migration of explosive vapours into the bow thruster compartment.
- The modification of the double non-return valve reduced its effectiveness and contributed to the migration of explosive vapours into the forecandle and bow thruster compartment.
- With no formal procedures and training to mitigate the risks associated with tanker operations, the effectiveness of the vessel's safety management system (SMS) was reduced.

- Safety depends on training and good procedures. In this instance, there were no written procedures for safe tank venting and equipment designed for tank drying was being co-opted for tank venting.
- Any modifications to equipment, such as the double non-return valve in this case, should be vetted through the vessel's classification society.

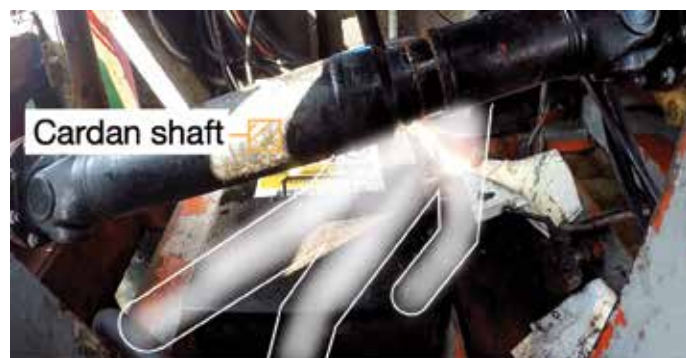
After helping the officer with an associated task, the Master returned to the bridge to inquire about progress with the tugboat. Suddenly, he heard a yell from the aft deck. He rushed back, finding the officer trapped under the cardan shaft. The officer had disconnected the lifting cylinder hose instead of the damaged hose, and the shaft had fallen down on him. The Master immediately searched for tools that could help release the officer. He tried to lift the cardan shaft using a strap and chain hoist, but without success. He then called for an ambulance, and, at the same time, got some persons on the quay to help him; a forklift truck and several crew members came from nearby ships. The forklift succeeded in lifting the cardan shaft, so the Master and another crew from a nearby ship could secure the shaft off of the victim.

Outline of victim under cardan shaft

The official investigation found, among others, that since the ship's crew (Master and officer) did not possess advanced mechanical engineering skills, they did not recognise that this repair might present special risks.

- On small vessels, the reduced crew can be tasked with duties that go beyond their competencies. This can bring unintended consequences that, as with this case, can prove fatal.
- If there is an emergency the first priority is to raise the alarm and solicit help. In this case, although well meaning, the Master lost valuable time rigging a strap and chain hoist for an improvised rescue before calling for help.
- Some perceived urgent situations can be, upon calm consideration, less urgent than initially assessed. In this case the vessel was nonetheless in a safe position near the berth and there was no need to undertake a hasty repair of the starboard propulsion.
- Mariners are often endowed with 'can-do' personalities; they wish to fix the problem in quick order. Resist this temptation and make a calm assessment of the situation before acting.

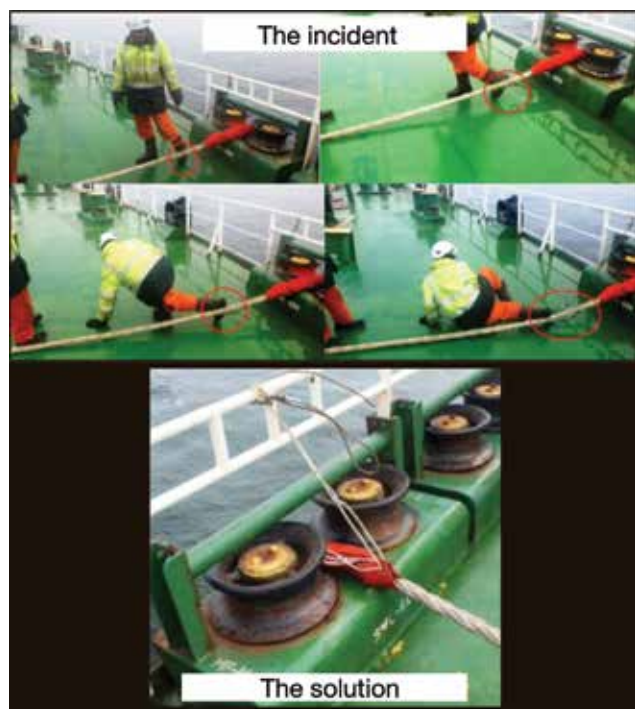
→ A vessel was in the process of berthing. A crew member carrying out his work at the forward berthing station tripped over the lanyard securing the spring line's chafing sleeve to the vessel's railing. The victim did not think he was injured but, when trying to stand he felt severe pain at his left hip.

- Even the most minor incident can lead to serious consequences. All incidents should be investigated and opportunities for risk reduction sought.
- A clean and unobstructed deck is a safe deck. In this case a small lanyard left adrift on the deck was enough to cause a repatriation.

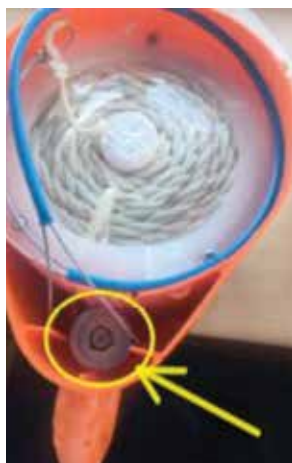
→ An officer was tasked with pyrotechnic inspection and replacement. While undertaking the rocket replacement in the Line Throwing Device (LTD) he found that the previously installed rocket had been inserted upside down, which would have certainly meant an improper activation if needed. The same was found in two other LTDs on board.

It was found that the LTDs had been delivered in this state but this defect had not been discovered during inspections.

- The inspection of even the most basic equipment might lead to surprises. This task must be taken with the utmost seriousness as even manufacturers can make mistakes.

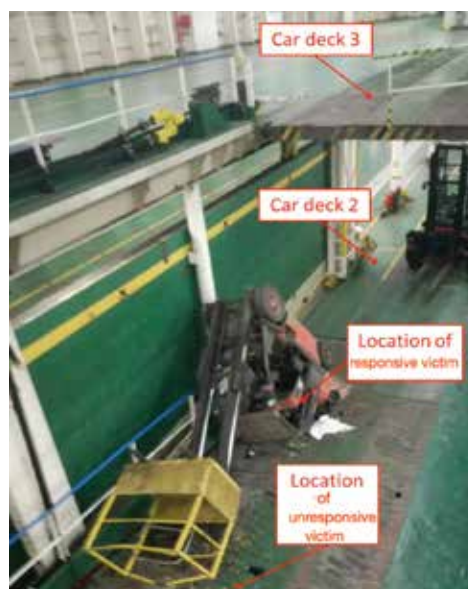
Later on, while most crew were at coffee break, a loud bang was heard. Various crew members went towards car deck 2 to identify the source of the sound. The securing barrier on car deck 3 was found broken, and the forklift had fallen from car deck 3 onto car deck 2. The forklift was lying overturned on the ramp with a crewmember inside the forklift cabin. This crewmember was injured but responsive. Another crewmember was found inside the overturned forklift basket and he was unresponsive.

The crewmember that was in the forklift cabin later recovered, but he did not remember events from the accident. The company investigation found that the forklift had been operated with the victim in the basket and the forklift mast extended to the top. It was also found that the crewmember operating the forklift truck did not have the training or authorisation to operate the truck. There was no dedicated procedure in the company's SMS providing requirements for the access and operation of the forklift. Neither was there any specific procedure for maintaining, recording or managing crew members' qualification and experience for operating a forklift truck.

- Forklift truck operation is an inherently high-risk operation. Operators of this equipment should have proper training and follow procedures. According to the website McCue.com, on average 95 people are seriously injured in a forklift accident every day and 1 person is killed in a forklift accident every 4 days in the United States alone (land-based use).
- Effective administrative and access controls must be maintained to ensure that only authorised and trained personnel can operate such equipment.
