# Mariners' Alerting and Reporting Scheme

MARS Report No 351 January 2022

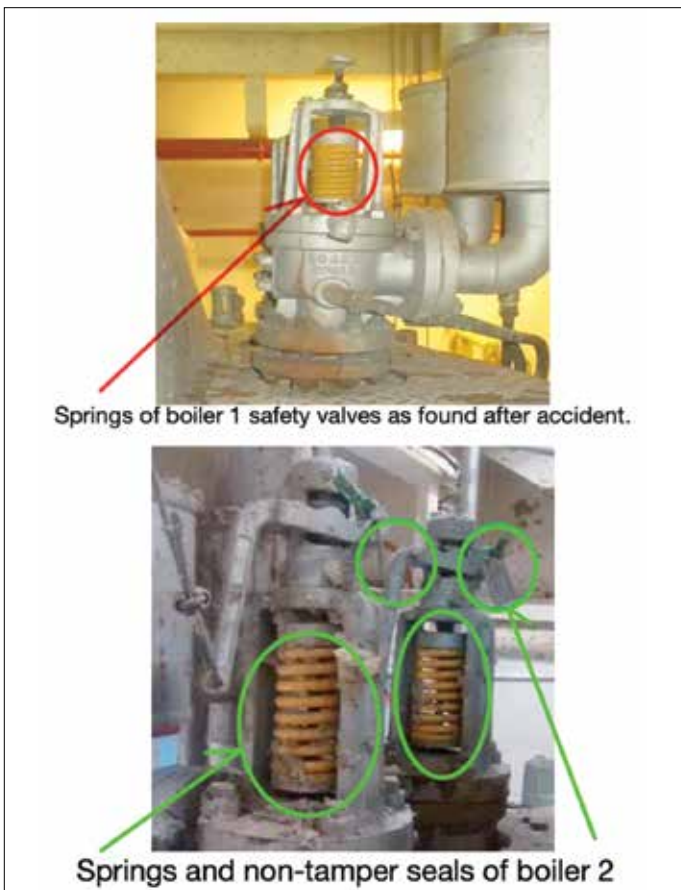
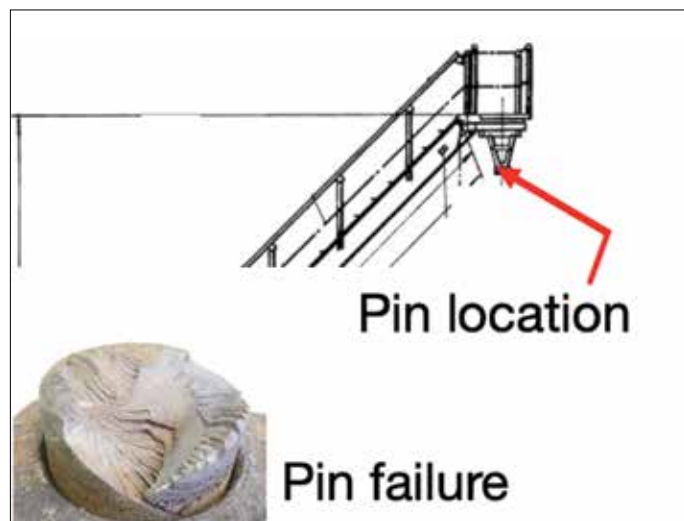
→ A recent incident brought to light a potentially dangerous situation involving failure of the turntable pin on accommodation ladders.

The vessel's crew was stowing the accommodation ladder when the turntable pin failed. The victim, who was on the accommodation ladder at the time, fell approximately nine metres and sustained serious injuries.

Currently, there are no established timelines or requirements to replace turntable pins. Without periodic examination (and replacement if needed), corrosion can ultimately lead to structural failure.

After the incident specific inspections were undertaken; local authorities noted that many vessels had accommodation ladder turntable pins that had been in service for more than 20 years without replacement. Notwithstanding the guidelines on the maintenance of accommodation ladders contained within 74 SOLAS (14) II-1/3-9, MSC.1/ Circ. 1331, and 74 SOLAS (14) III/20.7.2, none of these references include maintenance guidelines for turntable pins.

- While the turntable pin may seem like a minor component, failure can cause significant harm to anyone using the accommodation ladder at the time.
- Periodically inspect the condition of the turntable pins and replace when necessary.
- Revise accommodation ladder maintenance plans to include turntable pins.

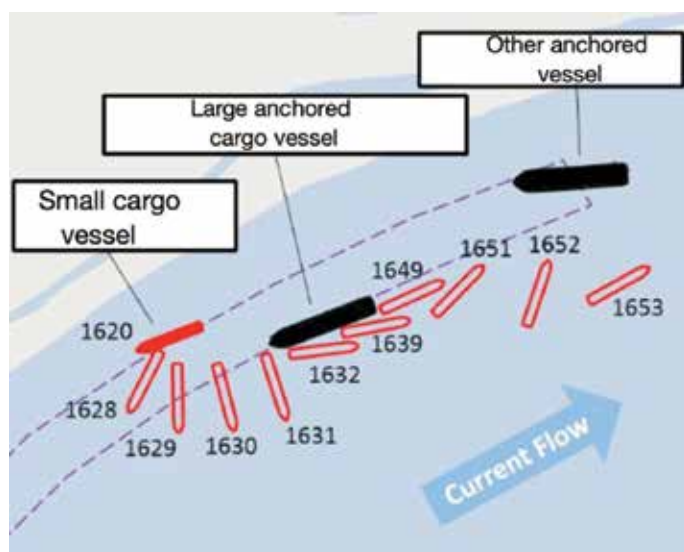
The transit downriver was without incident. With the assistance of two tugboats, the vessel was anchored at 16:00 using both anchors, placed at the ten and two o'clock positions respectively. By about 16:17 the anchor chains had become taut and the stern of the vessel was about 152 metres from the bow of a much larger general cargo vessel anchored astern. At about 16:26, as the pilot boat approached to disembark the pilot, the vessel's bow swung quickly into the river current. By the time the pilot regained the bridge the ship was almost perpendicular to the river. The pilot requested 'half ahead and starboard' but the engines were not able to overcome the force of the river current, and the anchors dragged. A few seconds later the pilot informed the Master that they were going to collide with the bulk carrier anchored astern. The pilot radioed the two tugboats that had been assisting during the anchoring, requesting that they return as quickly as possible. The ship's whistle was used to sound the danger signal and warn of the impending collision.

About 15 minutes after being 'safely' anchored, the vessel was being carried by the current at a speed of 5.5 knots. The vessel drifted until its propeller caught the starboard anchor chain of the larger vessel anchored astern. The entanglement pulled the drifting vessel's propeller shaft outward damaging reduction gears and cracking the gear box.

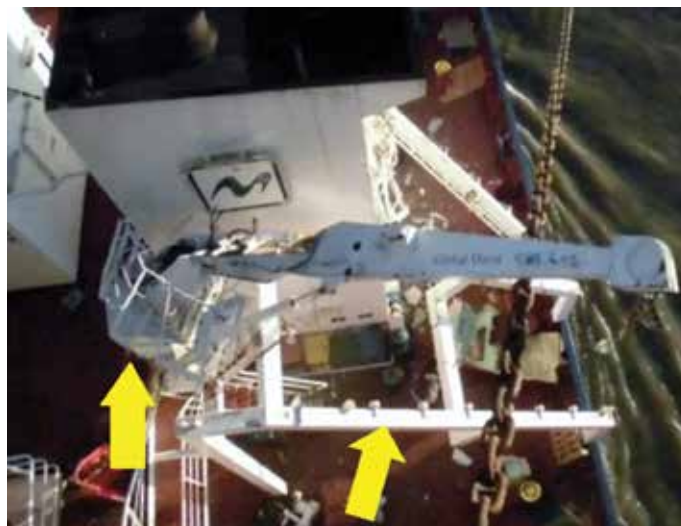
**Stern crane and lifeboat torn off by large anchored vessel's anchor chain**

Subsequently, the small cargo vessel drifted toward the port anchor chain and bow of the larger anchored vessel. The anchored vessel's port anchor chain caught and then wrapped around the drifting vessel's stern crane, holding the vessel in place as the current pivoted it around the bow of the bulk carrier. The crane and the stern mounted lifeboat of the drifting vessel were destroyed. The highest point on the drifting vessel's aft deckhouse was well below the main deck of the larger anchored vessel, and the bridge wing of the drifting vessel was torn off.
