MARS – Lessons Learned

MARS Report No 371 September 2023

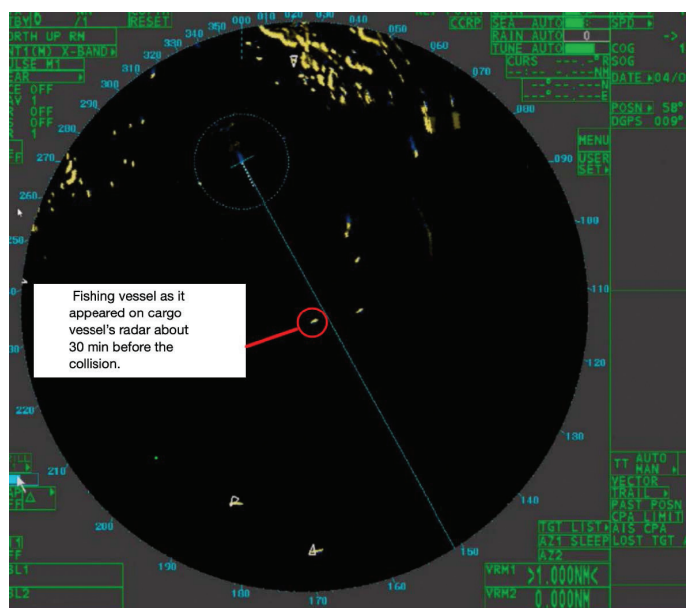
Collision in daylight and good visibility

➔ In the early morning a small cargo ship left port bound for a short sea destination. The OOW was alone on the bridge as it was now daylight and visibility was good. He set a SSE course, as per the voyage plan, and the vessel was making about 12 knots. The OOW scanned the horizon for potential dangers through the bridge windows and observed AIS signals from a few smaller vessels on the radar. He did not see any targets that concerned him, although there was a target near their heading line to port at about 6nm. The OOW then turned his attention to administrative tasks using a computer placed aft in the wheelhouse.

On the cargo vessel the OOW felt something hit the bow of the ship. Looking out, he saw the mast of a fishing vessel close along the starboard side. The time was 08:35.

The collision caused the fishing vessel to heel over and turn around almost 180 degrees. Once clear of the cargo ship, the fishing vessel still had propulsion. The crew were unharmed and proceeded to check the status of the vessel, which had sustained considerable damage to the port bow bulwark but otherwise was out of danger.

- Distractions, be they administrative or personal (mobile phones!) are antithetical to keeping a sharp lookout.
- Not all small vessels carry or use their AIS consistently, so keeping a sharp visual and radar lookout is essential.

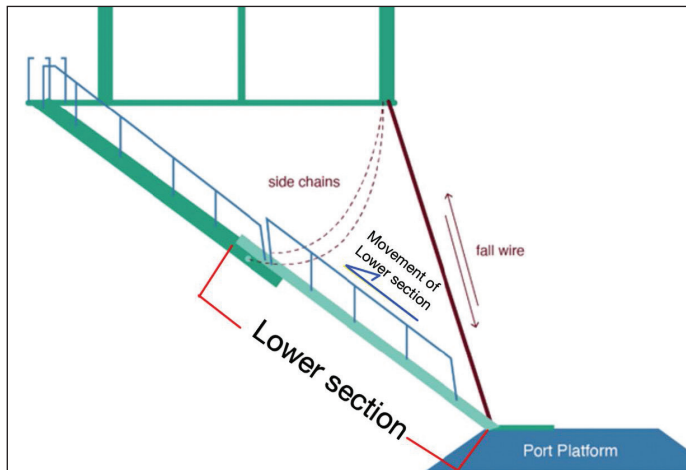
Accommodation ladder not accommodating

The inboard handrail side chain became caught between the sliding lower ladder and the fixed upper ladder, and a crewmember stepped onto the upper ladder to free it. Once he had cleared the inboard handrail chain, he picked up the outboard handrail chain and held onto both to prevent them from getting caught again. Holding both chains, he stood on a step close to the top of the fixed ladder, but within the area identified as dangerous from the previous incident.

On board, another crewmember resumed heaving on the fall wire to retract the lower section of accommodation ladder. As this was proceeding, the ladder end dropped off the port platform. Because the side chains were slack and not supporting the fixed upper ladder, the weight was transferred from the dock platform and onto the fall wire. This resulted in an unexpected and uncontrolled upward movement of the lower ladder.

The sudden upward movement of the lower ladder trapped the victim's left leg between the top step of the lower ladder and the third step of the fixed upper ladder. All work stopped immediately, and the

- Each close call, incident or accident is an opportunity to improve safety by analysing the events and implementing mitigating measures such as new procedures or engineering solutions. To be fully effective, the new procedures should be followed.
- Don't let your 'Can Do' attitude lead you into a dangerous position, as with the victim in this accident. Follow the established procedure.

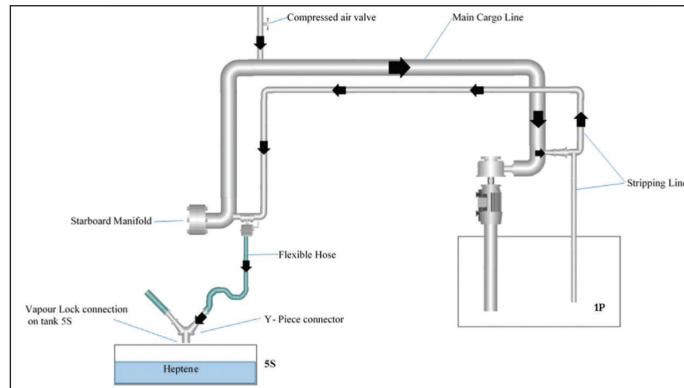
No inert gas means less tanker safety

Seconds after the compressed air was blown into the discharge line, an explosion occurred. The investigation was able to discount a pressurisation event as the cause. In all likelihood, an explosive mixture ignited in tank 5S due to static electricity.

No inert gas or closed vapour return system had been used when loading this cargo. During the first outflow of cargo (safety ullage), outside air was drawn in through the pressure/vacuum valve. This allowed an explosive mixture of gas vapours and oxygen to develop in tank 5S.

The official investigation found that maximum safety assurance can only be achieved by inert loading or loading with a closed vapour return system. Ships without these systems should therefore no longer be allowed.

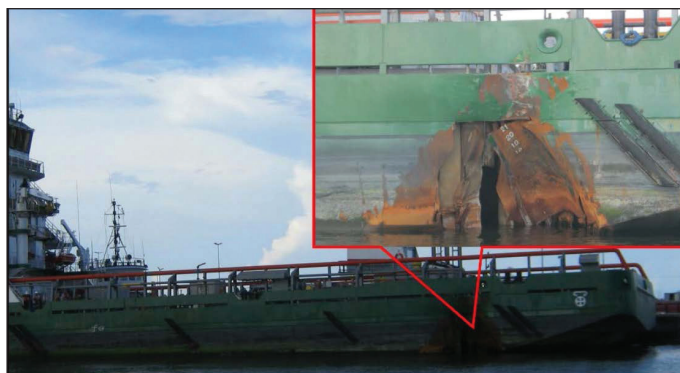
OSV Damage

Eventually, the OOW on the OSV became aware of the risk of collision. He disengaged the autopilot, increased the throttles and turned to port to minimise the damage to the vessel as a collision was now inevitable. The bulbous bow of the bulk carrier, which was traveling at about 14 knots, struck the port side of the OSV, which was traveling at 9 knots, and breached the hull. The impact caused the OSV to heel to starboard, and water rushed over the main deck from the starboard side.

The general alarm was sounded on the OSV, and all crew were instructed to go to their muster stations. As a consequence of the collision the port side propulsion room started to flood, and the OSV began to list to port and trim by the stern. The ship's ballast pump was used to dewater the space and to get the breach to the hull out of the water as far as possible. Although the OSV lost propulsion, the electrical generators in the engine room remained operational and provided power to the ship.

- Nonoperational use of cell phones and other wireless electronic devices by on-duty crewmembers in safety-critical positions has been a factor in casualties and accidents in all transportation modes. Using cell phones and other personal electronic devices has been demonstrated to be visually, manually, and cognitively distracting.
- Nonoperational use of cell phones should never interfere with the primary task of a watchstander or a bridge team member to maintain a proper lookout. It is important for personnel to follow established protocols regarding cell phone use.

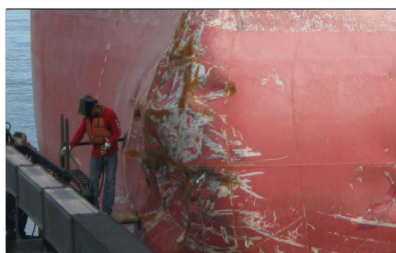
Bulk Carrier damage

The official investigation found that the probable cause of the collision between the bulk carrier and the OSV was distraction of the bulk carrier's OOW due to performing non-navigational tasks and distraction of the OOW on the OSV due to cell phone use, which kept both officers from keeping a proper lookout. Contributing to the casualty was the OOW on the OSV not following his company's watchkeeping policies, which called for two persons on the bridge at all times.
