MARS – Lessons Learned

MARS Report No 372 October 2023

MARS 202345

Scrap metal fire hazard

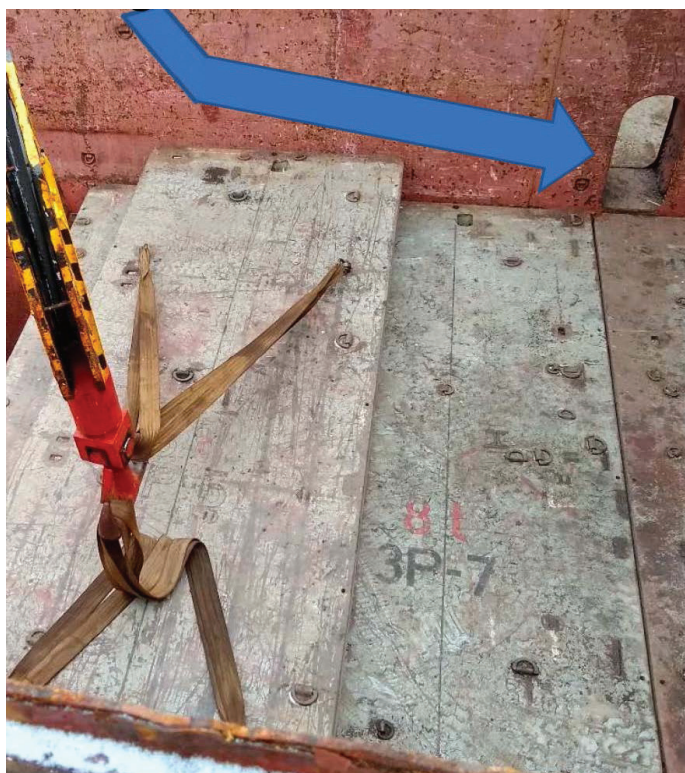
Designated safe area

The two crew were positioned in the forward part of the cargo hold, where they would hook the pontoons on to the crane. A third crew member was assigned to un-hook the pontoons once they were laid down on top of other tween-deck pontoons against the bulkhead in the aft part of the cargo hold. This crew member had to shelter in a safe position aft until the first pontoon was laid down on deck. The dedicated safe position during the manoeuvring was inside a passage between the port and starboard holds.

The lifted pontoon did not make any uncontrolled movement. The pontoon was not swinging or turning. Reportedly, nothing unusual was heard or seen until the signalman saw that the crew member who was supposed to be sheltering aft to unhook was lying on the deck. The signalman raised the alarm with the VHF radio and stopped the operation. The victim was given first aid and a doctor came to the scene but he was declared deceased.

The investigation found, among other things, that because the pontoon itself had blocked a proper and full view of the work area, neither the signalman nor the crane operator had been able to see that the victim had entered the danger zone between the bulkhead and the hoisted pontoon. Although the victim knew to stay in the designated shelter area until the pontoon was safely down, it is possible he attempted to quickly remove some cargo debris as the lift was under way.

- Human nature is such that we want to get the job done – the 'can do' attitude which probably explains the victim not remaining in the designated safe area. The 'can do' attitude can be perilous if we ignore established procedures in the process.
- The victim did not have a VHF radio so he would have been unable to stop the operation, had he seen this was necessary.
