# Mariners' Alerting and Reporting Scheme

MARS Report No. 318 April 2019

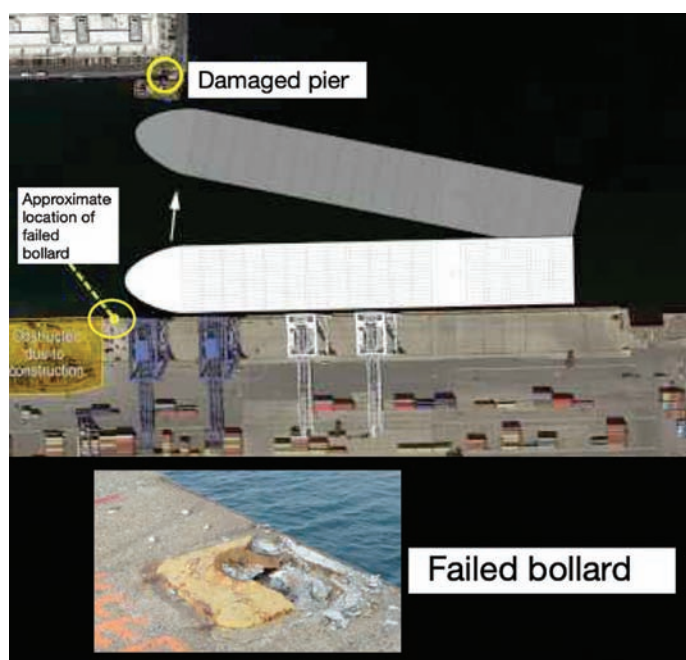
Later, as the vessel was discharging cargo, winds increased as expected with peak gusts near 40 knots. The bollard forward with the five headlines was torn from its base. The forward spring lines parted followed in quick succession by the seven remaining lines. The vessel drifted off the wharf and the bow struck a nearby pier. An anchor was walked out, bow thruster and main engine were brought on line and the uncontrolled drift of the vessel was stopped some 30 minutes after the bollard failure. Shortly afterwards, tugs arrived and assisted the container vessel to anchorage.

- Mariners can never be sure of the holding power of a particular shore bollard. In this case, all forward headlines were on one bollard. Best practice is to spread the load to several bollards.
- Once one part of a mooring arrangement fails, there is a high probability of the remaining parts failing in relatively quick succession. Loads can be distributed in a way that is beyond the design capacity of the system.
- If high winds are forecast it may be necessary to take extra precautions, such as an anchor outboard, having engines and bow thruster ready, or having tugs on standby.

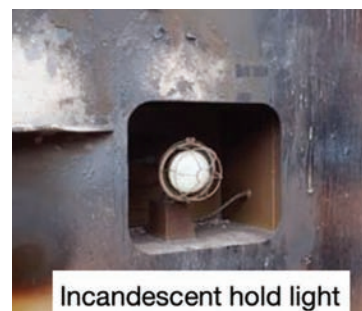
- The fire was caused by heat radiating from an incandescent cargo hold lamp. The lamp set fire to packs of timber that had been stowed within 45–50mm of the lamp.
- The ship had no written procedure or checklist for ensuring the cargo hold lights were switched off before flammable cargo was loaded against cargo light recesses, or when loading was complete and hatch lids were closed.

Incandescent hold light

- For a fire in a cargo hold, fixed CO<sub>2</sub> is usually your best option. Release, wait and boundary-cool. Monitor temperatures and do not open hatches too soon.
- The responsibilities of command structure when shore firefighters are on board should be clearly documented and understood by the various authorities involved in responding to the fire.
- High-temperature-producing cargo lamps are inherently more risky than LED lamps, which are now available at affordable prices.

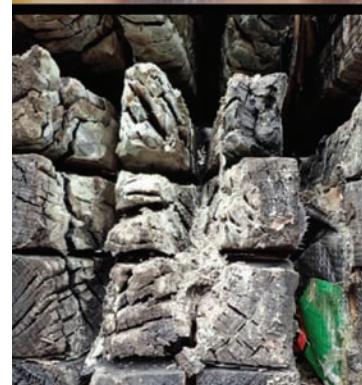
Charred timber at origin of fire

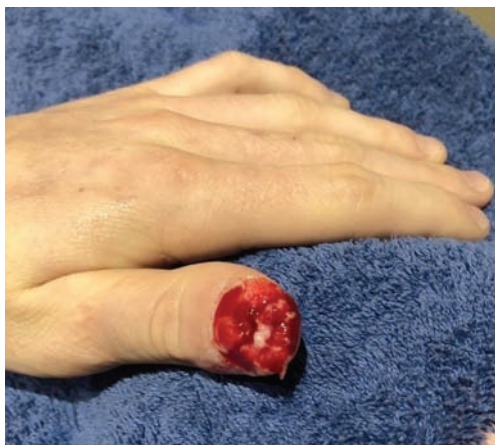
➔ On a large yacht, the beach lander was to be recovered at the port-side shell door. The beach lander was positioned under the davit hooks and secured fore and aft. The forward hook was lowered and a crew member attempted to attach the hook to the strop. At the same time, an unusually big wave that had lifted the beach lander up now was moving to its trough and the small craft descended rapidly, crushing the crew member's left thumb between the hook and the lifting strop.

- When hooking on in a seaway, ensure there is enough slack in the hook line to accommodate the rise and fall of the boat before attempting the manoeuvre.
- Proper work gloves might have mitigated the extent of injury.

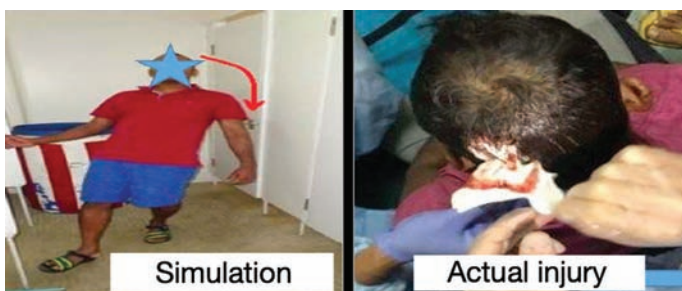
➔ A crew member had gone to the common toilet. After stepping out from the cubicle, he slipped on the wet floor. As he fell backwards his head hit the handle of the cubicle door and he fell unconscious. Shortly after the incident another crew member saw the victim sitting in a

- Keep washroom floors clean and dry.
- Some lounge shoes or 'flip-flops' have very slippery soles when wet. These should not be used in areas that are likely to become damp.

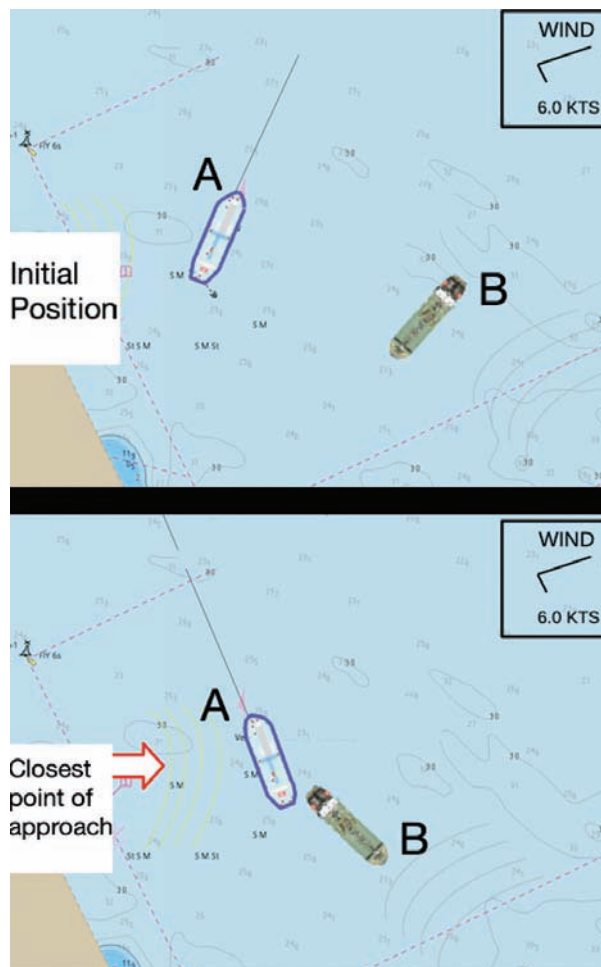
➔ A large oil carrier was anchored in an area reserved for these vessels when another large tanker anchored about 0.3nm away at the same anchorage. Some time later, the vessels began to swing about their respective anchors due to the shifting tidal stream, but the effects on each ship were slightly different. The vessel's sterns began to approach one another. Concerned about a possible collision, the OOW on vessel A repeatedly attempted to communicate with vessel B but received no response.

The Master was called to the bridge. With the vessel still receiving no response on VHF from vessel B, the anchor party was made ready and the main engine brought on line for manoeuvring. Only 25 minutes had transpired since the vessels began to swing from their initial positions, but they were now less than 0.15nm apart. Dead slow ahead was ordered and the anchor was heaved up simultaneously, increasing the distance between the vessels.

- When going to anchor, place your vessel in a position that allows for a 360° swing on the anchor chain and still provides a safety margin with other anchored vessels that may also swing 360°.
- At anchor, just as when underway, it is important to maintain close monitoring of your position and of those vessels around you.
- If you have concerns about traffic, weather etc while at anchorage, keep your main engine available at short notice to help prevent any risk of collision.

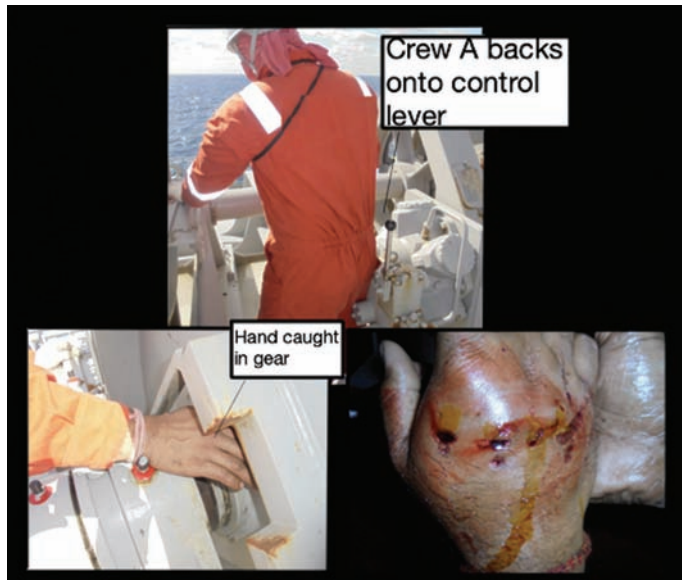
The winch lever safety locking mechanism had not been engaged and at one point, crew member A accidentally touched the winch control lever with his back, which caused the winch to move in the heave-up direction. His hand got stuck in the winch gear engaging assembly and he shouted for help. Crew member B immediately stopped the winch and, after checking with crew member A, slowly moved the winch in the opposite direction to clear his hand from winch.

- Tool box meetings are serious affairs and should account for all known risks and reiterate PPE use. In this accident it is hard to imagine that the tool box meeting accomplished this end.
- If machinery is running, as in the greasing phase, at no time should parts of your body be close to the moving parts of the machinery.
- If body parts are to be close to machinery that can potentially move, as in the excess grease cleaning phase of this report, lock out – tag out (LOTO) procedures should be employed. In this case, the power supply to the winch should have been locked out before the grease clearing began.

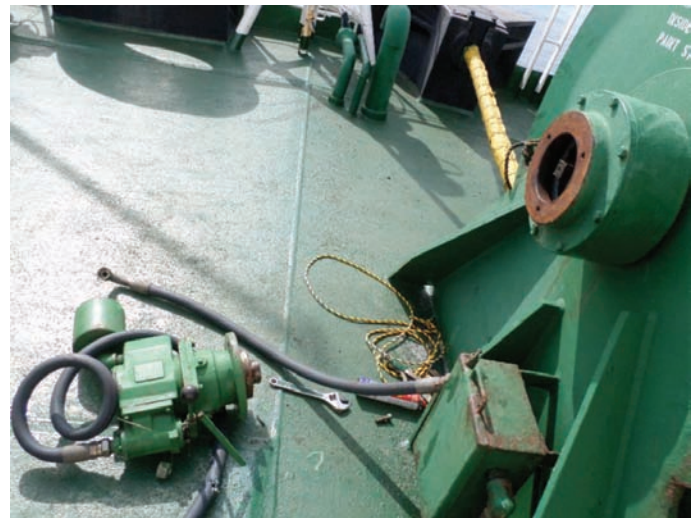
The motor, which weighed about 50kg, was dismantled and transferred to the engine room for lubrication and maintenance. Once completed, the motor was brought back on deck and re-installed using the three mounting bolts. The bolts were inserted but, for reasons unknown, were not tightened up completely.

The air supply valve of the motor had been closed and properly tagged during the maintenance, but now the valve was reopened to proceed with the test. As the air pressure turned the motor a strong torque developed and the motor began vibrating rapidly and unequally due to the unsecured bolts. The motor quickly came away from its mounting and struck the two crew members. Both were injured severely enough to require shore treatment and repatriation.

- Humans are fallible and a slip, lapse or mistake can happen. Always review and cross-check your work before testing a newly installed or maintained piece of machinery.
- Risk assessments should be completed for all aspects of a job and safeguards established against all identified risks.
