Mariners' Alerting and Reporting Scheme

MARS Report No. 316 February 2019

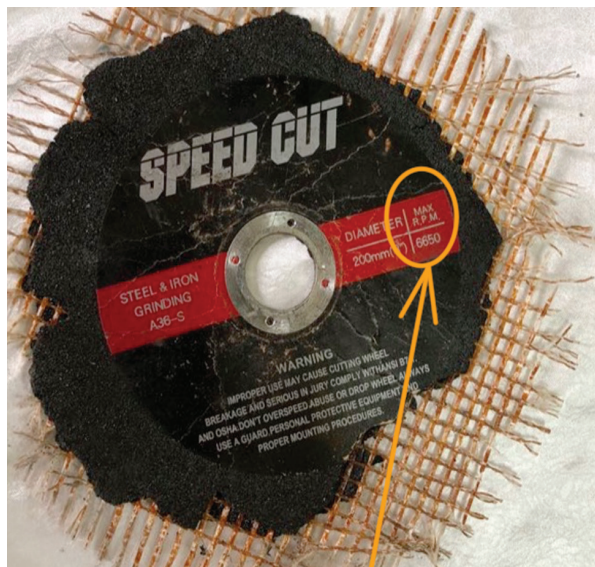
Once the pipe was cut, the fitter positioned the pipe in a vice to grind the cut end. Shortly after he began to work the grinding disc shattered into fragments. Although the guard was fitted, some of the fragments hit the fitter's left hand, which was protected only by a thin glove. He sustained a deep open cut.

- The grinding disc was designed for a maximum of 6,650rpm, but the grinder was designed to rotate at 8,500rpm, nearly 22% faster than the permitted speed of the grinding disc.
- Before starting the job, information on the angle grinder's design speed and the manufacturer's instructions were not checked to verify correct use of the equipment.
- Although the grinder's protection guard was in place, it was not at the correct angle to afford proper protection.

The disc was meant to be used at a maximum of 6,650rpm

- Angle grinders should be marked with their design specifications to help crew check them easily against the discs in use.
- The RPM rating of the disc or blade must be equal to or higher than that of the angle grinder.
- Guards should be adjusted to deflect flying particles away from operator. The guard between the operator and the wheel should be at an angle of 180°.

- Hand protection is essential when grinding. Only robust leather gloves are acceptable.
- Cutting wheels or discs should not be used for grinding jobs, nor should grinding wheels be used for cutting jobs.
- Wheels should be used solely for the specific material and purpose for which they are designed, and always according to the manufacturer's recommendations.
- The British Abrasives Federation recommends using abrasive discs that comply with standard EN 12413:2007+A1. The standard stipulates that discs must be marked with a date of expiry that is no more than three years after the date of manufacture.
- Wheels worn small through use should be discarded and never used on smaller machines.

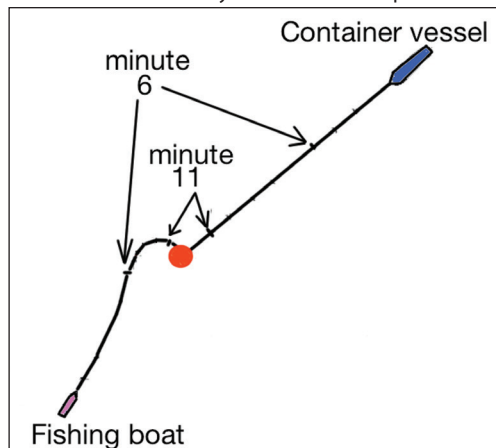
→ A container ship was underway on the open sea in darkness and during a rain storm, on a course of 228° and at a speed of almost 17kt. The helmsman and OOW were each at a radar but were engrossed in a social conversation with each other. The helmsman sighted the port sidelight of another vessel at a distance of about 0.6nm on the starboard bow and reported the sighting to the OOW. About one minute later, after changing the range of his radar from 12nm to 6nm, the OOW saw the vessel in question and thought it was crossing ahead on the starboard bow – the distance was now about 0.3nm. The OOW ordered 15° to starboard and blew the ship's horn, then gave the order for hard to starboard.

The other vessel, a fishing boat proceeding at about 8kt, changed course to starboard at the last minute because the OOW on that vessel believed a port-to-port passing was required.

Notwithstanding these actions, the container ship collided with the fishing boat. The crew of the fishing boat abandoned into a lifeboat and were later recovered by the container ship. The fishing boat later sank.

- Lookout, lookout, lookout. Had a proper lookout been kept on each vessel this collision could easily have been avoided.
- A good lookout is always necessary but extra concentration and vigilance is needed in darkness and in reduced visibility such as during a rainstorm.
- VDR data confirms that the container ship's radar was showing the fishing vessel's echo fully 14 minutes before the collision. The bridge team were preoccupied with their conversation, which probably helps explain why they only saw the fishing vessel at the last minute.
- The OOW on the fishing vessel had seen the container ship but he did not adopt a proper systemic methodology for tracking it. At the last minute he acted on assumptions that contributed to the collision.

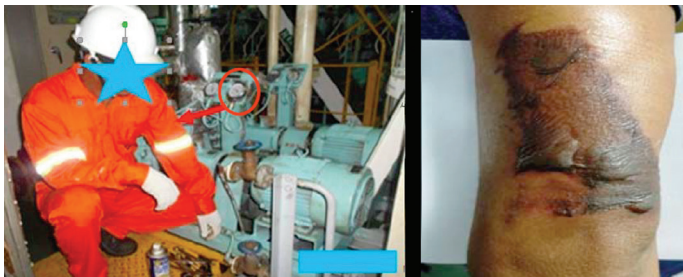
As the rating was securing the tools near the work site, the steam inlet pipe to the pressure gauge gave way and hot water and steam splashed over the victim's left arm. He sustained second degree steam burns on his left hand and was sent to a shore hospital for further medical attention.

- The engineer in charge did not check the tightness of the fitting (ferrule with pressure gauge) prior to opening the steam valves.
- The newly renewed pressure gauge and its associated components were not tested for a sufficient time at normal working pressure.

- Testing of newly renewed pressure components should be carried out at working pressure and for a sufficient time interval to assure the integrity of the job.
- The area near the components should be cleared of personnel during the test.

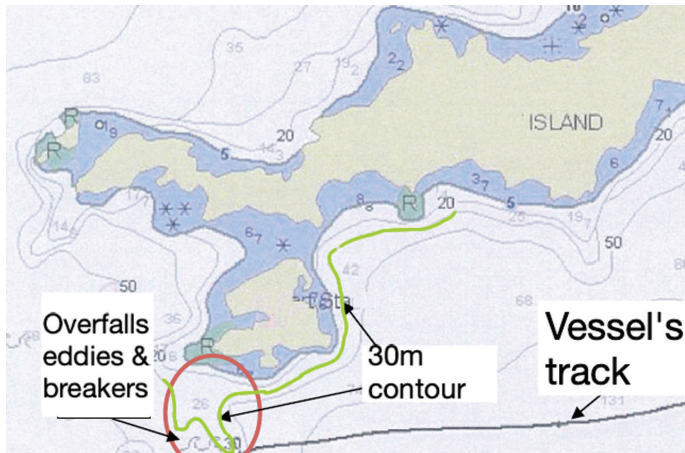
While the Master was focused on manoeuvring the ship to facilitate the safe recovery of the rigid-hulled inflatable boats and communicating with the operation taking place at the ship's stern, the ship drifted very near the island and it struck an uncharted rock. The rock pierced the hull in an empty void tank, which flooded with water. The damaged compartment had little effect on the ship's stability, and the ship was able to continue to another island before returning to port for temporary repairs. Nobody was injured.

- The standard of bridge resource management on board the vessel did not meet good industry practice.
- The electronic chart display and information system was the primary means of navigation on board the vessel, yet the operating crew were not fully familiar with the capabilities and the limitations of the equipment and were not making best use of it.

- Undoubtedly, some rocks and shoals remain uncharted. Coming close to shore in areas where hydrographic information is sparse can be a risky proposition.
- If the shallow contour parameter had been set to 30m, the ECDIS would have displayed a warning or alarmed when the vessel was predicted to cross the 30m contour, thus giving better situational awareness.
- Every part of a ship's voyage must be planned, and all members of the bridge team must be fully familiar with the plan and agree to it. This is a cornerstone of effective bridge resource management.
- Good bridge resource management relies on a culture where challenge is welcomed and responded to, regardless of rank, personality or nationality.

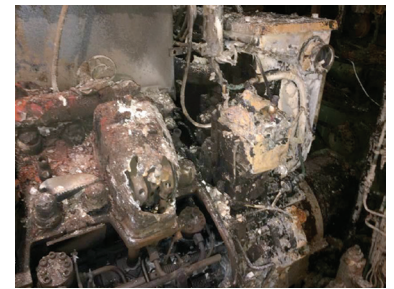
An investigation was started and it was found that the top bolt of the fuel inlet pipe was missing from one of the fuel pumps. It is highly probable that the bolt worked loose because of the vibration of the engine, which may have been a result of the bolt being incorrectly torqued in the first instance. Fuel had then made contact with a hot surface and ignited.

Some of the damage incurred

- Fixed fire suppression systems work well... when they work. In this case, the zone sprinklers had to be manually activated, which gave more time for the fire to grow. Boundary cooling and cool heads will always work.

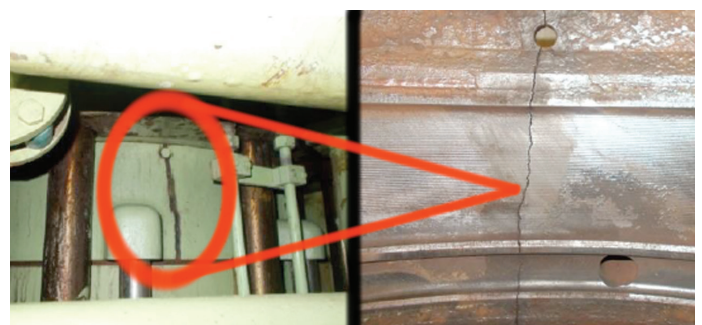
Crew already stationed at the bow were asked to lower the starboard anchor to water level for immediate use. The bridge was then informed that the automatic slowdown was caused by a crack in the main engine unit number two cylinder jacket cover, which had caused a loss of pressure in the cooling water system. The vessel was maintained in safe waters on the bank of the channel using the bow thruster and helm. Tugs were called for additional safety. The propulsion was restored by isolating the number two unit and the vessel brought to berth.

- The investigation found that one of the four screws that secured the jacket had not been tightened correctly. This in turn had affected the gap between the cooling jacket and the screw head, causing the cooling jacket to crack.
- Irrespective of the actual cause of the failure, the bridge team reacted with aplomb by overriding the automatic slowdown for the time needed to place the ship in a secure position, avoiding any further damage.
