Mariners' Alerting and Reporting Scheme

MARS Report No. 313 November 2018

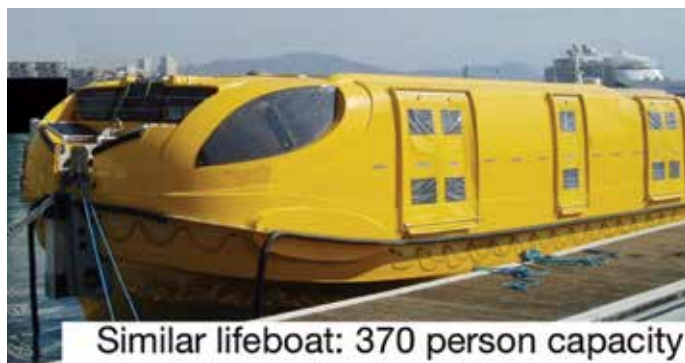
➔ On a passenger vessel, two members of crew were preparing a lifeboat for lowering as a drill. The lifeboat's doors were opened and the two locking pins were inserted in the dedicated slots. The lifeboat was lifted slightly from the stowed position so that the forward and aft lashing gripes could be retracted. The aft lashing lever was released by one crew member and the lashing gripe retracted normally. The other crew member was busy disconnecting the battery charging supply cables and checking that the engine was ready to start. Somehow, both crew forgot about the forward lashing lever. It remained in position and thus the bow of the boat remained secured.

Soon afterwards, other crew members arrived to assist in the lowering: five to man the boat and one to lower the boat. The crew member who was to lower the boat did not visually check the fore part of the boat. He released the winch brake, and the stern of the boat immediately started to descend, but the bow was locked in the guide by the forward lashing gripe. The lifeboat was destabilised and tilted heavily backwards. Under the combined effects of the excessive inclination and the weight, the bow of the boat freed itself from the guide and the forward long-link slipped out from its release hook. The lifeboat tilted heavily forward, creating a new imbalance. The aft long-link in turn slipped from its hook, tearing its stop pawl. The lifeboat then fell into the sea with a forward tilt angle.

Due to the force of the impact, the forward hook-man was fatally injured. Two other crew were seriously injured and two more sustained minor injuries.

- Lifeboat accidents continue to happen despite the introduction of gear incorporating extra defence mechanisms to help prevent falls. Human error is still a major contributing factor to lifeboat accidents.
- When performing lifeboat lowering manoeuvres it is vital to follow procedures strictly.
- If the lifeboat lowering crew cross-check procedural steps, they are more likely to catch mistakes before negative consequences occur.

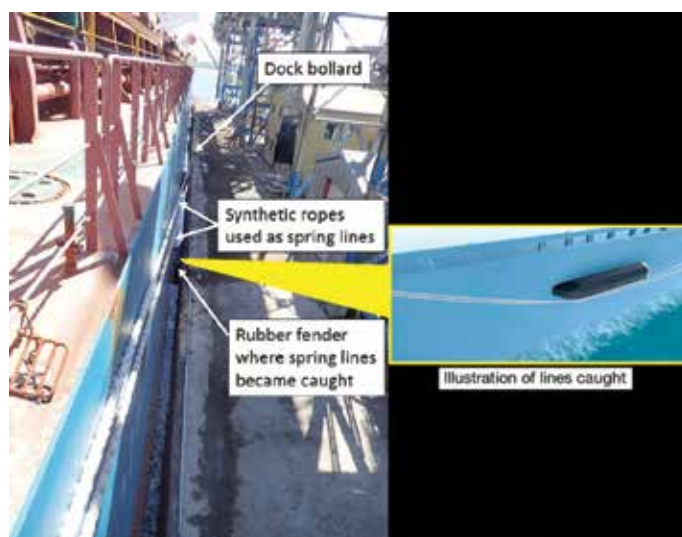
The spring lines were under increasing tension, and the linesmen heard the typical sound of synthetic ropes being stretched. The linesmen noticed that the mooring lines were caught on a fender, and were not leading in a straight line from the vessel's fairleads to the dock bollard as they would normally. They informed the ship's bridge team by VHF radio.

The information was relayed to the OIC. He leaned over the vessel's side to assess the status of the mooring lines and then ordered the mooring party to heave on the winch to put more tension on the lines. The pilot ordered the forward tug to stop pushing. A few seconds later the vessel's bow started to shift sideways and away from the dock's fenders. One of the linesmen on the dock shouted to back away from the handrail. The OIC moved back for a few seconds, but then came forward and leaned over the handrail again to look down at the point where the spring lines were catching.

Suddenly, the two spring lines came free of the fender and sprang upwards like a slingshot. One line went well above the handrail, hitting the OIC on the chin. He fell unconscious to the deck.

- This incident is testament, once again, to the dangers of mooring work. Be aware of your environment and the potential hazards.
- The energy within mooring ropes can easily injure or kill. Always use extreme caution when working within the mooring area, even if snapback areas are undefined.
- If there is no clear, unimpeded path from fairlead to bollard, do not increase tension. Slack or hold until the obstruction has been cleared.

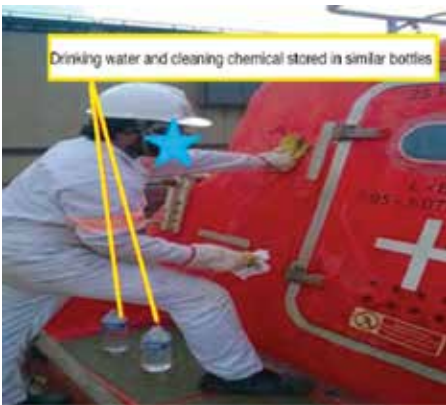
➔ A junior officer was assigned to clean a lifeboat during dry docking. He took a small amount of tank cleaning chemical in an empty plastic mineral water bottle for the task. Because there were no drinking water arrangements available at the jetty, he also carried with him some drinking water in a similar bottle. The two bottles were unmarked except for the water brand label; both liquids were clear.

While cleaning the lifeboat the officer picked up one of the bottles, assuming it contained the fresh water and took a drink. However, it was the tank cleaning chemical and not the water. As soon as he realised this, he spat it out immediately. He soon started getting an irritation in his mouth and throat, which persisted for some time. He was given immediate first aid and was later taken to hospital for further checks and medical attention.

- Always transfer the chemicals in the chemical storage area
- Use a container in good condition and of the appropriate type for the chemical
- Ensure that the containers are clearly labelled. The labels should be clean and legible and should include: full product name, manufacturer name and material safety data sheet (MSDS) reference. Never use drinking water bottles for the storing/transferring of chemicals.

Tank cleaning chemicals should not be used for cleaning lifeboats.

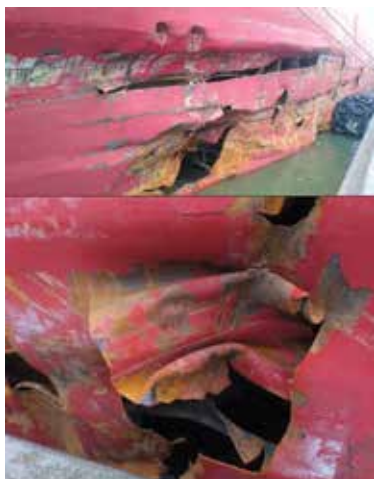
The general cargo vessel collided with the rock barge. At this point, the vessels remained locked together but stopped dragging anchor.

Collision damage with rock barge

- Good seamanship is, in part, anticipating weather and acting before conditions deteriorate.
- If severe weather impedes progress, good seamanship usually means having to heave-to and ride out the storm. It can also include deploying one or more anchors to supplement the ship's propulsion in overcoming the effect of the weather.
- From this report it is unclear what specific manoeuvres with helm and engine the Master was using to attempt to turn the vessel. Using robust astern thrust will often help bring the stern into the wind.

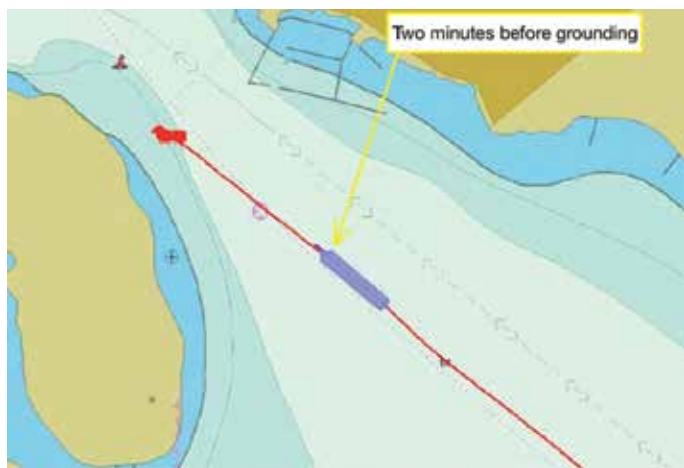
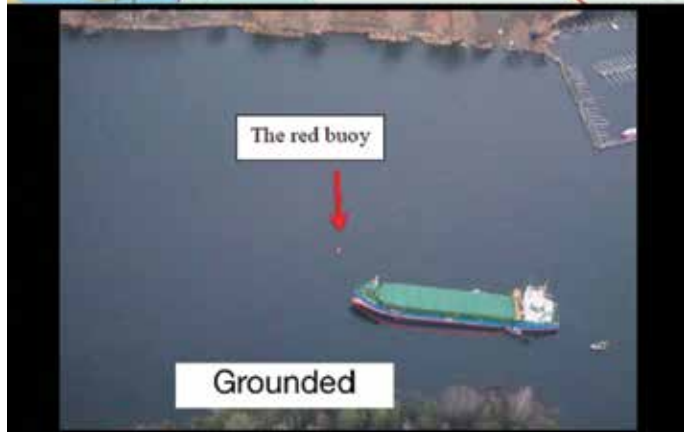
The bridge was manned by an OOW and the pilot. At 04.31 the pilot informed the OOW that about half an hour remained before they would reach their destination; the Master came back up on to the bridge at about this time. The pilot set the course to 309° on the autopilot, steering in the direction of the red buoy ahead, which was the location of the next course alteration to port. The pilot began reducing speed and simultaneously switched over to manual steering. After a few minutes the pilot discovered that the vessel was on the wrong side of the buoy. He was not able to turn, but stopped the engine before the vessel ran aground at about 04.50.

- The vessel lacked charts for the intended voyage, meaning that it was not seaworthy according to applicable regulations and the shipping company's ISM scheme.
- No voyage plan had been completed, which coincided with the lack of charts.
- Bridge co-operation (BRM) before the grounding was limited, with very little communication and no participation by ship's crew.
- At the time of the grounding it is probable that the pilot's level of alertness had been adversely affected by fatigue as a result of cumulative sleep deficit, the time of day, the long pilotage and the lack of opportunities for rest and recovery.

- Do not undertake a voyage without the proper charts and a detailed voyage plan.
- Actively participate in pilotage: check the position, watch the helm orders, maintain situational awareness.

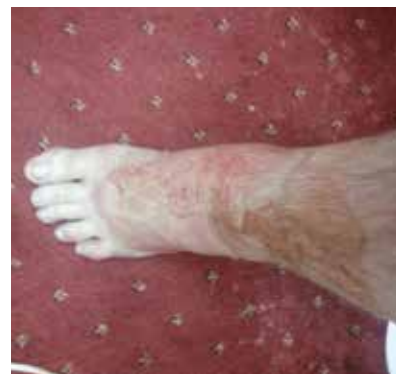
→ The crew of a tanker were undertaking cargo tank cleaning operations while at sea. Two boilers were in use. The deck steam valve in the engine room was unintentionally opened far more than the required 20–40%. This resulted in a surplus of steam and decreased the water level in the boiler. The feed pump started (in auto mode) to replenish the water in the boiler, which in turn created a low level of water in the hot well.

Due to the surplus steam, the return line was filled with a volume of steam that exceeded the condenser capacity. Steam filled the condenser and subsequently escaped into the hot well. Low level alarms were activated on the boiler and then in the hot well. Working in haste, the EOW was focused solely on the boiler low level alarm and did not check the level gauge for the hot well tank before opening it. The steam and water mixture in the hot well splashed on to his feet, causing a severe burn on his lower left leg.

- Mistakes made upstream of a process may have serious unintended consequence later and at point downstream in the process.
- Try and keep your overall situational awareness about you when undertaking a specific task.
