MARS – Lessons Learned

MARS Report No 375 January 2024

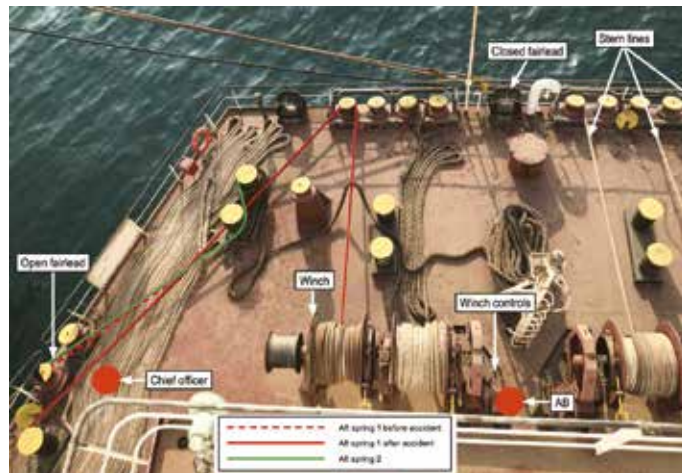
The three crew on watch and the chief officer of the receiving vessel manned the forward and aft mooring decks to warp the vessel forward using the spring lines. The Master decided not to wake the off watch crew to assist as this would disrupt their hours of rest. On the aft mooring deck, the chief officer was standing close to the vessel's side with the other crew standing by the winch ready to heave in the aft spring. As the forward springs were slackened, the winchman aft began to haul in on one of the aft springs to heave the vessel forward. Almost as soon as the mooring line came under tension, it sprang out of its open roller fairlead and struck the chief officer's head as it snapped tight. The victim fell unconscious to the deck.

The accident investigation found, among other things, that the chief officer was standing in a hazardous location but, almost certainly, had not appreciated the risk of the spring line jumping out of the fairlead. The investigation also found that, although the chief officer's working hours were compliant with STCW requirements, he was likely to have been in a fatigued state. This may have influenced his actions and motivated him to complete the job quickly so he could rest.

- An operation to shift a vessel involved in an STS transfer should be assessed for the development of potential new hazards over the course of the operation – for example, the change in relative vertical reference due to draft changes of each vessel.
- During STS transfer operations, mooring lines will develop increasingly vertical leads as the discharging vessel's freeboard rises and that of the loading vessel falls. To ensure containment of mooring lines that have or develop more vertical leads, closed fairleads should be used.
- Always evaluate your physical position at a mooring station and stay clear of potential snap-back or other energy release zones.

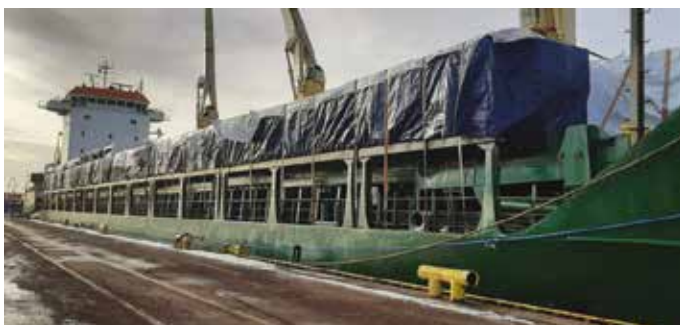
Person A, who was moving aft along the edge of the deck, was caught in the tarpaulin, which then caught the wind and acted as a sail. The other crew present were likewise unable to withstand the forces that acted on the tarpaulin. As a result, person A was pushed over the edge of the deck and fell to the dock. The crew immediately administered first aid to the victim until port rescue personnel arrived. The victim was transported to hospital by helicopter but was declared deceased the next day from injuries sustained.

Several strong gusts of wind force person A under the tarpaulin and push him close to the edge

Person A is pushed over the ship's side and falls to the dock

- Time pressure is no reason to relax safety standards, as tempting as it may be to 'get the job done'.
- Safety leadership means ensuring good practices and that the vessel's SMS is always put into practice.
- A checklist mentality – where you consider ticking the boxes more important than the task they relate to – must be avoided. Remember, most checklists are the result of a risk assessment that was done to reduce harm. Only check 'yes' on something if you have actually done it!

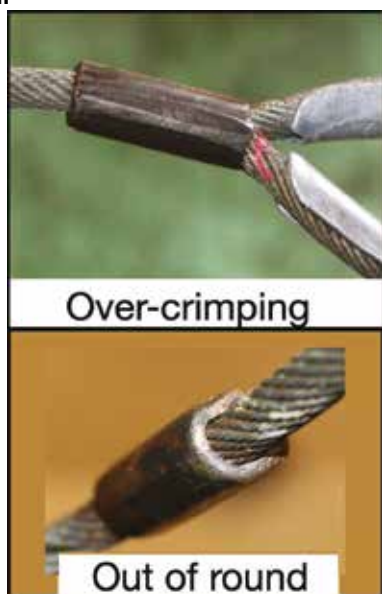
Improperly applied swaged fittings could result in unintentional damage to the wire rope, resulting in failure of the termination. Different types of fittings/end terminations might decrease

the safe working load (SWL) of the wire rope. For example, a swaged sleeve in a common turnback eye results in a 90% or better efficiency of the termination (i.e. 10% or less reduction in the SWL of the wire rope) when properly installed in accordance with manufacturer's recommendations.

- When renewing material such as wire rope and fittings, materials should be selected to match the specifications of the original equipment manufacturer.
- Visually examine wire rope terminations for abnormalities that may indicate improper installation such as out-of-roundness or over-crimping.
- Ensure that the termination type does not reduce the SWL of the wire rope below the minimum safety factor for the type of service.
