MARS – Lessons Learned

MARS Report No 381 July 2024

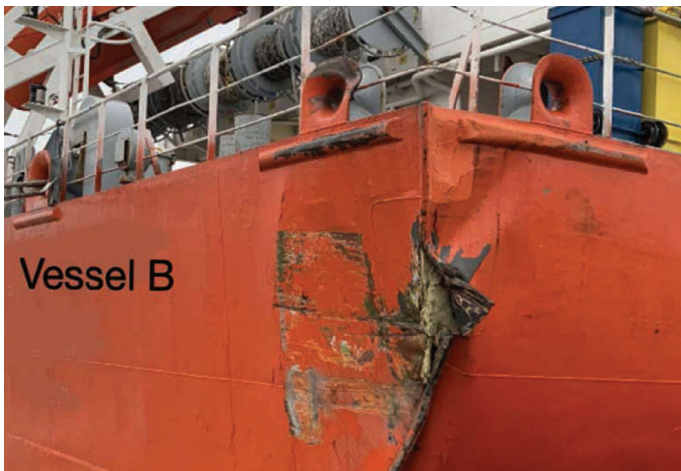
MARS 202435

Over the next 20 minutes, vessel A's OOW continued to undertake other duties on the bridge and was not monitoring nearby traffic. As vessel A approached the drifting vessel B on a virtual collision course a crew member who had been working on deck ran to the bridge and alerted the OOW to the developing situation. Still making a speed of 12 knots, the OOW immediately used the autopilot to initiate a turn to starboard before switching to hand steering to increase the rudder angle. However, the turn was not sufficient to avoid collision 10 seconds later. Vessel A's port side struck vessel B's starboard quarter, resulting in hull damage to both vessels above the waterline.

The preliminary assessment found, among other things, that the ECDIS unit on both vessels was set to silent mode, with all audible alarms deactivated while underway. Also, although vessel B was visible on both of vessel A's radars, the target had not been acquired on the ARPA.

- An OOW should actively navigate the vessel and not undertake any other tasks, ever!
- Activated alarms are an asset when at sea – use them.
- If your vessel's navigational situation changes, set the appropriate instruments and signals to reflect this change in status.

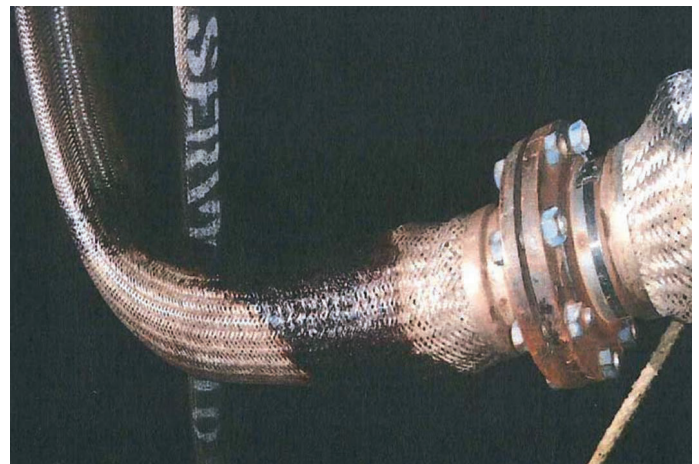
MARS 202437

The bunkering station reported normal operations and no leaks so the rate was gradually increased to 180 tonnes/hr. Soon after the rate increase, a minor leak was observed in the hose and the bunkering was stopped. A small quantity of oil had spread on deck and was cleaned. No oil was seen to be released into the sea.

The bunker hose had apparently been tested under pressure four months earlier but was now clearly less than adequate for the job.

- Visual inspection of a bunker hose before use is necessary but cannot guarantee the integrity of the hose under full operating pressure.
- Vigilance at the bunkering station is a primary defence against pollution. When bunkering in darkness, ensure the hose is well lit and visible along its entire length.

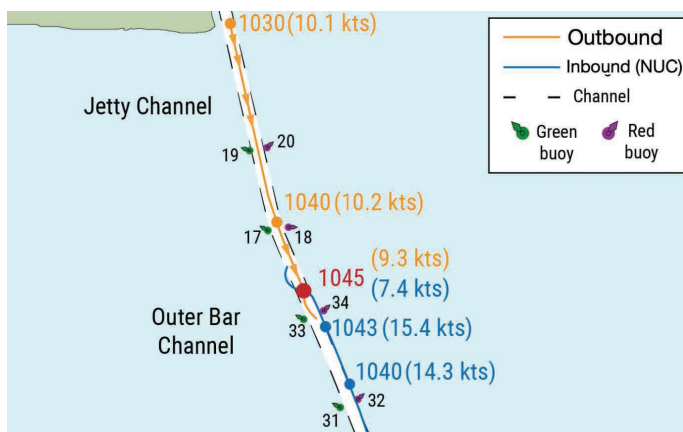
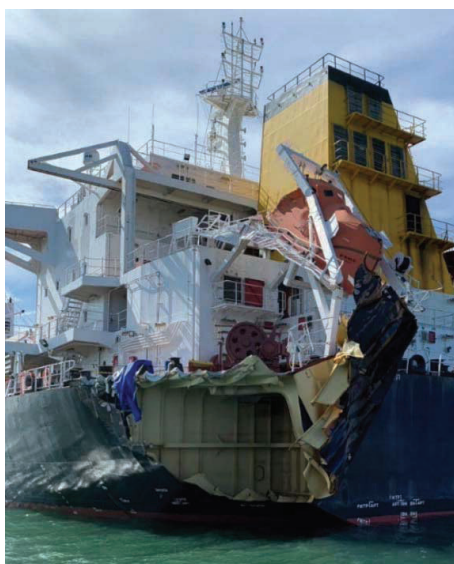
MARS 202438

Two minutes after having lost main propulsion and with the NUC vessel still moving at a speed of 7.4 knots and the outbound vessel at 9.3 knots, the bow of the NUC vessel struck the port quarter of the outbound, peeling back about 12 metres of that vessel’s hull plating forward of the transom and wrapping it around the stern.

The official investigation found that the automatic shutdown of main engine on the inbound vessel was likely due to a false alarm. The investigation posited that the oil mist detector had sensed water vapour resulting from the engine maintenance and incorrectly identified it as oil mist. This had falsely triggered the alarm and ensured the automatic shutdown.

- Cooling water can be introduced into engine lube oil systems during maintenance. Ambient air conditions, such as high humidity or extreme cold temperatures, can also increase the water content within engine lube oil sumps. An elevated quantity of water in lube oil systems can trigger false alarms in engine crankcase oil mist detectors (and lead to an engine shutdown).
- After an engine’s crankcase is opened and exposed to cold or humid conditions during maintenance and repair, it is good practice for engine crews to inspect and test the lubricating oil system for water intrusion and ensure lube oil purifying equipment is functioning properly to remove any water or other contamination in the lube oil.
