Mariners' Alerting and Reporting Scheme

MARS Report No 355 May 2022

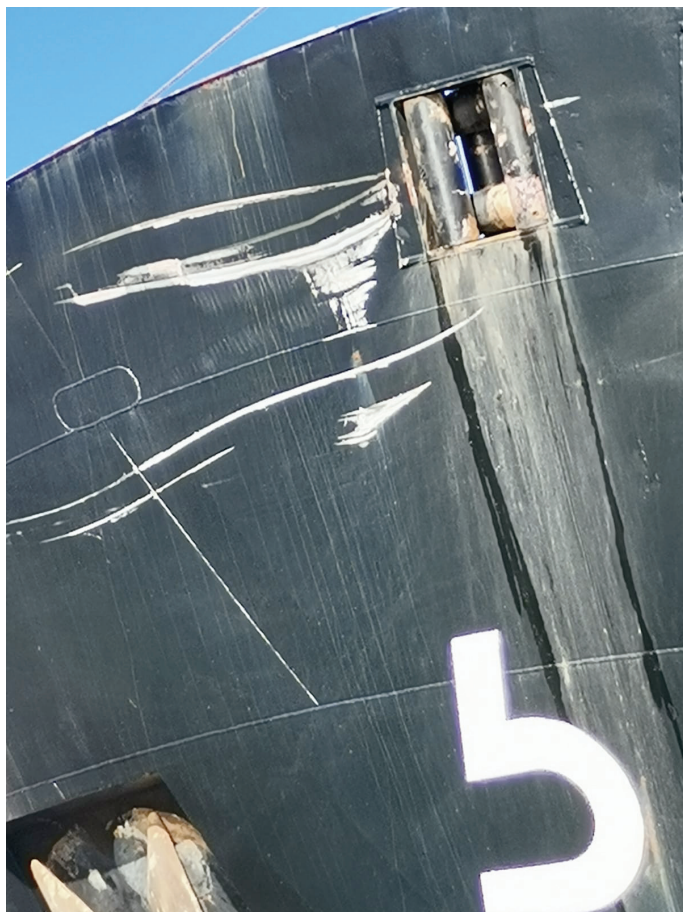
With the oncoming vessel now dragging anchor at about 1.2 knots, the crew at the bow were called back to prevent injuries in the case of collision. The impact was light and caused some scraped paint and a small indentation at the bow just above the starboard anchor.

- Collisions are possible even when both vessels are at anchor. A vigilant anchor watch is always advisable.
- In this case, the vessel that was struck had a vigilant anchor watch, but even that did not save them from a collision. Tight anchorages with vessels less than two cables from each other are fraught with such risks.
- Wind direction shifts in a crowded anchorage can change the risk scenario. What was once a safe situation can change into one of concern.
