# Mariners' Alerting and Reporting Scheme

MARS Report No 356 June 2022

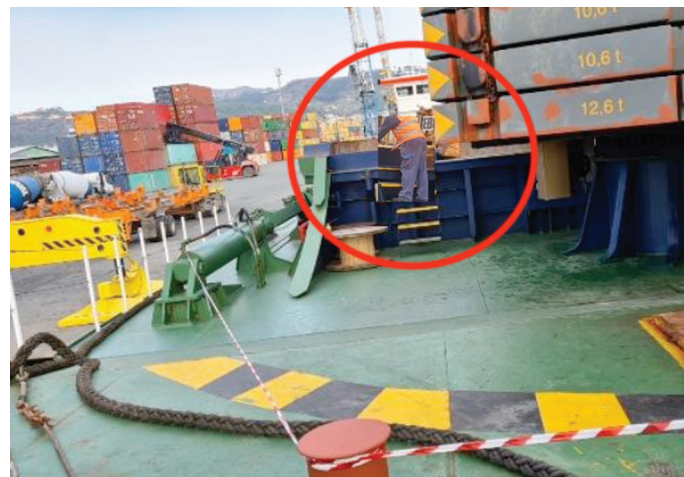
the crane operator had the crane's boom in line with the cargo hold and was picking up a boulder from the hold. Within a matter of seconds, the crane turned clockwise towards the breakwater, trapping the Master between the body of the crane and the cargo hold coaming. (Photo is a reenactment – the red and white danger tape was not present at the time of the accident.)

The investigation found, among other things, that although access to the forecastle from the port side of the cargo hold had been cordoned off by physical barrier system (a chain), access to the forecastle from the starboard side was unobstructed. Black and yellow 'hazardous area' markings were painted in a semi-circle on the deck around the crane, extending from port to starboard. But paint markings are a symbolic barrier system and therefore require interpretation to be effective (as opposed to a physical barrier system).

- While symbolic barriers are better than nothing, their effectiveness is debatable. Physical barriers are much better. And an excellent complement to physical barriers are administrative barriers documented in a vessel's SMS.
- MARS report 201851 documents a very similar accident but one with more serious consequences as the victim, new to the ship, died of his injuries. In that case, not only was there an absence of physical barriers but there were no danger warnings.

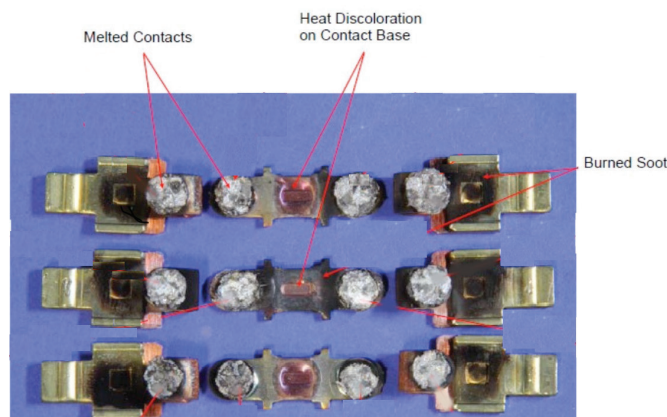
Disassembled contactor during forensic analysis (Image courtesy Chevron North America)

Metallurgical analysis carried out after the event found that the failure occurred when the winch control contactors fused together due to the duty rating being exceeded. Additionally, it appears that the contactors were not rated for intermittent cycling (repeated start/stop sequences) of the winch. After inspection on other installations, several contactors showed evidence of overheating and indications of welded and scorched contacts were found.

- Verify the condition of winch motor contactors and replace any contactors that show signs of excessive wear, overheating, or welding.
- Check the duty cycle ratings of lifeboat and rescue boat davit electrical components and compare those ratings to recommended and commonly-practised boat recovery procedures/processes.
- Confirm the design of the davit safety devices (ie, E-stop and limit switches) to see if they will secure electrical power to the motor in the event of welded contacts.
- Implement training for all personnel that operate the davits to ensure awareness related to electrical duty cycles and the actions needed to isolate power in the event of a welded winch motor contactor.
