Mariners' Alerting and Reporting Scheme

MARS Report No 356 June 2022

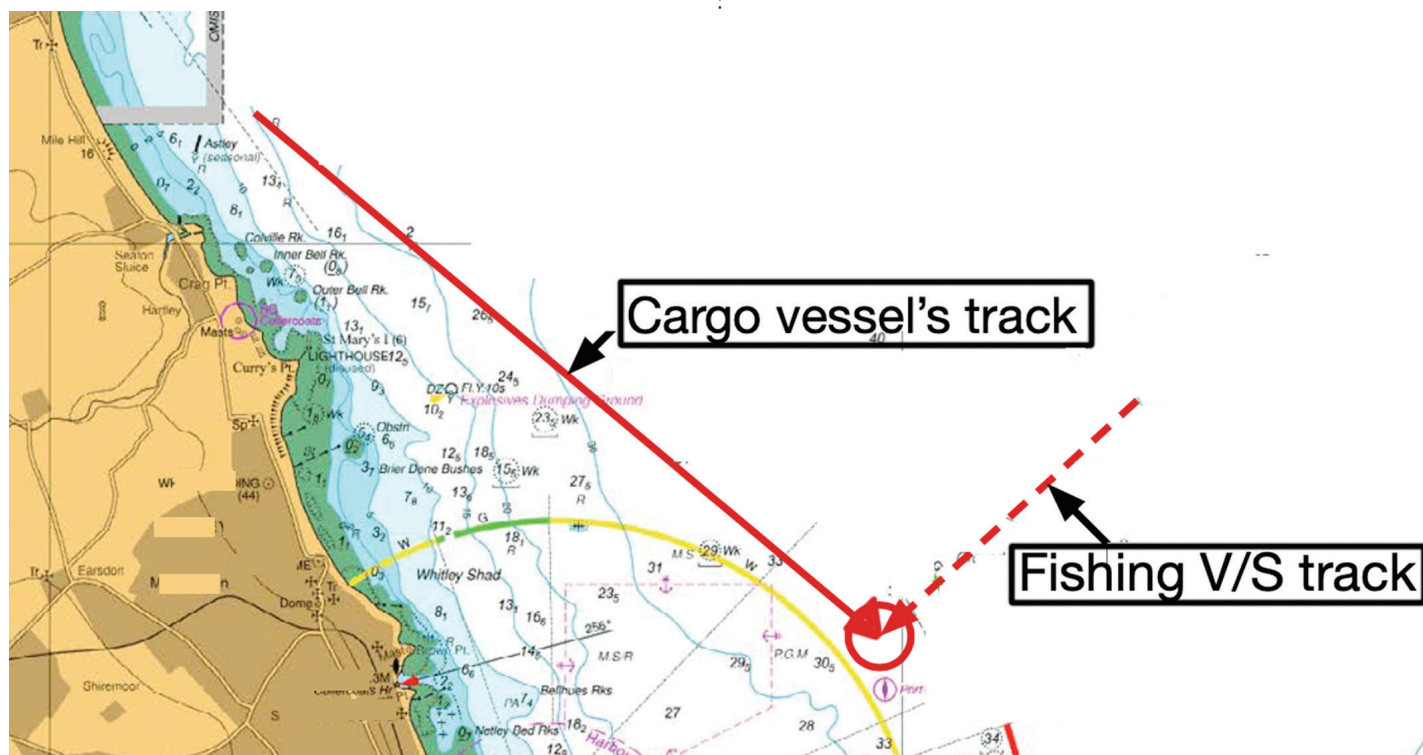
Suddenly, they both saw the fishing boat emerge from the fog, 30° on the port bow. The OOW sounded one long blast on the ship's whistle and then switched the helm to manual control and put the rudder hard-to-starboard. This action was too late, and the fishing vessel struck the cargo vessel's port side. The fishing vessel's captain and deckhand were thrown to the deck by the force of the collision. The crew of the fishing vessel were rescued, but the fishing vessel eventually sank due to an ingress of water.

The report found, among other things, that neither vessel was making sound signals, which could have alerted them to the other's presence. Of course, with the captain of the fishing vessel not even in the wheelhouse, an effective lookout was impossible on that vessel. The report also found that, due to administrative duties that distracted from his navigation, the OOW of the cargo vessel became aware of the fishing vessel's radar return only when it was less than 1nm away. At that range, and with a closing speed of about 11 knots, it gave him only about five minutes to assess the risk of collision and take avoiding action.

- Navigating in fog is not a time to undertake administrative duties in lieu of navigation.
- Some fishing vessels, especially those made of wood, can give poor radar returns. Constant attention to the radar is needed in poor visibility to detect small targets such as these as soon as possible.
- AIS is a useful tool for detection but not all vessels, especially fishing vessels, are so equipped.
- This lesson learned is a recurring one for MARS reports ... When in doubt, slow down.

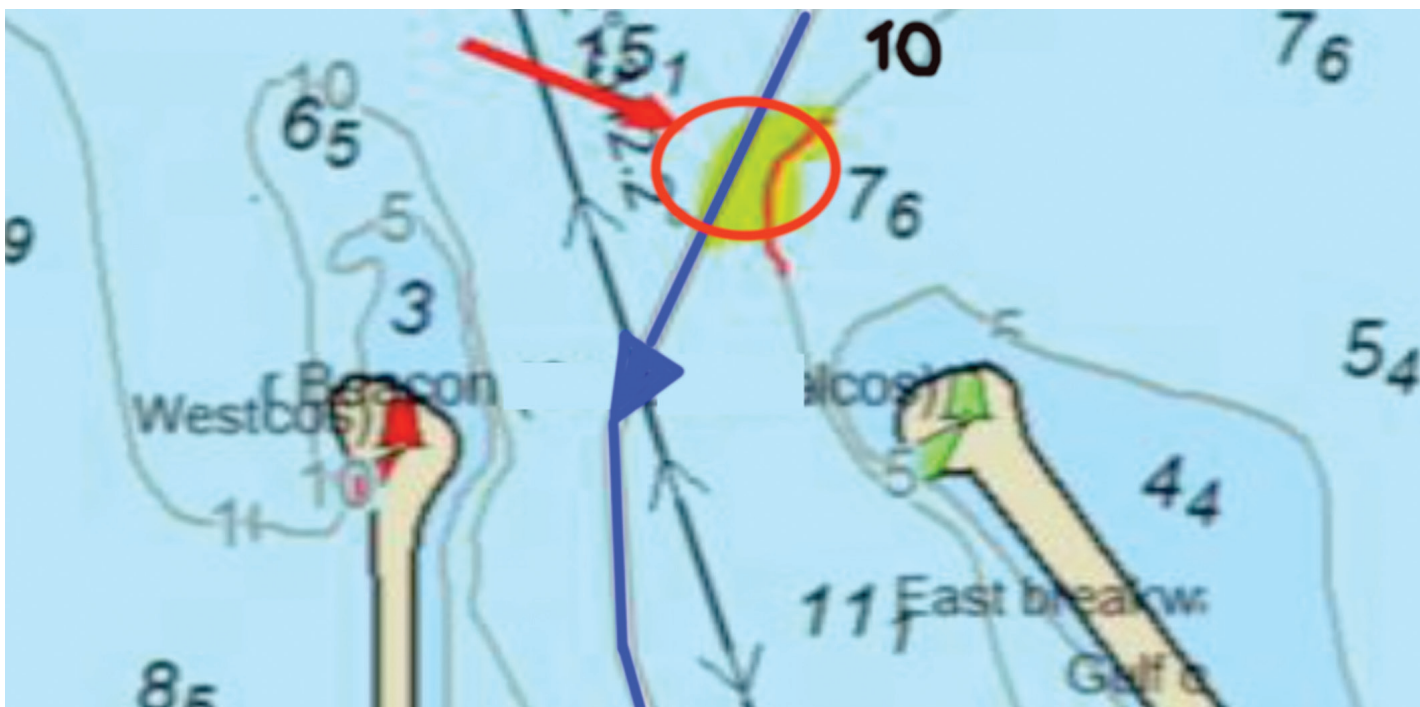
Almost immediately a strong vibration was felt throughout the ship and the vessel started swinging to starboard. The pilot ordered 'Stop the engine'. The bridge team now knew they had touched bottom and the depth sounder was turned on. It showed 1m.

Tanks were sounded and water ingress was discovered in the port side ballast tanks.

- Once again we have the classic question of when and how to challenge a pilot. In this case the Master warned the pilot but it appears this was already too late. Being too far to the east of the port entry leading lights from the beginning was a red flag that should have been resolved before the vessel came close to the breakwaters.

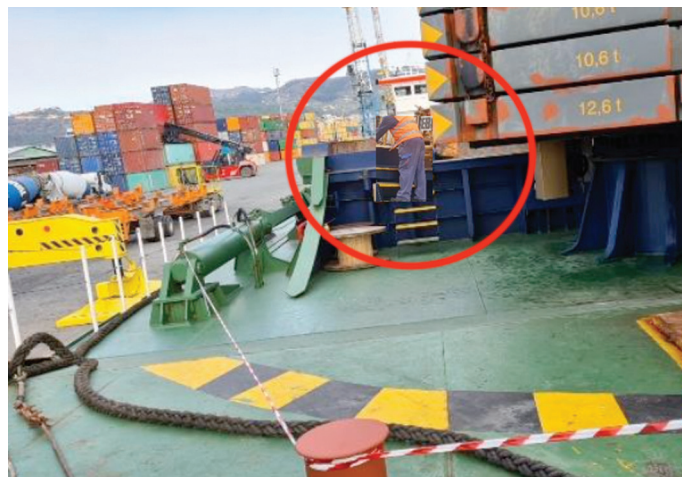
the crane operator had the crane's boom in line with the cargo hold and was picking up a boulder from the hold. Within a matter of seconds, the crane turned clockwise towards the breakwater, trapping the Master between the body of the crane and the cargo hold coaming. (Photo is a reenactment – the red and white danger tape was not present at the time of the accident.)

The investigation found, among other things, that although access to the forecastle from the port side of the cargo hold had been cordoned off by physical barrier system (a chain), access to the forecastle from the starboard side was unobstructed. Black and yellow 'hazardous area' markings were painted in a semi-circle on the deck around the crane, extending from port to starboard. But paint markings are a symbolic barrier system and therefore require interpretation to be effective (as opposed to a physical barrier system).

- While symbolic barriers are better than nothing, their effectiveness is debatable. Physical barriers are much better. And an excellent complement to physical barriers are administrative barriers documented in a vessel's SMS.
- MARS report 201851 documents a very similar accident but one with more serious consequences as the victim, new to the ship, died of his injuries. In that case, not only was there an absence of physical barriers but there were no danger warnings.

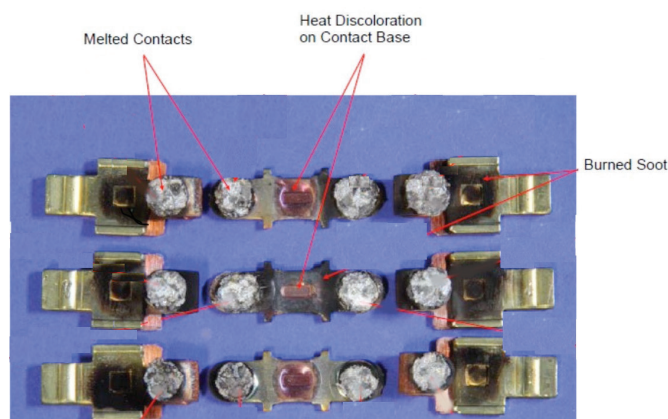
Disassembled contactor during forensic analysis
(Image courtesy Chevron North America)

Metallurgical analysis carried out after the event found that the failure occurred when the winch control contactors fused together due to the duty rating being exceeded. Additionally, it appears that the contactors were not rated for intermittent cycling (repeated start/stop sequences) of the winch. After inspection on other installations, several contactors showed evidence of overheating and indications of welded and scorched contacts were found.

- Verify the condition of winch motor contactors and replace any contactors that show signs of excessive wear, overheating, or welding.
- Check the duty cycle ratings of lifeboat and rescue boat davit electrical components and compare those ratings to recommended and commonly-practised boat recovery procedures/processes.
- Confirm the design of the davit safety devices (ie, E-stop and limit switches) to see if they will secure electrical power to the motor in the event of welded contacts.
- Implement training for all personnel that operate the davits to ensure awareness related to electrical duty cycles and the actions needed to isolate power in the event of a welded winch motor contactor.
