# Mariners' Alerting and Reporting Scheme

MARS Report No 360 October 2022

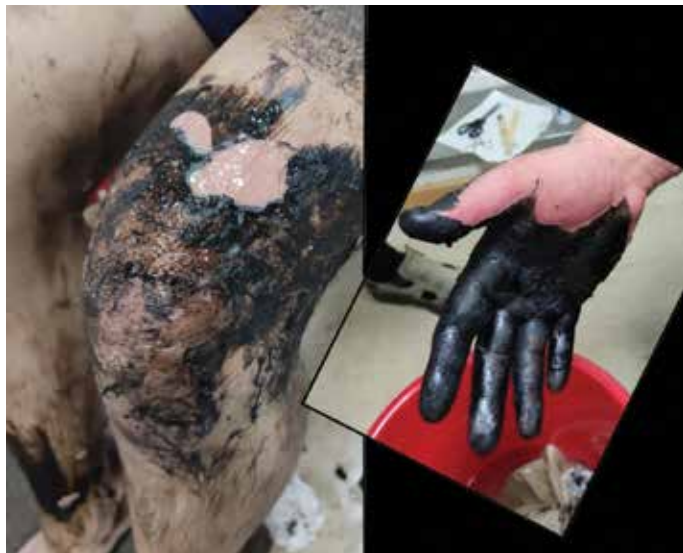
Procedures also specified that two crew should always enter the engine space together. Despite this, the engineer on duty entered the space alone, and did not put on his coveralls and gloves as he entered the engine room – again contrary to procedures. Having transferred to the standby separator and shut the alarming separator, he opened the plug of the inspection hole of the sludge discharge line to verify the condition. The discharge line was completely blocked, so this did not decrease the pressure between the blockage and the bowl opening. Hot (40C) sludge oil gushed out of the inspection hole and covered the engineer's arms and legs.

The victim called for assistance and other crew arrived. They attempted to wash the sludge off the engineer's hands at the washstand but the sludge was sticking to his skin. He was escorted to the ship's hospital and pain-killers were prescribed. After consultation, the Master decided to evacuate the victim at the nearest port, approximately 250nm from the vessel's location. In the shore hospital, it was found that

- A long sleeved overall and leather gloves could have greatly reduced the amount of sludge that contacted the victim's skin.
- The regular clogging of the fuel oil separator on board was probably due to the cold flow properties of the particular blend of VLSFO in use. Mitigating action was taken to keep the process running by cleaning the oil separator twice a day, but the source of the problem had not been dealt with. A more detailed analysis of the specific blend of VLSFO, and in particular its cold flow properties, could have solved the separation problems with this blend of fuel.
- Cleaning the separator was not a standard job on board. It was decided to carry this out twice a day to deal with the new batch of fuel, but no further risk assessment or safety measures were implemented to mitigate the risks associated with this job.

- Expect the unexpected - in this case, that the discharge line was completely blocked.
- The discharge line was not equipped with a pressure gauge, since the sludge inside the discharge line is normally not under pressure. It was unusual and unexpected that the sludge was under pressure after switching off the separator.
- This is yet another example where lack of proper PPE was an aggravating factor for the negative consequences.

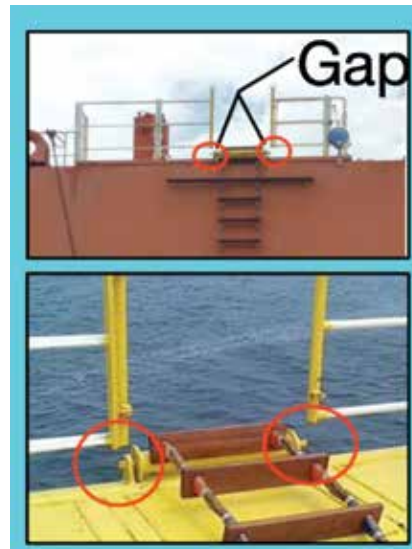
→ The US Coast Guard is investigating a casualty involving a fall from a pilot ladder where the handholds in the gate arrangement aboard the vessel were modified so that the gate arrangement was not rigidly secured to the vessel's structure at the point where the ladder comes

aboard. This left a gap in the handholds where an embarking person might reasonably be expected to reach to pull themselves up.

The gap above the vessel structure appeared to be a modification to allow for the passing of the spreader during deployment and retrieval of the pilot ladder. This made it possible to retrieve the pilot ladder without having to lift the spreader up and over the vessel's railings.

A Safety Alert has been issued, although, at this time we cannot speculate on how this modification contributed to the accident. Readers are reminded that pilot ladder requirements as specified in SOLAS 2004 (Consolidated) and by IMO Resolution A.1045 (27) should be strictly adhered to.

The International Organization for Standardization (ISO) recently published a series of standards aimed at improving pilot ladder safety. These standards supplement existing IMO recommendations and requirements for pilot ladders. Vessel owners and operators, shipboard personnel and system designers are strongly encouraged to review and comply with these standards.

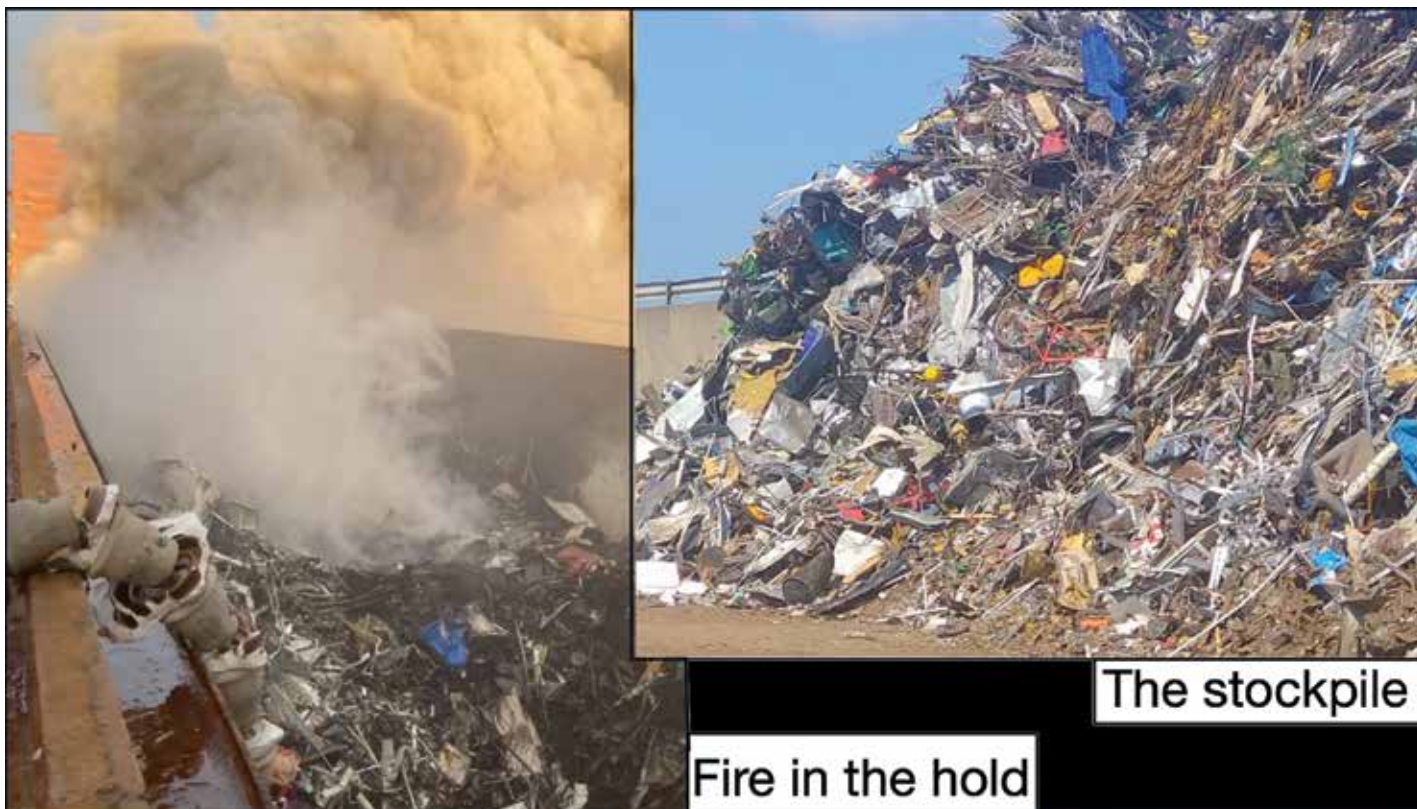
The investigation found that the fire was probably caused by sparks or frictional heat generated during loading, which then ignited flammable liquid or other flammable material within the load of scrap metal. The investigation concluded that management practices in regard to the scrap metal were less than adequate. In particular, the risks of handling metal waste mixed with combustible material had not been adequately assessed.

Fire in the hold

The stockpile

- Sometimes, obvious risks are not seen until an accident happens. In this case, the oil contaminated objects and flammable refuse mixed in with the scrap metal were easy to spot. In cases like this, it is important to have the fortitude and firmness of character to stop loading (or not load) if nothing bad has yet happened.
- Vessels have capsized at berth to firefighting efforts by shore teams. Close coordination is between the Master and fire chief is needed in order to properly execute the extinguishing effort without further risk to the vessel.

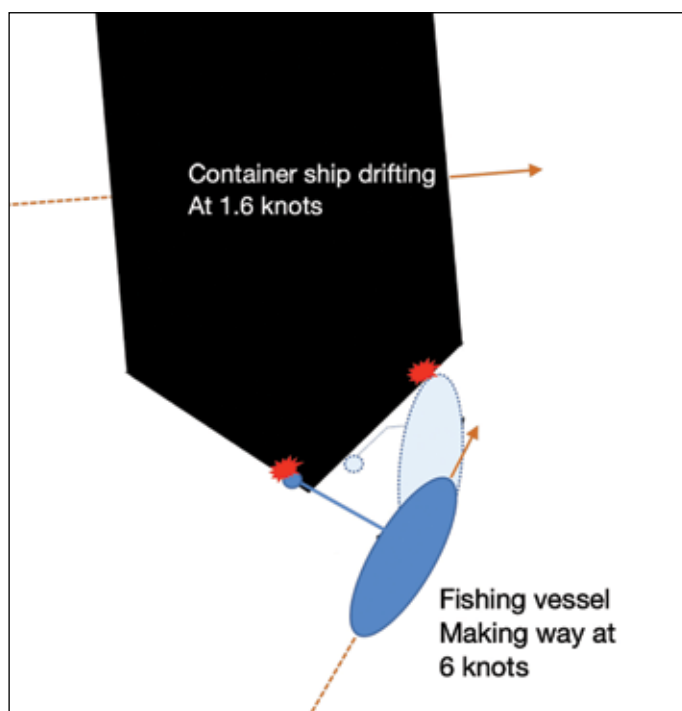
The fishing vessel had crossed the container vessel's bow with the narrowest of margins; so close that the stabiliser arm collided with the stem of the ship's bow. The fishing vessel then pivoted around the stabiliser arm and its port bow collided under the flare of the container vessel's port bow near the anchor. Still on autopilot, and with its engine still driving ahead, the fishing vessel slowly scraped along the container vessel's hull as it rose and fell with the waves.

The investigation found that, although drifting, the container vessel was nevertheless considered to be a power-driven vessel underway and was therefore required to follow the Colregs and take the appropriate action to avoid a collision, which it did not. The container vessel's bridge crew had detected and were plotting the progress of the fishing vessel on their radar. They had correctly identified the target as a crossing vessel, but it did not occur to them that their vessel was the give way vessel.

- All vessels have a part to play in preventing collisions at sea, regardless of whether they are the stand-on or give-way vessel.
- Making assumptions about the intentions of other vessels based on false or scanty information is high risk, which will inevitably contribute to collisions at sea.
- When drifting, you are still a vessel underway and may need to manoeuvre as per the Colregs. Keep your engines at the appropriate level of readiness given the local circumstances.
- Should you wish to attract the attention of another vessel, do not use a laser pointer. Try the Aldis lamp, the ship's searchlight or the ship's horn (at least 5 short blasts).
