# MARS – Lessons Learned

MARS Report No 364 February 2023

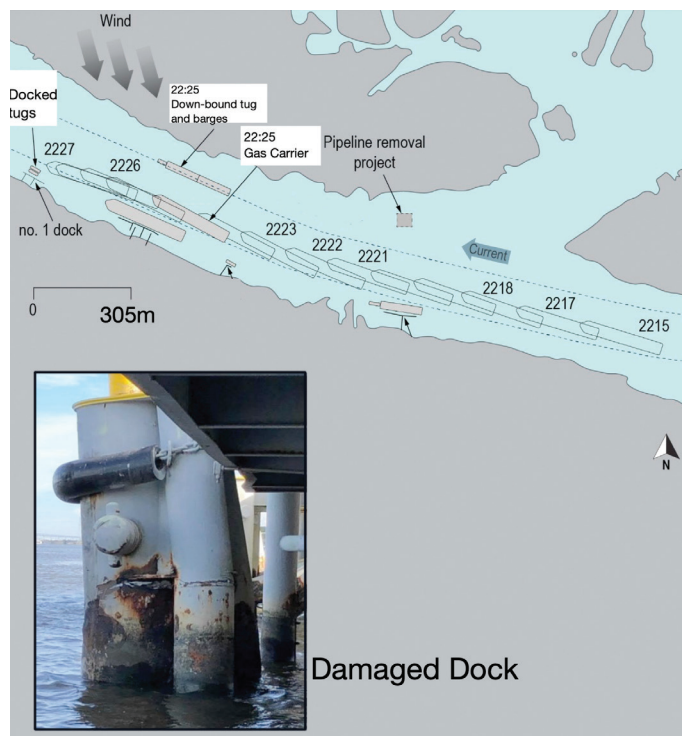
and requested the escort tug to give full thrust as well as various engine and helm orders. The gas carrier's bow was now moving toward some tugs moored at dock number 1 (far left of diagram), so the starboard anchor was released and engine emergency full astern was requested. Notwithstanding these last desperate actions the gas carrier's port bow collided with a berthed tug at dock number 1. Combined damage to the moored tugs and the dock were in the order of one million USD.

Although the NTSB found that the 'probable cause' of the collision was the low speed of the gas carrier causing a loss of rudder effectiveness in strong crosswinds, other factors also contributed. For example, down-bound traffic made for less space at a critical juncture in the narrow waterway. The escort tug secured astern could not effectively help the gas carrier's bow come away from the berthed tugs at a critical instance. Another factor was the darkness, which affects visual perception, acuity and depth of field. This in turn affects a person's responses and timing during manoeuvres. Finally, a following current will adversely affect a manoeuvre making a vessel's speed through the water less than its speed over the ground, thus inherently less manoeuvrable.

- It is often said that hindsight is 20:20. In this case we can see, after the fact, that given the winds and current, a meeting with the tug and barges may have been safer at a spot other than abeam the docked vessel.
- Factors that negatively affect a situation are not always evident at

first but as the situation develops they become risk multipliers. In this case darkness was a pre-existing negative factor. Combined with the winds, the following current, the vessel's slow speed to accommodate the pipeline removal project and the down-bound traffic at a critical juncture made for an almost untenable situation.

- In restricted waterways manoeuvres, it is an advantage that our foresight be as acute as our hindsight. Be mindful of accumulating 'risk multipliers' and act conservatively.

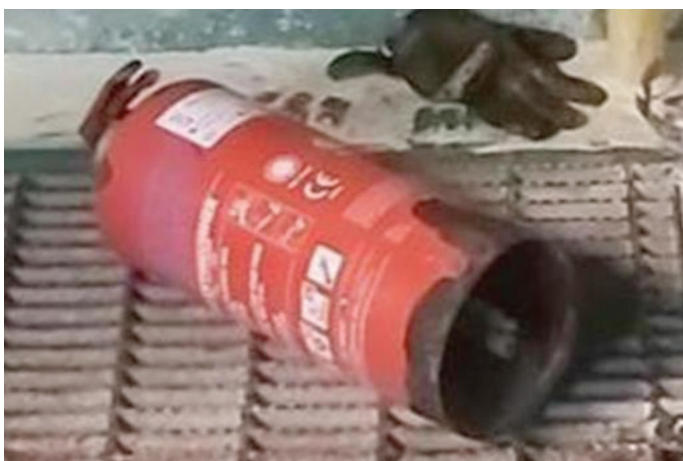
➔ A handheld (cartridge-type) dry chemical powder fire extinguisher was condemned during an annual third-party inspection due to corrosion issues. It was subsequently discharged, ostensibly for demonstration purposes. When the internal carbon dioxide cartridge was activated to pressurise the fire extinguisher, the unit ruptured at the base.

The person activating the extinguisher was struck in the head by pieces of flying metal which proved to be fatal.

- Condemned material should be discarded, not used for demonstration purposes.
- Cartridge-type fire extinguishers that utilise a cartridge to charge the main fire extinguisher cylinder shall be handled with care. The fire extinguisher should be placed on the deck at arm's length from the body. Point the top of the extinguisher away from the body while holding the handle and hose in one hand. Trigger the carbon dioxide charging cylinder with the other hand. Do not energise these types of fire extinguishers near the body.
- Consider using stored pressure type fire extinguishers as opposed to the cartridge type.

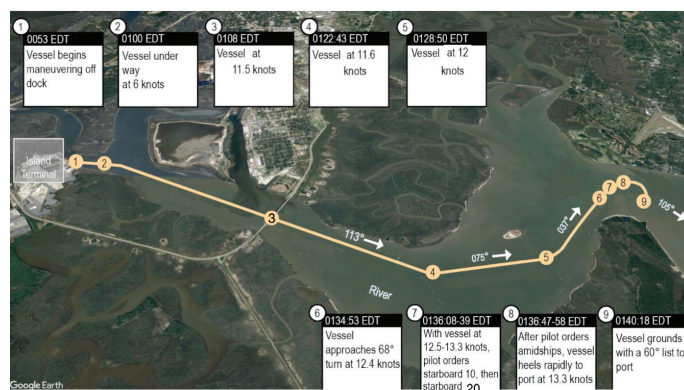
The car carrier's GM at the time of the heeling was not more than 1.8 metres, well below the 2.45 metre GM reportedly calculated in the stability computer. The investigation postulates that the chief officer had entered the data for the ballast tanks into the stability computer manually, and in doing so had made a data entry error. This in turn led to an incorrect determination of the vessel's stability. At a higher level, the investigation found that the vessel operator did not have a method in place (training and auditing) to ensure that the chief officer, although experienced, was proficient in using the shipboard stability computer.

- When only one person is responsible for a safety-critical task without a backup to help identify possible errors, single point failure can occur. Had the Master taken a more active role in reviewing aspects of the vessel's stability and the chief officer's stability calculations, he may have been able to identify the error.
- Given the critical nature of stability calculations on car carriers, it is of utmost importance that operators ensure officers are well trained in the use of the loading computers on board, and that they have adequate procedures in place to guide crew in ballasting practice and sequencing.

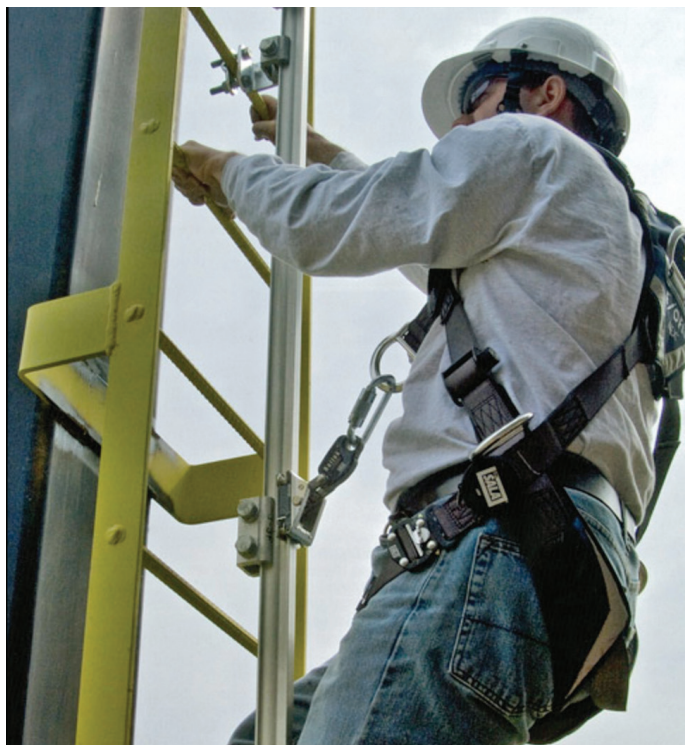
Single strap/clip in conjunction with continuous vertical safety line/rail

- The only way to reduce the risk of falling from a vertical ladder is to use either a double strap/clip arrangement such that one clip is always attached to a secure point or, if a single strap/clip, to use it in combination with a vertical continuous safety line/rail and fall arrestor, as in the photo left.
- If such equipment is not on board, Australian ladders should always be used to enter and exit a hold.
- Never climb or descend a vertical ladder without continuous fall protection. Your life depends on it.

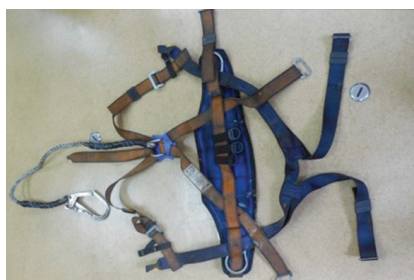
Safety harness used by victim

It could not be determined why the victim, a very experienced seafarer, chose to descend the vertical ladder instead of the Australian ladder. This went against recent practice and the agreed method to enter and exit the hold. The investigation found that although the victim was wearing a safety harness, it was of the single strap/clip variety, not a double strap/clip. There were no indications that the safety harness, lifeline, or clip had failed.

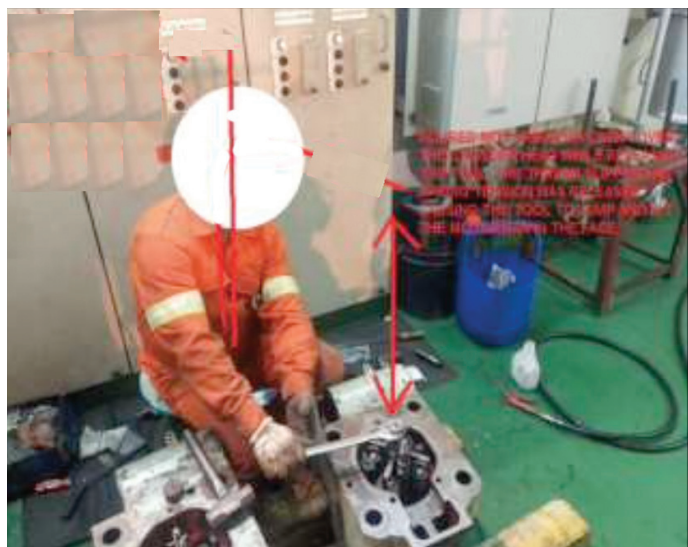
→ A member of the engine room staff was carrying out routine maintenance on an auxiliary engine while the vessel was at anchor. He was extracting the suction and exhaust valves of the auxiliary engine by decompressing the support springs, using the correct tool for the purpose, when the tool slipped and the springs jumped off, striking him on the chin, lower lip and left eye.

Correct position is with back straight – head away from the tool and cylinder head while loosening the nut to avoid such injuries

- When working with elements that have potential energy, proper PPE and correct body position are vital for safety.
