MARS – Lessons Learned

MARS Report No 365 March 2023

MARS 202311

Procedural shortcut undercuts quality

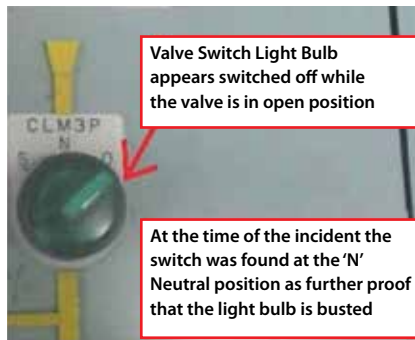
Photo 1

- The light indicating that the tank valve is open was defective. When the vessel arrived at the discharge port, the fact that the light was off was taken as an indication that the valve was closed. (Photo 1, left)

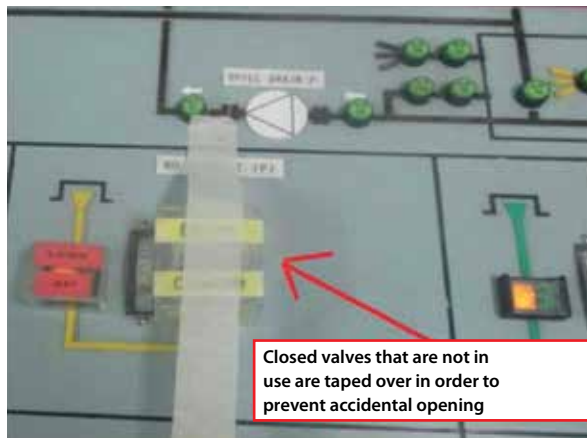
Photo 2

- It was standard practice that when more than one parcel is loaded, the valves that are not being worked are protected by a plastic cover which is secured in position with tape. This precaution causes its own unsafe condition; making harder to visually check the actual status of the valve. (Photo 2)

- Procedures can be (and sometimes are) sidestepped by crew with a mind to ease the workload and accelerate a process. Attention to detail by vessel leaders should nip this practice in the bud before it becomes routine.
- Sometimes, well meaning 'barriers to hazards' put in place by crew, such as the plastic cover protection on the valves of tanks not being worked, can have unexpected negative consequences.

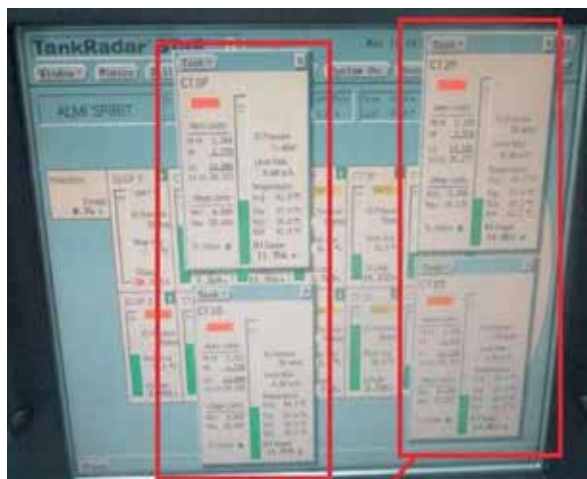
Photo 3

- Other 'barriers' in place to allow timely identification of any deviation from the plan were also sidestepped or otherwise annulled:
- The digital cargo level gauging system screen was rearranged so that the display for the first parcel was shown on top of the other tank readings. It was therefore difficult to see the change in quantity of the second parcel that was being simultaneously discharged. (Photo 3)

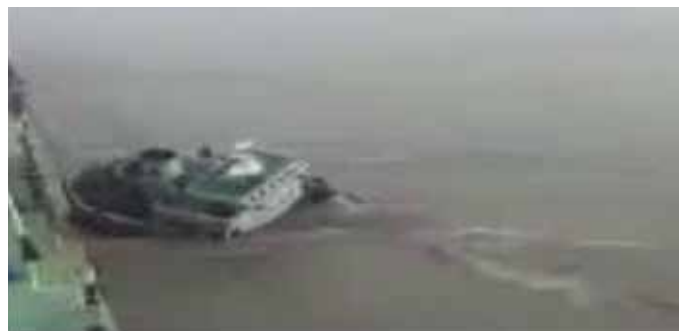
It became apparent that course made good was bringing the bulk carrier into a collision situation with an anchored vessel. In a desperate attempt to avoid contact with the anchored vessel the engine was increased to half ahead and then full ahead and hard port helm ordered. The bulk carrier nonetheless made contact on its starboard side with the other anchored vessel. The lightering barge that was moored on that side sustained major damage and foundered within five minutes. Some of its crew jumped into the water and were recovered. Unfortunately two crew were trapped within the sinking barge and were later declared deceased.

Lightering barge foundering after contact

- Good seamanship would normally see the lightering operations halted and the barges released prior to weighing anchor and re-positioning the vessel. This would have increased manoeuvrability, possibly allowing the move to be accomplished without incident. No fatalities would have been sustained even had the collision nonetheless occurred.
- Low under keel clearance will cause increased drag forces on a vessel and can initiate dragging anchor when all other factors seem benign.

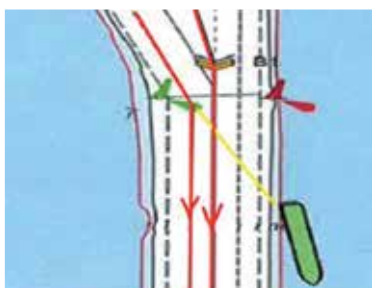
Very soon after ordering full ahead the pilot made another personal call on his mobile phone lasting approximately four minutes and sent a text message image to another pilot on non-urgent business matters. As the vessel approached a course alteration point the pilot ordered a heading of 161°. The helmsman confirmed this order. About two minutes later, the pilot viewed another screen on his PPU with the intention of taking a screenshot from another voyage. This action had the effect of distracting the pilot; he was now preoccupied with saving the screenshot and sending a non-urgent business email to another pilot. Meanwhile, the vessel crossed the inbound lane, overshooting the next course alteration to starboard.

The OOW voiced his concern, stating that the vessel's heading was 161° and speed was approximately 13 knots. The pilot, looking at his phone, verbally acknowledged the OOW but took no action. The OOW then informed the pilot that the pilot's PPU did not match the ship's ECDIS – in which he was correct, as the PPU was still showing a previous voyage that the pilot wanted to make a screenshot of. The pilot put away his mobile phone and began to use the ship's ECDIS, ordering first 15° starboard rudder, then hard to starboard approximately 20 seconds later. The vessel grounded in the mud outside the channel soon afterwards.

— Intended route(s)
— Actual route

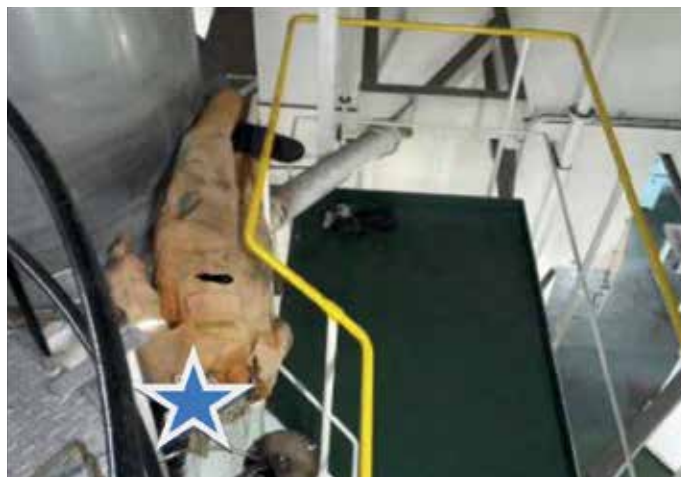
➔ A vessel was at anchor near a port. As part of regular maintenance checks, a member of the engine room crew went into the funnel space to verify whether the funnel flaps were working. In order to do this he installed a ladder in the relatively confined space and climbed up, unassisted. He slipped from the ladder and fell to the deck. He suffered multiple minor injuries for which he had to be evacuated to a shore hospital.

Reenactment of victim's final position

- Routine, everyday tasks can be deceptive; we tend to discount the potential harm of hazards we have successfully avoided in the past.
- A rule of thumb when using a ladder: have a second person hold the base while you climb. It is generally accepted that if the height of your climb is greater than 2/2.5 metres, use a safety harness.
