MARS – Lessons Learned

MARS Report No 366 April 2023

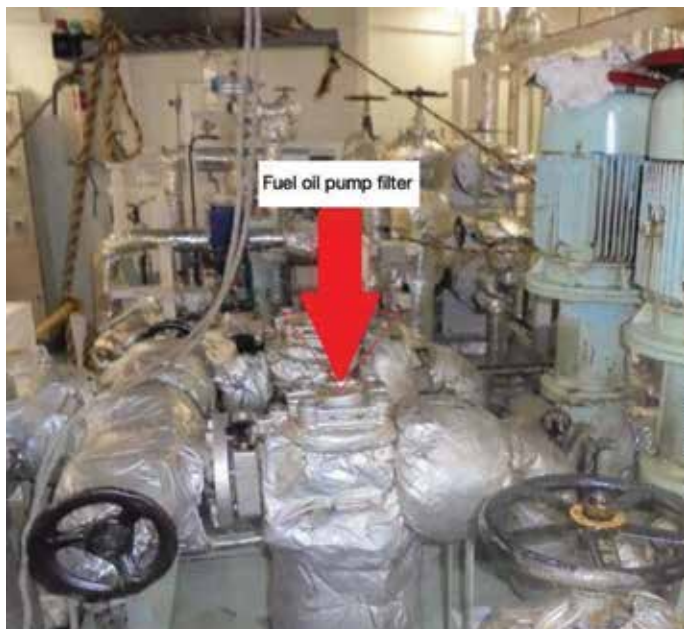
The maintenance work began after lunch. The Second Engineer was dismantling the pump's filter cover, while also acting as the work supervisor. The pump had been isolated by closing the inlet and outlet valves – but the vent cock fitted on the system had not been opened, so the system was still under pressure.

As the pump's filter cover came loose, hot fuel and gases under pressure escaped from the pump. The Second Engineer and three other engine crew who were involved with the work suffered burns on their faces, neck and hands from the hot oil, even though they were wearing PPE (safety hats, gloves and eye protection). After the accident the outlet and inlet valves to the pump were checked and found to be closing efficiently. There were no signs of leakages into the system.

- Checking the boxes of a 'permit to work' form is not going to protect you from the known hazards. Working according to the precautions on the permit will protect you.
- A supervisor who is taking part in the work itself (instead of acting only as a supervisor) is less likely to be able to control the work and assess the risks.

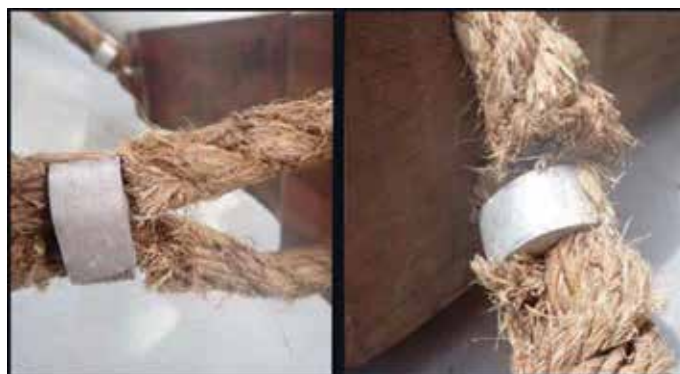
→ During a regular crew inspection of lifesaving and other equipment it was found that both pilot ladders had sustained damage on the side and on the top part of the manilla side ropes. The ladders had been in service for only six months, and were stowed on the pilot ladder reel. The damage is believed to have been caused by the mechanical crimping which is used in place of rope seizing to secure the steps when the ladders are rolled onto the ladder reel. Similar ladders which had been stowed on deck were not reported damaged.

The company investigation found that in addition to causing undue wear/chafing of manila ropes, the use of crimps to secure the steps may cause twisting in the side ropes. This in turn can inhibit grip.

- It is of paramount importance to have a thorough and frequent pilot ladder inspection regime in place – a person's life depends on it!

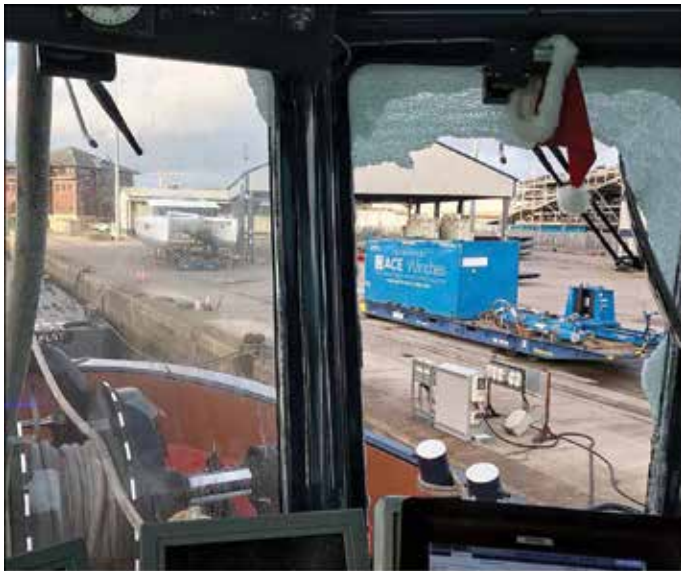
After the winch had slipped for the second time, the towline pennant parted close to the container vessel's deck and snapped back towards tug A. Part of the line struck the starboard forward wheelhouse window, shattering it completely. It also struck the centre forward window, fracturing the inner pane.

Shattered wheelhouse window

- The tug's 'toughened' glass wheelhouse windows were unable to withstand the high energy impact load of a towline snapping back. There is currently no suitable glass standard for tug wheelhouse windows that provides a measurable level of crew safety against the hazard of a recoiling towline.

- Tugs and their associated equipment are constantly dealing with high loads which in turn produce high potential energy. Impeccable maintenance and testing of equipment should be undertaken to ensure risks are as low as reasonably practicable.
- 'Toughened' glass windows for tug wheelhouses present higher risks for injury to crew than glass that is both toughened and laminated. Laminated safety glass has been a standard for automobile front windows for many decades.

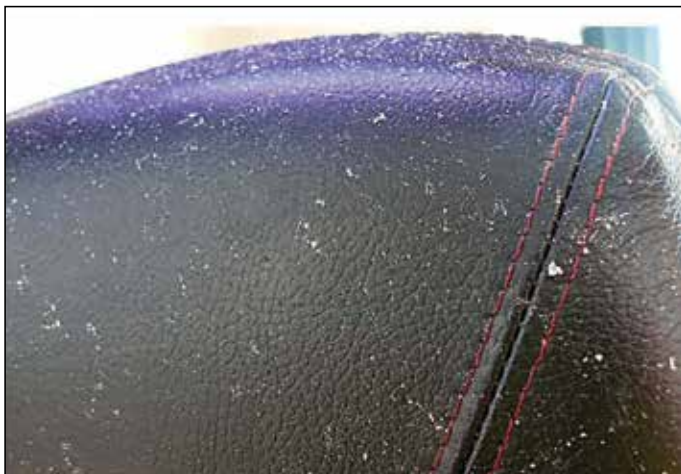
Five crew in the wheelhouse of tug A were struck by flying glass fragments and suffered multiple minor facial, arm and upper body lacerations, including both Masters. All of the crew were wearing some form of eyewear, which prevented any eye injuries. The rest of the wheelhouse was riddled with glass fragments. Two of the inner panes of the aft-facing windows were also cracked but did not break.

Glass fragments embedded into chair

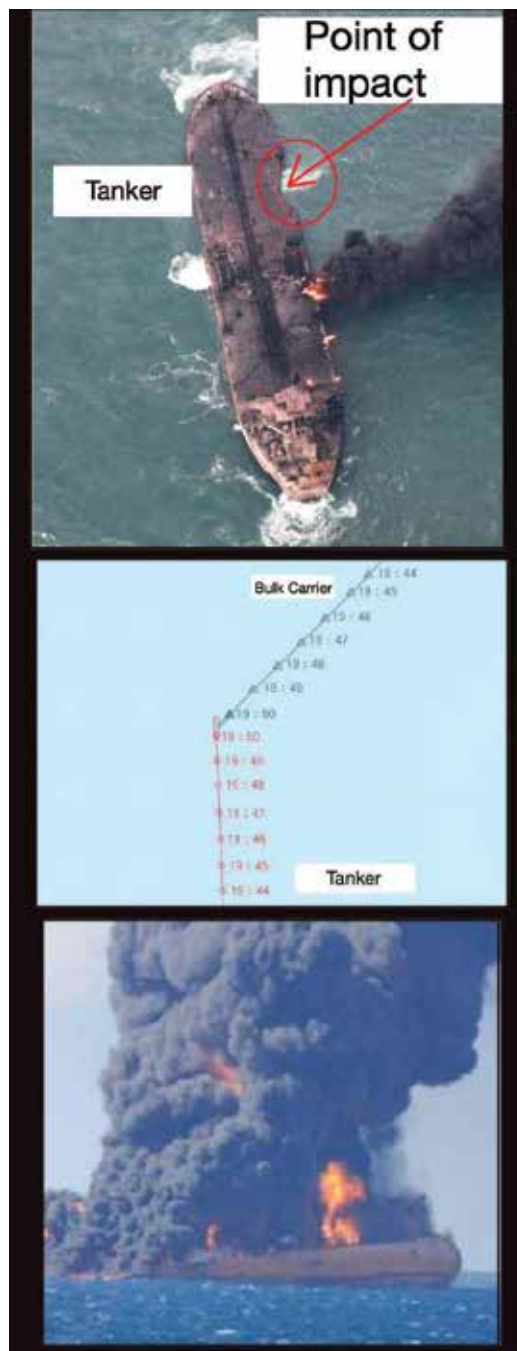
As the distance between the two vessels decreased, the OOW of the tanker called the Master to inform him of the dangerous situation. At the last minute the OOW on the tanker ordered hard starboard helm just as the Master entered the bridge. The helm action was too late to avoid collision and the bulk carrier's bow hit the tanker's starboard side. The resulting damage caused leakage of the condensate oil cargo which quickly caught fire and caused various explosions. Within minutes the vessel, including the bridge, was engulfed in flames.

- Neither vessel's OOW complied with the collision regulations. The tanker, as the give way vessel, should have taken early and substantial action to avoid collision. The bulk carrier, as the stand on vessel, should have taken action when it became apparent that without their action a collision was inevitable.
- Although the OOW of the bulk carrier had noticed the tanker on AIS, he assumed it was a fishing vessel and he did not confirm with a visual sighting.

- Early and substantial action was required by the tanker as the give way vessel. The OOW seems to have thought that a course alteration (to starboard) was the only option and, as his starboard side had other vessels present, he did nothing. Had he reduced speed in good order this would have allowed both the fishing vessel and the bulk carrier to pass ahead.
