# MARS – Lessons Learned

MARS Report No 367 May 2023

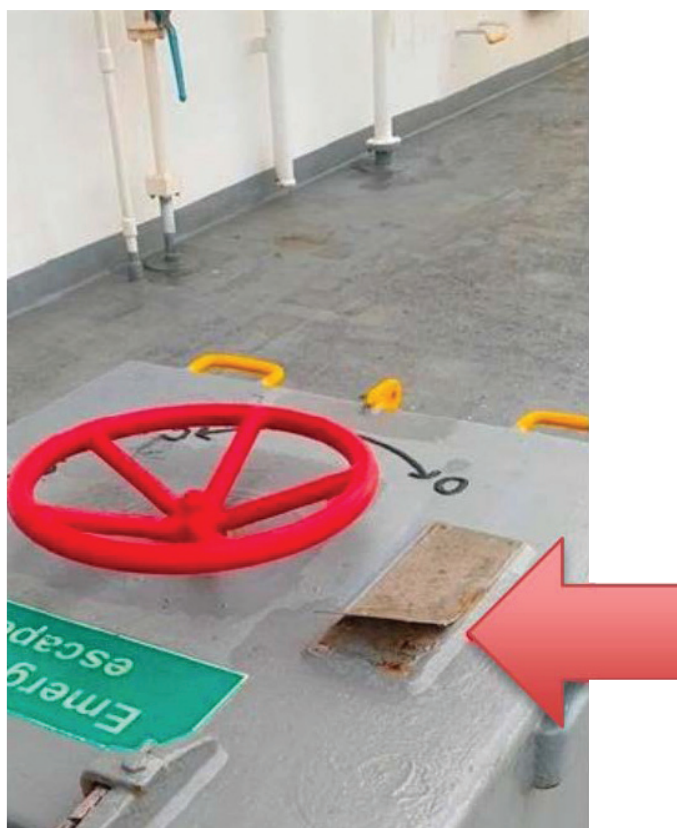
→ During a safety check on deck, the name-plate of an engine room escape trunk was found to be partially detached. This unsafe condition could easily have caused a serious injury. The name-plate was quickly repaired.

- Do a safety round on your vessel; try to look with 'new eyes' to see if there are hazards hiding in plain view.
- Even seemingly small defects can have potentially terrible consequences. This nameplate was an accident waiting to happen.

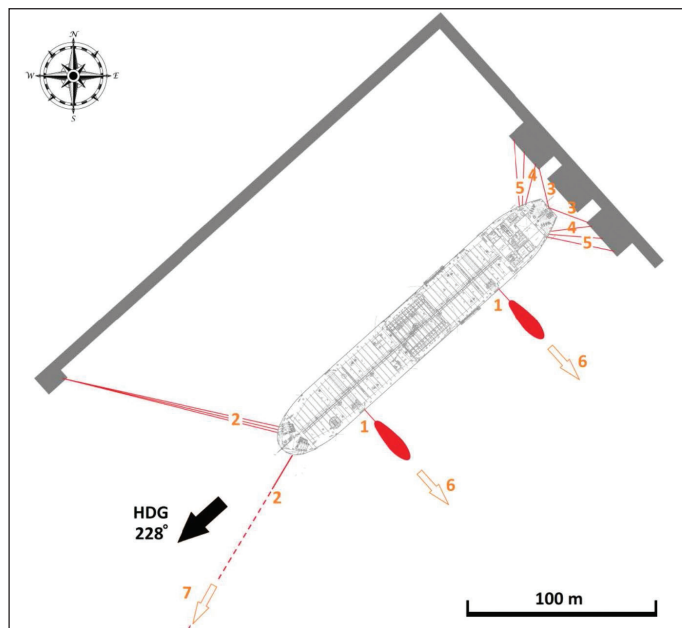
→ A tanker in ballast was departing berth under pilotage with the assistance of two tugs on the port side. The vessel was berthed 'Mediterranean style,' with lines running astern to the pier and to starboard on another pier in combination with an anchor on the port side, as shown in the diagram.

The Master then requested the Officer astern to engage all six remaining lines (three from each side) and bring them on board. Meanwhile, the two tugboats on the port side were already beginning to pull the vessel to port. With so many lines aft to bring in at once, the operation was not easy at the aft mooring station. One line to starboard remained taut as the others were being brought aboard.

Before the tension could be released, the line parted and whiplashed on deck. The end of the broken line hit a crewmember on the back and he collapsed. Despite resuscitation efforts both onboard and later on shore, the victim succumbed to his injuries.

The official investigation found, among other things, that the stern line had probably failed at a tension that was less than the indicated amount on the Test Certificate, even though it was in good condition. Upon further investigation the Test Certificate was found to be non-authentic.

- Good plans can quickly fall to pieces if there is miscommunication or a change in planned sequence. In this case the aft mooring team was overwhelmed, as steps 4 and 5 of the original plan were combined into a single operation, and the tugboats started to pull too early.
- Acute situational awareness around lines under tension is a critical attribute to avoid bad consequences at mooring stations. Crew should be aware of snapback risks and have training on how to predict snapback areas depending on where a line may fail.
- Non-authentic documentation is not easy to spot. Efforts should be made to use credible suppliers and transparent supply chains.

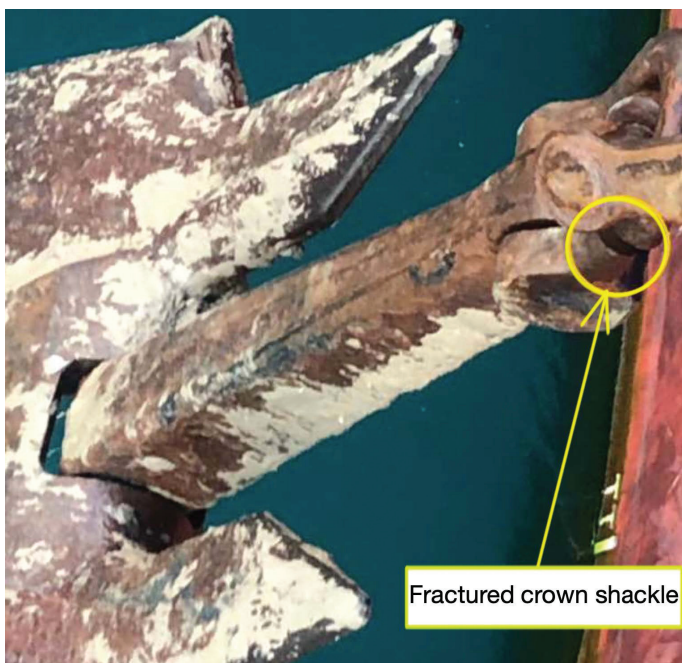
➔ The crew were heaving anchor on a tanker in ballast. As the starboard anchor came into sight above the water the officer noticed something was not right. He stopped the operation and informed the bridge team. Upon closer viewing it could be seen the anchor crown shackle was fractured.

The port anchor was released and arrangements were made to have the starboard anchor disconnected and a new crown shackle installed. The investigation could not establish a cause for the fracture. The crown shackle had been installed only five years earlier and was duly certified by a recognised classification society.

- Proper certification for ship's equipment is a first layer of safety. In this case, in contrast to MARS report 202322, the certification was authentic. But wear and tear will obviously decrease initial specifications and any hidden defects, if present, can become critical.
- Anchor gear is subject to brutal forces and good practice would include a close inspection of the chain and anchor on each recovery.

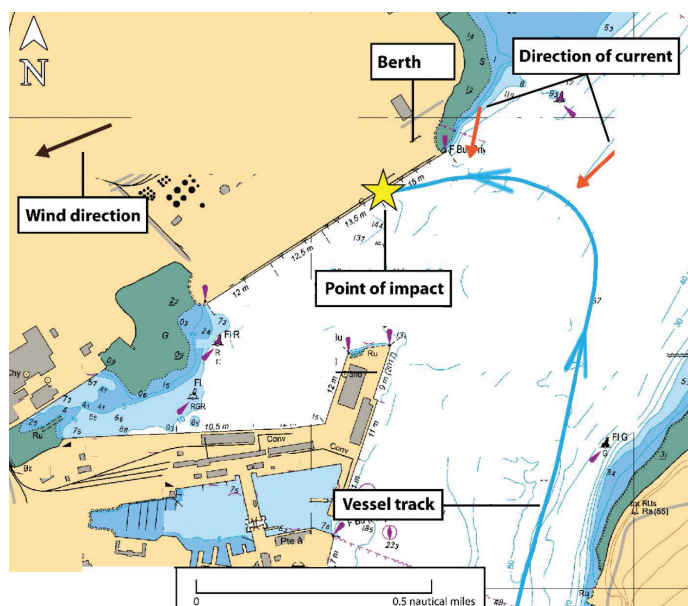
The vessel completed half of its turning circle toward the berth. Its speed at that time was 2.2 knots. Shortly after, the pilot noticed visually and on the PPU that the vessel's approach trajectory had changed; the predicted trajectory was no longer parallel to the berth as planned, but would result in contact with the berth. The vessel's rate of turn had noticeably slowed, and the vessel's speed had increased to 2.7 knots.

- The flood current acted against the port turning moment, reducing the vessel's rate of turn. Consequently, the vessel was not parallel to the berth as it made its final approach.
- As a result of the incomplete turn to port and the combined effect of the current and wind, the vessel approached the berth at a speed of about 3 knots, limiting the time available for the crew to take effective corrective action to prevent the vessel from striking the berth.

- Bridge team members must consistently communicate to establish a shared understanding of a vessel's status, to ensure that crucial manoeuvres for safe navigation are adequately planned, coordinated, and executed.
- If a passage plan does not include a realistic berth approach that integrates actual conditions and vessel characteristics, there is a risk that bridge team members will not establish a shared mental model and therefore be unable to effectively monitor and anticipate the vessel's progress during the berthing manoeuvre.
- Even when wind and current conditions are seemingly benign, berthing a large bulk carrier without tugs is a tricky affair, especially turning across a current and then having it astern.

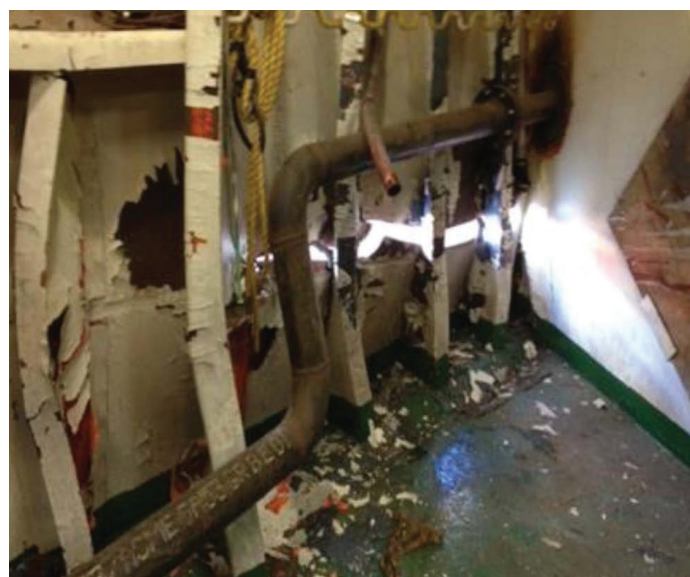
Shortly afterwards the vessel's starboard bow hit the berth at a speed of 2.1 knots, striking between two pneumatic floating rubber fenders at an angle of approximately 30°. One of the berth's D-shaped rubber fenders punctured the vessel's starboard bow. After the impact, the pilot asked the Master to complete the docking.

Allision damage as seen from inside the vessel
