MARS – Lessons Learned

MARS Report No 377 March 2024

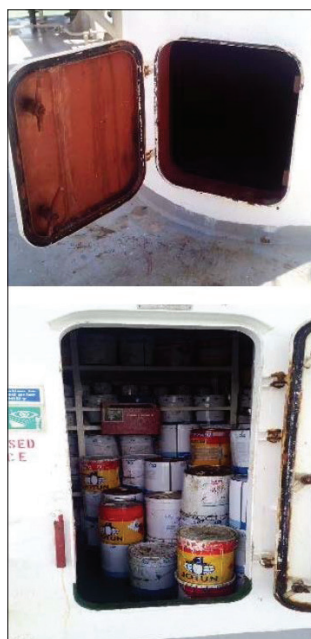
The company investigation found that the paint stored in the crane pedestal was not listed in the vessel inventory, despite a recent update. The paint was transferred to the pedestal during the last dry dock because of a lack of space in the paint locker and ongoing work in the area. The crew who had attended the drydock work did not report this information to the relief crew. The paint in the pedestal was subsequently forgotten due to crew turnover and a deficient inventory listing.

Paint stored in crane pedestal

- The paint locker on a vessel is the ONLY place to store paint and related products. This space is approved for this use and is protected by fixed fire extinguishing equipment.
- Crew handovers are opportunities for information to be lost. Make sure the full state of affairs on your vessel is documented for handover.
- Ship store inventories are important tools for quality vessel management. Keep them true.

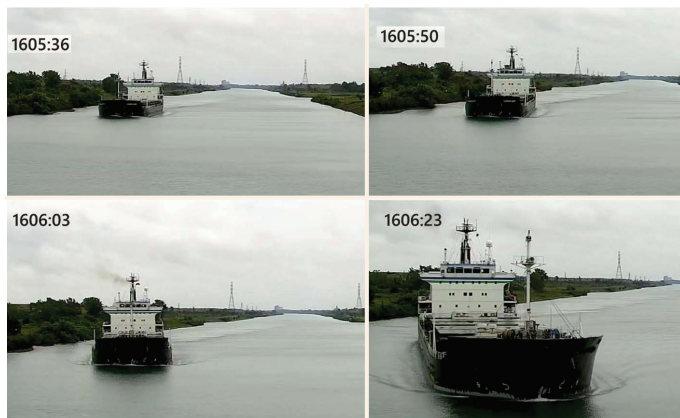
On the down-bound vessel, the helmsman was now applying 30 degrees of helm to starboard to try and attain the extra four degree order, yet the vessel's heading was trending slowly to port. When the distance between the two vessels was 0.38nm, the Master of the down-bound vessel ordered the helmsman to steer two degrees to starboard instead of four, with the goal of bringing the vessel parallel to the centre of the channel. To comply, the helmsman reduced the starboard rudder

angle from 30 degrees to 10 degrees. Within seconds the vessel started to sheer to port. Even with full starboard helm reapplied, they collided with the up-bound vessel within minutes.

- The down-bound vessel proceeded at the canal's maximum permissible speed of 9.9 knots. At this speed, the hydrodynamic forces (bank effect) acting on the vessel were substantially increased as the vessel neared the starboard bank.

- Once the helm was reduced from 30 degrees to 10 degrees the lift force of the rudder was greatly reduced. With the stern under strong bank suction effect, the vessel immediately sheered to port and initiated the sequence of events that ended in a collision.

- It would appear that the down-bound vessel was coned too close to the bank too early prior to the encounter. Better practice, as was the initial plan, sees the two vessels each remaining close to the center of the channel during the approach and then, when about 0.8nm apart, they each jog their headings slightly to starboard.

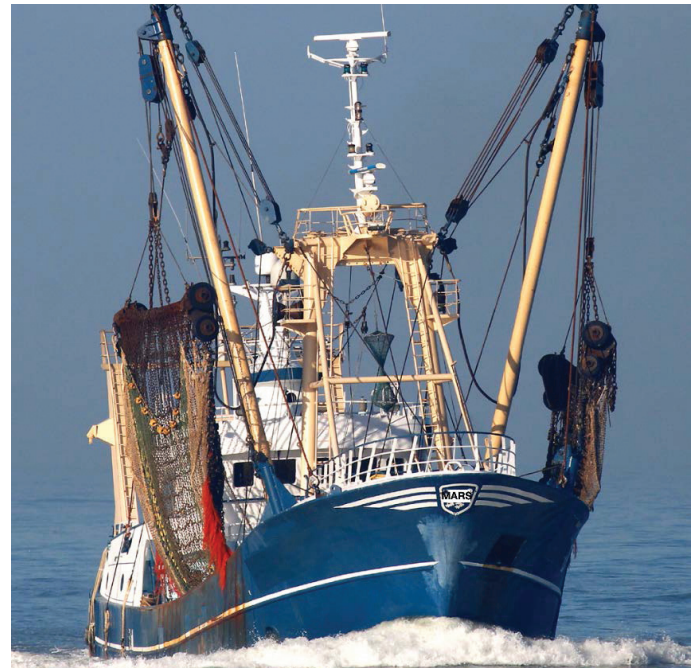
The cargo vessel suffered a hole in its stern in way of the steering gear compartment. Taking on water, the vessel had to make a deviation to a port of refuge.

Among other things, the investigation found that the cargo vessel's small size and low freeboard made it difficult to see the white stern light, which was positioned just above the waterline. Additionally, the fishing vessel was trimmed aft, and had masts that hindered the view of low objects forward (see image below), again making visual detection of the cargo vessel difficult. The report also found that the CPA alarm on board the fishing vessel was not activated prior to the collision.

- Notwithstanding the low aspect presented by the cargo vessel and the poor visibility from the fishing vessel's wheelhouse, there is no substitute for keeping a sharp lookout by all available means. There really is no excuse for bumping into another vessel ahead and not even knowing what happened.
- Never assume a situation is clear until it is truly clear. In this case the OOW of the cargo vessel attended to other duties after assuming the fishing vessel was taking the appropriate action to avoid his vessel.
- CPA alarms are a welcome tool – keep them active.

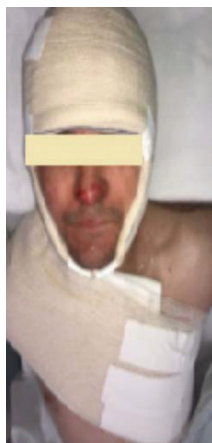
The senior engine room crewmember switched the pump to manual control and put it in the stop position. He isolated the pump from the system by closing the inlet and outlet valves. He then proceeded to loosen the bolts of the filter cover. Suddenly hot fuel and gases spewed out of the loosened filter cover. All four crew were struck by hot fuel on their faces, necks and hands. The victims were given first aid and quickly disembarked to a shore hospital.

The accident investigation revealed that the crewmember had loosened the filter cover without first releasing the system pressure from the vent cock. The vessel's 'Permit to Work on Pressurized Systems' included a check box for pressure release, and the box had been ticked, but the check had not in actual fact been done.

One of the victims

- Avoid the 'checklist mentality'. The Safety Management System (SMS) tools are there for your benefit; use them.
- A supervisor cannot supervise if they are doing the work themselves.
