MARS – Lessons Learned

MARS Report No 378 April 2024

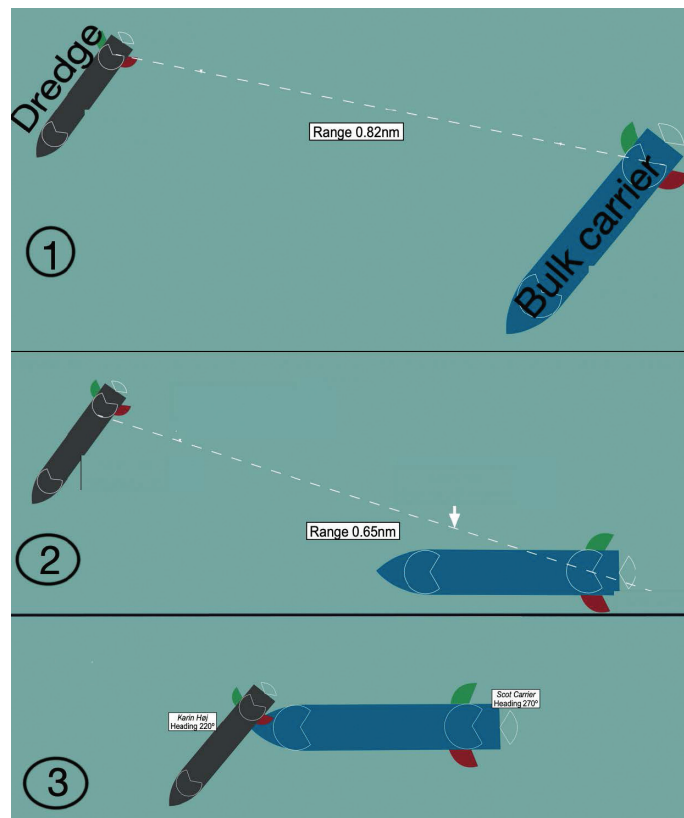
Shortly afterwards, he switched on the searchlight to show a chat user the ship's deck and cargo on the hatches forward. He then continued to engage with several individuals on the chat site. At 03:03, the bulk carrier's AIS registered the dredger as a dangerous target 2.2 nm ahead on the starboard bow, with a closest point of approach (CPA) of 0.88nm and a time to CPA of nearly 20 minutes. About 18 minutes later, with the vessel close to a course alteration waypoint, he told the chat user that he needed to alter course and adjusted the autopilot to 270 degrees. The dredger was now bearing 289 degrees at 0.82nm range (see picture 1).

Three minutes later, both vessels exited the TSS and entered a precautionary area. The OOW on the bulk carrier once again connected with a chat user and conversed with them while altering course. Now, the bulk carrier was steering 270 degrees with the dredger on a steady bearing of 298 degrees and a range of 0.6nm (picture 2). Very soon after, the OOW was heard to exclaim 'Wait, wait, wait!' He then pulled back the main engine propeller pitch control lever, switched on a second steering motor and disengaged the autopilot. Fifteen seconds later, he moved the telegraph to full astern.

Notwithstanding these last minute attempts, the bulk carrier collided with the port side of the dredger at a relative speed of 8.7kts (picture 3). The bulk carrier's Master awoke when he felt a bump; assuming it was a large wave hitting the bow, he did not consider it unusual and tried to resume sleep. The collision caused the dredger to roll over and capsize in as little as 20 seconds. Neither of the two crew members survived.

The investigation found, among other things, that the bulk carrier's OOW had reduced situational awareness due to unnecessary distractions; he had not seen the dredger until the last moment. The tablet had been almost constantly in use for over two hours, during which no interaction with navigational equipment such as target acquisition on the radar or target interrogation on the ECDIS was recorded on the Voyage Data Recorder (VDR). Additionally, the bridge equipment was not set optimally, and the alarms designed to warn of dangerous situations had been disabled, silenced or switched off. The investigation also found that, subsequent to tests after the accident, the OOW had been under the influence of alcohol at the time of the tragedy.
