MARS – Lessons Learned

MARS Report No 384 October 2024

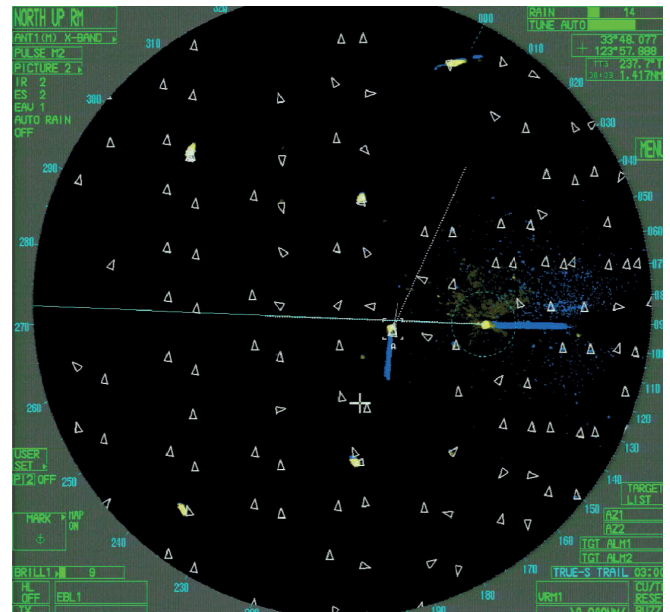
Tanker's radar at 21.33

At 23:19 the lookout reported what he believed to be a fishing vessel ahead and the OOW acquired it as an ARPA target on the X-band radar soon after.

The investigation found, among other things, that there were no navigational constraints that prevented the tanker from reducing speed or altering course to starboard in ample time. Also, whilst the tanker attempted to attract the attention of the FTV with an Aldis lamp, no use was made of suitable sound signals until five seconds before the collision, when the tanker sounded two short blasts.

- Passage plans should, to the extent possible, be adjusted to avoid well known highly congested fishing grounds.
- It is good practice to reduce speed when in highly congested waters.
- Trying to attract the attention of another vessel? Rule 34(d) is clear. When vessels in sight of one another fail to understand the intentions or actions of the other, or if one vessel is in doubt whether sufficient action is being taken by the other to avoid collision, the vessel in doubt shall immediately show such doubt by giving at least five short rapid blasts on the ships whistle.
