MARS – Lessons Learned

MARS Report No 386 December 2024

Container lashing MOB fatality while in port

Container lashing related MOB fatality while at sea

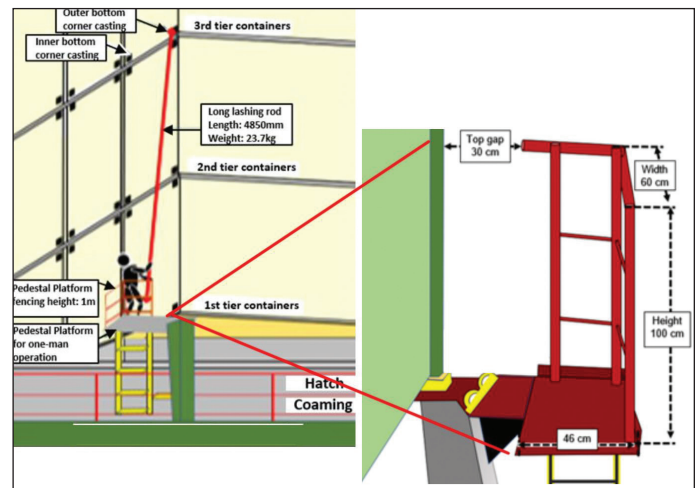
At one point during the task, Crew 4 could be seen struggling to remove the swivel head from the outer bottom corner casting of the third tier container, which was well above his head and required him to look upwards. He was manoeuvring the swivel head to unlatch it from the container bottom casting, a task that requires both hands, not to mention skill, effort and strength. The lashing rod weighed almost 24kg and was 4.85m long. It took Crew 4 three to four minutes to unlatch the swivel head.

When the swivel head of the lashing rod came free of the corner caster, Crew 4 immediately attempted to lower the rod, but it swayed sideways towards the berth and quickly gathered downward momentum. Crew 4, still holding the lashing rod, fell overboard

between the vessel and the berth, falling through the gap between the pedestal platform fencing and the container.

The investigation found, among other things, that lashing and unlash tasks are commonly performed by stevedores in many parts of the world. These stevedores are specifically trained for the physical demands of specific cargo tasks such as container work. Such a physical skill requires time and practice to develop. Ship's crew may have limitations when performing such tasks as these are not their primary roles.

- This tragic accident underscores the importance of not rushing into a job, especially one that is not a common onboard practice, without properly assessing the risks involved and the appropriate mitigating measures.
- The two crew members unlash containers at the outboard rows of bay 18 did not don fall protection or flotation devices, even though the task presented hazards such as working at height and risk of falling overboard.
- The port's safety policy required two stevedores to safely undertake unlash tasks. This should have been a red flag to the vessel's CO to undertake a risk assessment and safety briefing with his crew before work began.

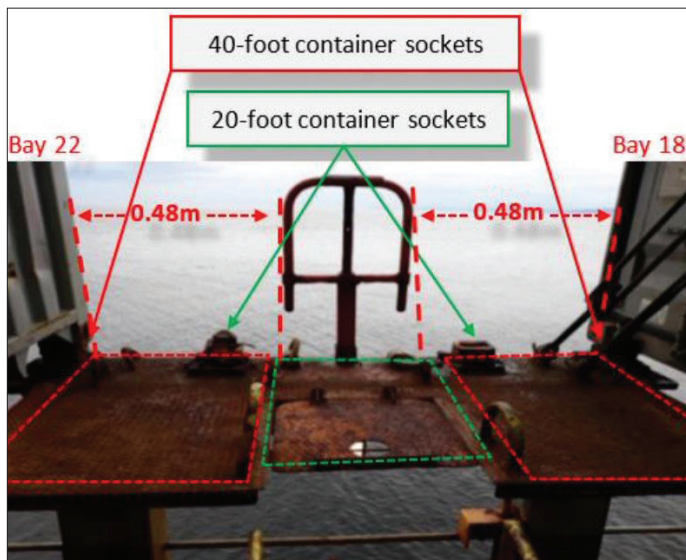
At one point, the second officer was observed by another team member removing a vertical lashing rod from the third-tier container at the outermost row on the port side. The turnbuckle of the lashing rod had been removed and he was attempting to stabilise the rod. The lashing rod was 4.4m long and weighed 22.5kg. He was unable to control the rod and started swaying towards the ship’s side before falling through an unsecured gap into the sea 12.5m below, still holding the lashing rod. At that time, the vessel was making about 15 knots and was about two nautical miles from the pilot station.

Although the investigators were briefed on the roles of the persons involved, it was not possible to establish why the victim went to the outmost row and attempted to remove the outboard lashing

rod. This role was to be performed only by persons wearing a safety harness attached to a strong point. The company’s personal protective equipment (PPE) matrix required crew members performing lashing and unlashings tasks at the outboard side to wear a safety harness which was to be tied to a lifeline. At the time of the incident, there were four sets of safety harnesses distributed to each team, and one person in each team had been assigned the safety harness.

According to the company’s own risk assessment for this task, safety lines were to be rigged across the 0.48m gaps between bay 18 and 22 as a risk control measure to prevent falling overboard, yet there were no such safety lines rigged at these locations.

- Safety lines were not rigged at the openings between bay 18 and 22, contrary to the vessel’s Safety Management System (SMS);
- The victim disregarded his role as supervisor of Team 2 and proceeded to undertake a dangerous act (rogue behaviour);
- Other team members did not intervene to prevent the victim’s unsafe act;
- Some crew unfamiliar with deck operations, such as the cook and steward, were nonetheless enrolled for the task.

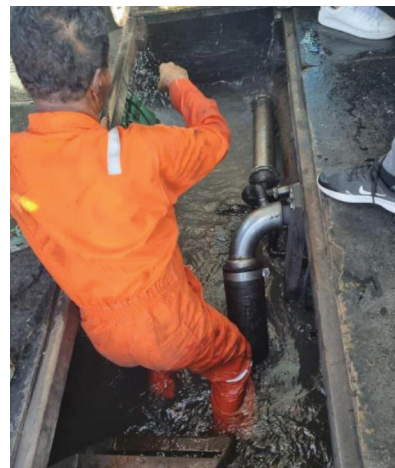
Water flooding the service boat

As the service boat was making way, water started flooding into the machinery space. The service boat crew tried to find the cause of the flooding in order to plug the leak, assisted by some vessel crew. Their efforts were unsuccessful, and the water level continued to rise. The service boat crew reported the incident by radio, and it was decided to abandon the service boat into a liferaft. The service boat sank a few minutes later.

- Marine emergency duties are a useful skill; you never know when you may need them.
- Be aware of your surroundings and keep your cool.
