# MARS – Lessons Learned

MARS Report No 374 December 2023

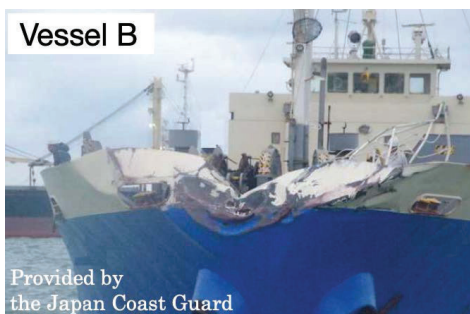
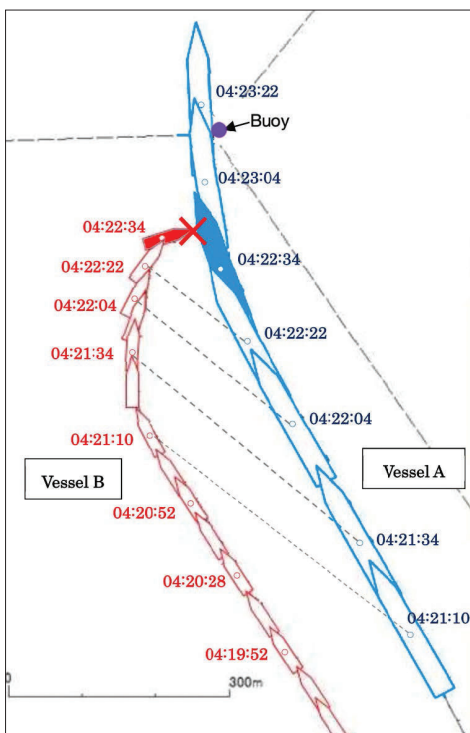
Vessel A, under pilotage, was bound for the port and had been assigned a berth. It was making way at about 13 knots, gaining slowly on Vessel B which was making about 10 knots. The pilot of Vessel A observed Vessel B cross their bow from starboard to port about 0.5nm ahead. Based on this action, the pilot assumed the vessel was headed for the North exit of the Traffic Separation Scheme (TSS). Up to this point there had been no VHF communication between the two vessels. Vessel A continued to gain on Vessel B, and it appeared they would pass Vessel B on their port side at a distance of about 200 metres.

Meanwhile, on Vessel B, the lone watch keeper was contacted by the local Vessel Traffic Services (VTS) on VHF. VTS inquired if they were headed to 'K' anchorage. The OOW, although unsure of the exact anchorage, responded in the affirmative. The VTS then informed the OOW that in order to make 'K' anchorage they were required to navigate the Traffic Separation Scheme (TSS) on their starboard side. The OOW was surprised, but took the VTS advice as an order. He knew he had to act quickly to enter the TSS, so he informed VTS he was coming to starboard. He knew there was a vessel astern, but without verifying, he assumed it was still some way behind.

The local VTS immediately called Vessel A on VHF and informed the bridge team that Vessel B was destined for an anchorage and that the vessel would take the appropriate TSS to starboard. At about the same time, the pilot of Vessel A saw Vessel B begin to turn sharply to starboard, which meant that this vessel would cut in front his vessel. He attempted to call Vessel B on VHF but there was no response. He ordered the main engine be put to stop, while the Master simultaneously ordered hard to starboard. At the same time the OOW of Vessel A blew a long blast on the whistle. Despite all this, a collision was now unavoidable and Vessel B collided with the port side of Vessel A. The starboard bow of Vessel A then struck the navigation buoy that had been close to starboard.

- Assumptions made by both vessel operators on the actions or position of the other vessel contributed to this accident. Keep your situational awareness honed sharp and communicate with other vessel operators to augment understanding and shared mental models.
- When passing another vessel close by, as in this case about 200m, it may be advisable to have a mutual understanding of the manoeuvre.

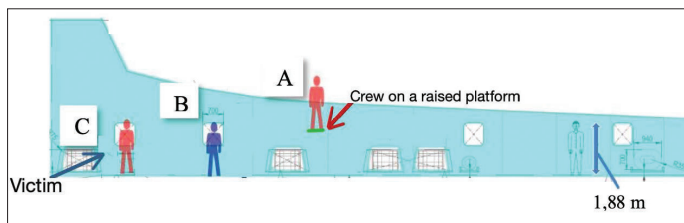
In order to set the berthing lines with their appropriate heaving lines, the deck crew were passing the heaving line outboard from position A, where the deck crew was standing on a platform due to the high bulwark, to position C, via position B. A gaff was used to catch the line through a bulwark port at position B. The line was then passed outboard to position C. A deck crew at position C had his arm out of the bulwark port holding a gaff to catch the heaving line.

A few seconds before the line passing manoeuvre began, one of the bow thrusters came offline due to an overpower surge. There was no alarm to warn the bridge team of this situation. The ferry was quickly pushed back to the berth, and the bridge team, realising the situation too late and preoccupied with the manoeuvre, gave no warning to the deck crew, who were unaware that the ferry was closing on the

berth. The ferry's starboard side struck a berth fender at the level of the bulwark port at position C just as the deck crew had his arm outstretched and outboard. His arm was instantly severed.

The victim was treated immediately for profuse bleeding. Within minutes the vessel was re-berthed and the victim sent ashore for professional medical attention. The official investigation found that, among other things, the ferry, which was a new build still under guarantee, had suffered numerous bow thruster and electrical problems since beginning service a few months prior.

- Following the accident, a task analysis made it possible to establish a work method which eliminated the risks due to the use of a gaff outboard.
- Everyday practices, when conditions are benign, can hide hazards in plain sight. Take the time to re-analyse current work methods using the 'what if' risk assessment methodology. Can risks be further reduced by eliminating hazards or questionable procedures?
- New vessels can be subject to a 'breaking in' period where numerous minor or even major anomalies are discovered. These should be corrected as soon as possible to avoid unwanted negative consequences.

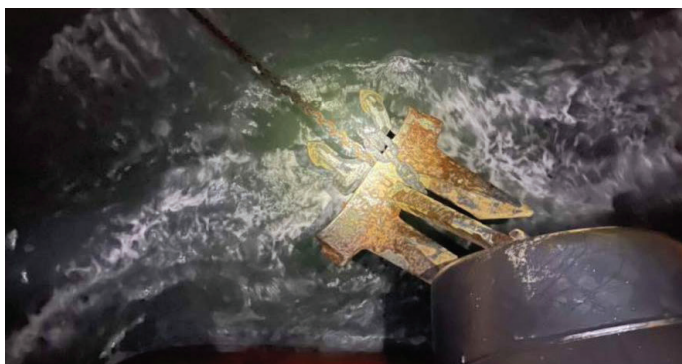
→ A loaded tanker had dropped anchor in a designated anchorage in depths of 30 m, using six shackles in the water. Upon receiving clearance to berth the deck crew began recovering the anchor but the windlass was experiencing considerable strain. The hydraulic motor was damaged due to the heavy load, so the operation was stopped and VTS informed accordingly. A spare hydraulic motor was installed and about 12 hours later clearance was again received to heave anchor.

On this attempt the anchor was successfully lifted out of the water. The crew observed the vessel's anchor was fouled with another anchor and chain. After careful consideration and with the exercise of good seamanship, this abandoned anchor and chain was freed from the vessel's gear and the vessel continued normal operations. The local VTS was informed.

Anchor fouled with abandoned anchor and chain

- If you lose an anchor and/or chain in a designated anchorage always report such an incident to local VTS, as it will then be identified as a possible foul ground area.
- If your windlass is struggling to lift the anchor in otherwise normal conditions consider the possibility of it being fouled. Divers may be needed to inspect.

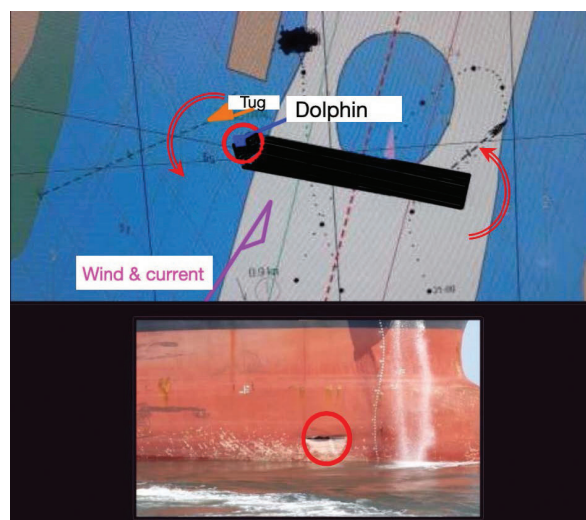
The tugboat aft was ordered to move to vessel's starboard bow to better assist in the rotation. With the tug pushing at the starboard bow, the vessel was now moving aft with a Speed Over Ground (SOG) of 2.4 knots. Soon, the vessel had turned about 60° to port, but the current and wind were moving the vessel to the north. The main engine was set to half ahead while rudder was hard to port.

As the vessel achieved approximately 90° of the turn, it was reported to be 10 metres from a dolphin on the starboard bow. The tug was at full power, but could not control the vessel's set toward the dolphin and had to abandon its position for fear of being crushed. The vessel's main engine was set at full astern, but the starboard bow brushed against the south corner of the mooring dolphin. Within minutes the vessel completed the turning manoeuvre and commenced the outbound passage to the anchorage, where damage to the hull was observed.

- In a very restricted waterway and with wind and current conditions that made for a complicated 180° turn, the use of one tug is, in retrospect, a hazardous decision.
- Only one tug was available in this port, so the hazards were 'normalised' by the Master and pilot as 'acceptable'.
- Plan a manoeuvre beforehand and think about the forces acting on your vessel. In this case the vessel had to come 180° after leaving the berth and at one point was perpendicular with the current in a restricted channel. The tug could not overcome the forces acting on the hull pushing it to the North.

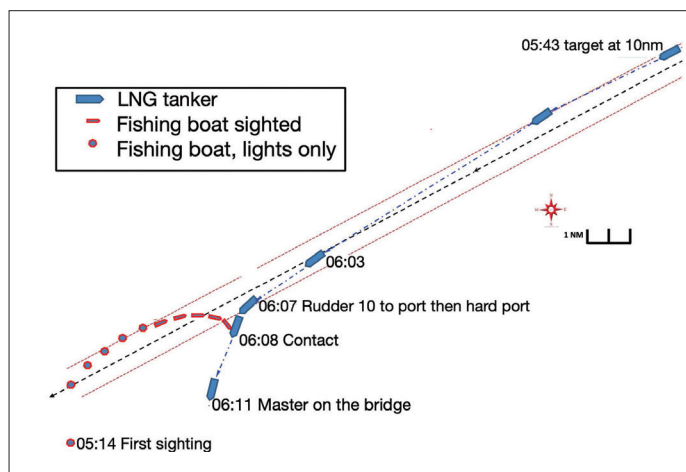
At 06:03, the fishing boat now only 1.7nm away, was seen to alter course further to starboard showing only its red light. The OOW deemed this to be an attempt by the fishing boat to cross ahead of them. Finally, the OOW ordered hand steering engaged and ordered 10 degrees to port and then hard port. Shortly after the fishing boat disappeared from view from the conning position.

The OOW went out onto the starboard bridge wing and observed the fishing boat in contact with their vessel mid-ships. He ordered the helm hard to starboard to help move the stern away from the fishing boat. The fishing boat's port bow came in contact again in way of the tanker's starboard engine room water ballast tank and then cleared. The OOW called the Master, and it was confirmed that the fishing boat was intact, and the crew were not injured.

- The OOW did not use all available means to determine if risk of collision existed. For example, he did not take compass bearings of the light when it was first reported to port and as the range decreased.

- At a critical decisional moment, with the fishing vessel 7.6nm away and clearly on a reciprocal course the OOW decided to alter course to port – but only by a few degrees. With a closing speed of about 26 knots this meant the vessels would meet in about 3.5 minutes. Now was the time for an alteration to starboard large enough to be readily apparent to the fishing vessel.
- Hand steering was not engaged until virtually the very last moments before contact. Given the situation and the levels of risk, it would have been more appropriate to do so much earlier.
