MARS – Lessons Learned

MARS Report No 376 February 2024

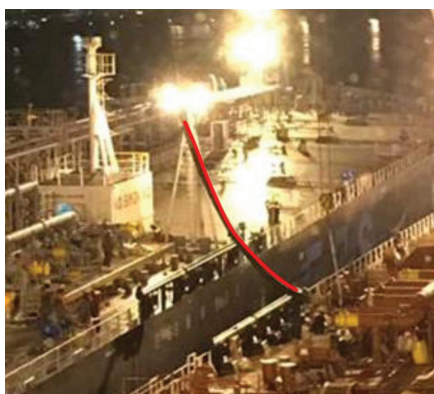
Correct lift for drainage
