MARS – Lessons Learned

MARS Report No 369 July 2023

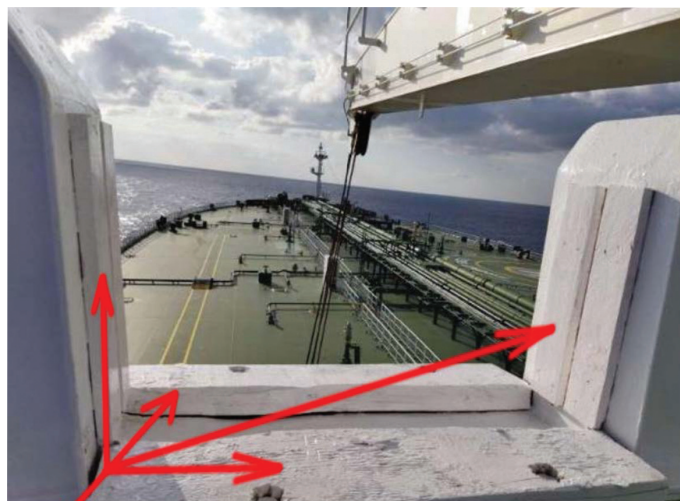
→ While disconnecting the cargo hose on a tanker with the ship's crane, a member of the shore personnel working on deck suffered a minor injury from a small piece of wood that fell from height. The wooden piece was sheathing placed around the boom's 'parking crutch' to avoid metal-to-metal contact. Over time, the securing arrangement for the sheathing had come loose, and when the boom was lifted, it slipped from position and fell, striking the shore crew. The victim was given first aid and was in good medical condition thereafter.

The company investigation found, among other things, that the monthly maintenance of the crane was not carried out as per the Planned Maintenance System (PMS). Visual inspection of the sheathing would likely have identified the wear and probably avoided the accident.

New wood sheathing as installed after the incident

- Monthly PMS inspections are established for a reason and should be carried out with due diligence and 'fresh eyes' at each repetition.
- In this instance, no specific PMS task was assigned to checking the condition of the wood sheathing. When new hazards are discovered, risks can be reduced by creating a specific PMS task for the object of the hazard.

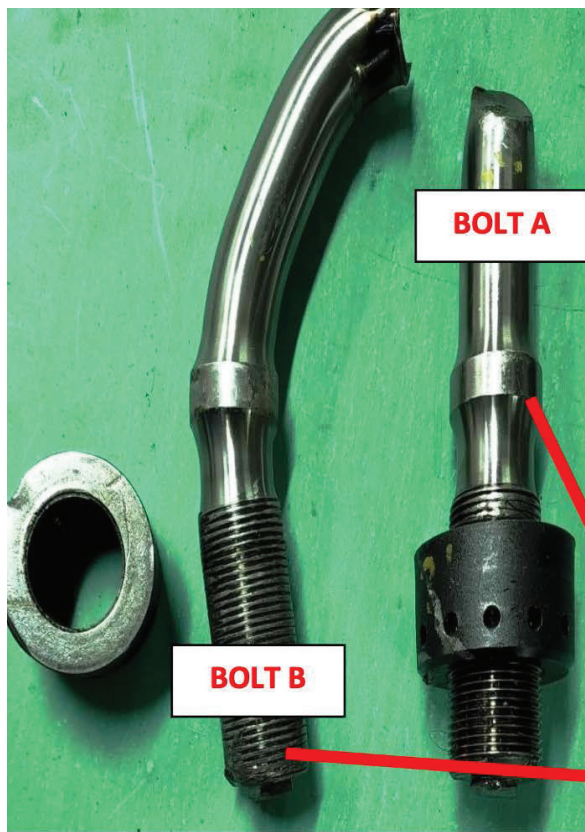
< Mechanism of Con Rod Failure > / 6N21 (A) L

A forensic examination of the damaged engine and reconstruction of the sequence of events suggested that one of the two studs of the cam shaft connecting rod for cylinder two had not been adequately tightened during maintenance. A gap developed due to stud B being under-torqued. This overstressed stud A, which consequently sheared and caused the subsequent damage sequence.

Following this hypothesis, the hydraulic stud tensioning pump used for tightening the con rod mechanism was thoroughly examined. The pressure gauge on this pump read 60 bar higher than actual supplied pressure. This could well have led to the less than adequate tensioning of the connecting rod nuts during maintenance, and could be the cause of premature failure. The company subsequently added periodic calibration of the hydraulic stud tensioning pump as a separate item within the PMS.

1. The con rod is tightened normally as Fig 1 and rotates 12(720min⁻¹) or 15(900 min⁻¹) times in a second.
2. In the case of the lower Bolt B is improper tightened, the Bolt B is gone to loose. The serration part B is going to open as Fig 2 with opening C.
3. The all combustion load F goes to Bolt A, the Bolt A is exceeded its strength. Then brake and shear off Bolt A in strait shape as Fig 3, the serration part A open freely as Fig 4. The tightening seats Bolt B and cap B side get the fretting and pitting marks.
4. The all combustion load F goes to Bolt B, the break and shear off Bolt B with bended shape, caused by opened serration part A hit several places, liner, cylinder block and balance weight of crankshaft as Fig 5.

- Correct stud/bolt torquing of engine parts is a critical feature of maintenance. Many incidents and accidents have occurred in the past due to incorrect torquing. Having a properly calibrated tensioning pump is vital to attain the required specifications.
- Planned Maintenance Systems (PMS) are a lynchpin of safety – use them rigorously and add value to them when the opportunity presents itself, as in this occurrence.

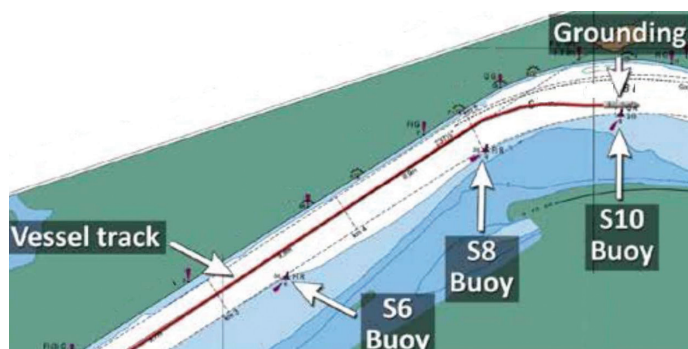
- The pilot's PPU was obtaining information from the vessel's AIS, which was subject to GPS 'smoothing'. As a result, the predicted vessel positions displayed on the PPU were not accurately reflecting the vessel's future positions, but the pilot was unaware of this. Also,
- The pilot did not inform the bridge team about the extent of silting within the navigable channel nor had the bridge team taken steps to obtain this information. As such, the bridge team was unable to identify or to assist the pilot in resolving the developing unsafe situation.

- Had the pilot used an independent DGPS antenna for his PPU the predicted positions would probably have been more accurate than those represented by the vessel's AIS pilot plug.
- Communication and planning is everything! The silting in the channel was not communicated to the bridge team by the pilot – but neither did the vessel's team take the time to research this fact which was readily available via on-line sources.
- Speed changes everything! In this case the vessel was proceeding at near 13 knots (6.68m/sec) in a narrow channel in near zero visibility. Proceeding at nine knots (4.63m/sec) would have given them extra time, about one minute, to reevaluate the circumstances and manoeuvre. This would likely have prevented the grounding.

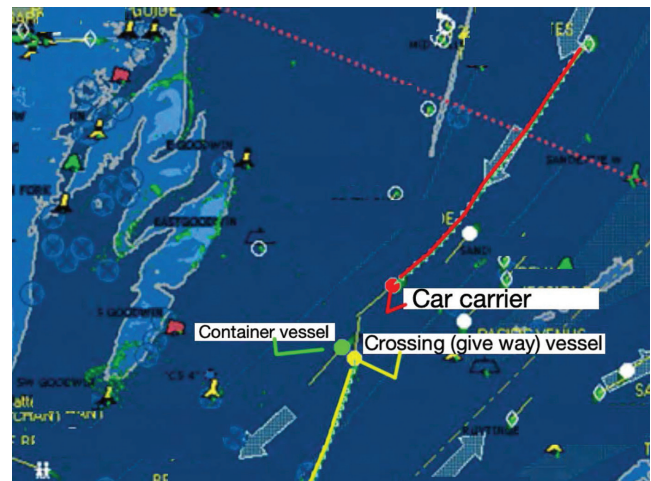
The investigation found, among other things, that in conducting the 'trial manoeuvre' without a time delay, and evidently mistaking the real time CPA data at the bottom right hand corner of the radar display for the CPA following the intended alteration, the information on which the Master based his decision to adjust course to pass between container vessel and the car carrier was inaccurate. It also demonstrated that neither the Master nor the OOW were familiar with the 'trial manoeuvre' function. Also, the slow alteration to port of give way vessel during the crossing of the south-west traffic lane was confusing, and the intentions of the bridge team were not readily apparent to other vessels.

Situation one minute before 360 loop undertaken by car carrier

- Always cross a TSS at as close to 90 degrees as possible. This allows for unambiguous identification of your intentions.
- Being in a TSS does not give you an automatic right-of-way. In this case, the car carrier in the TSS had the right-of-way. However, had the crossing vessel been coming from the other side of the TSS the car carrier would have been the give way vessel.
- The golden rule for the give way vessel when risk of collision exists: 'take early and substantial action to keep well clear'. Making small, incremental course changes in the hopes of increasing CPA will only add uncertainty and danger to the situation.
