# MARS – Lessons Learned

MARS Report No 382 August 2024

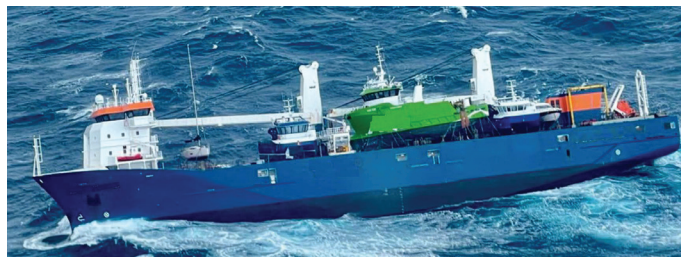
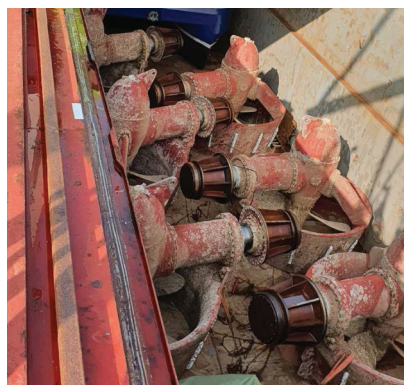
An officer and the cargo superintendent went together to check the cargo hold. They found a large quantity of water and noticed that the three forward stowed azimuth thrusters had been dislodged. One of these three had come loose first and had caused a domino effect, causing the other two to shift as well. The thrusters had punched a hole in the port side anti-heeling tank. This had originally been full, but its contents were now running into the hold.

The report notes that the information about the cargo of azimuth thrusters provided by the freight broker to the operator did not contain any specific instructions for loading, unloading, lashing or any detailed information on lashing points. The chartering department did not request more detailed and specific loading instructions and presumed that the information it had received was sufficient to perform proper lashing of the azimuth thrusters. The discrepancy between the available information and the required information made it difficult to devise an adequate and symmetric lashing system.

Six azimuth thrusters as stowed and lashed

- Even though 'extra lashing' was used, one azimuth thruster nonetheless broke free and caused others to also come adrift. Lashing can only do so much when cargo pieces are extra heavy, as in this case. In hindsight, cargo stoppers should also have been welded at the bases.
- An inland route would have been a safer alternative to sailing across open sea under the predicted weather conditions.
- Heavy cargo items deserve extra attention and detailed lashing plans. For quality assurance, the final lashing state could be observed by a qualified third party.

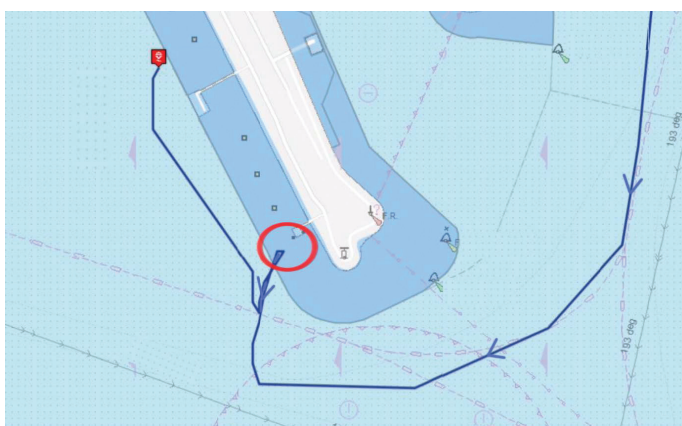
Later, an underwater inspection revealed no damage to the dolphins but the sand around the base of the dolphins was slightly disturbed. The vessel's rudder was found to be about eleven degrees offset to starboard, presumably due to the bottom contact. It was later found that the rudder stock was fractured. Repairs required dry-docking the vessel including installing a new rudder stock. The vessel was off-hire for more than two months.

The incident investigation found that the pilot had misjudged the current. At that time, the pilot reportedly considered that the current was running away from the berth (in a westerly direction), yet the current was actually acting towards it. The investigation also concluded that the pilot was essentially working alone during the docking manoeuvre, thus indicating a Bridge Resource Management (BRM) failure.

Contact with the bottom at red circle

- Even local experts, such as a pilot, can make mistakes. They are human too! Have the bridge team fully engaged with the people doing the manoeuvring and set up agreed distance parameters and speeds when in confined waters.
- Be prepared to challenge the person with the con if the manoeuvre is not going as planned.

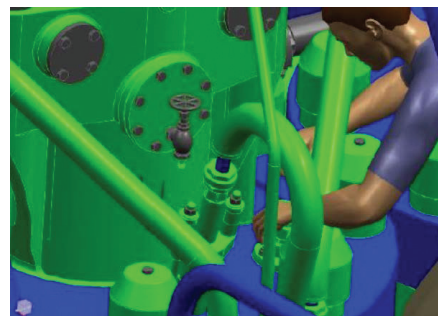
The crew in the vicinity rushed to help; they found the victim's face badly injured near the right temple with profuse bleeding. The FOIV from the cylinder was on the deck beside the victim. This valve is fitted to the cylinder cover by two securing nuts with a spring housing for each nut. The securing nuts had been removed and residual pressure within the main engine had ejected it with force.

The investigation found that the victim had probably prematurely removed the securing nuts of the defective FOIV, as several steps to prevent injury had been missed prior to removing these nuts. Apparently, the engine RPM had not yet reached zero. It is also probable that the engine start air valve was not closed nor was the engine turning gear engaged. These lock-out measures, as prescribed in the engine maintenance manual, would have prevented the tragedy. There was no system in place to ensure that all the safety precautions stipulated in the engine manual had been performed prior to the replacement of the FOIV.

Probable position of the victim just prior to the accident

- Any system that has stored energy needs a lock-out/tag-out (LOTO) safety procedure and strict compliance.
- Senior vessel officers must ensure safety compliance and procedural integrity, but so too must each and every crew member.
- Time pressures are usually self-imposed. Even if time pressures are overt the proper mindset should be 'Safety First'.

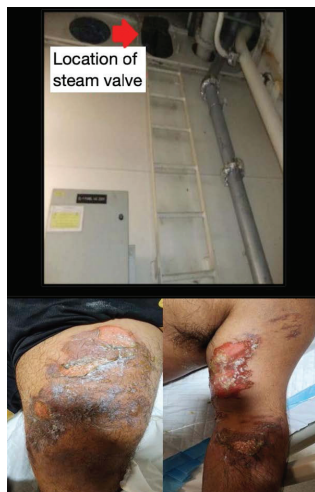
The valve was located in the engine room in an area that required the crew to climb up and into a restricted space. When the crew was in position he began opening the valve, and was suddenly exposed to copious amounts of steam. It was later discovered that the valve gasket had failed, probably due to 'water hammer' effect.

The company investigation found that the instructions on how to accomplish line draining prior to opening the steam valve were inadequate. The crew completed the task as best they remembered based on their own knowledge. Ultimately, formalised instructions are needed to ensure that the steam supply line is free of water before opening the valve to avoid the water hammer effect.

Victim's burns

- New hazards can emerge when modifications are undertaken. In this case it took nine years for the hazard to be revealed.
- New hazards or old (hidden) ones need careful analysis. Then, a procedure should be written and dutifully practised.
