Seaways

Mariners' Alerting and Reporting Scheme

MARS Report No. 299 September 2017

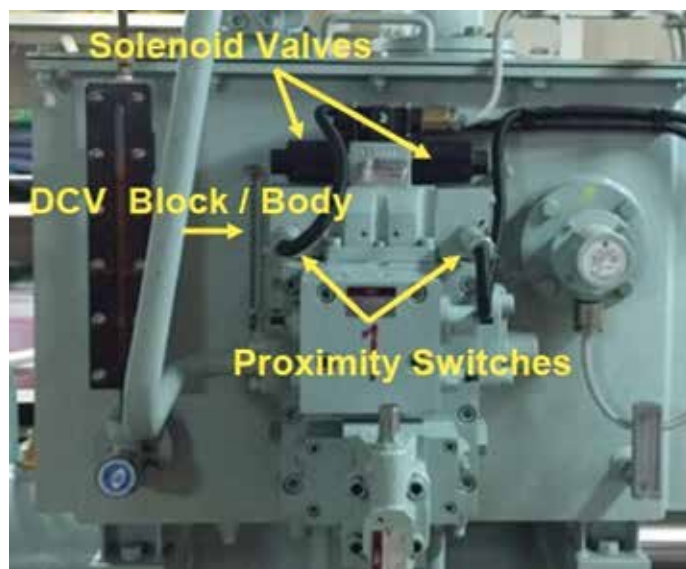
➔ Repetitive alarms occurred when crew performed steering tests to move the rudder through its range of motion. The alarms indicated a 'hydraulic lock' event, even though the steering gear had moved the rudder adequately during the test. On each occasion the crew simply acknowledged the alarm, without making any further investigation to identify the cause.

The hydraulic system that moves the steering gear's rams involves a directional control valve (DCV), which is a hydraulic shuttle valve. A set of solenoid valves receives an electrical signal from the bridge helm or autopilot, which causes a flow of oil to certain sections of the shuttle valve. The DCV shifts and initiates flow to the system's hydraulic rams dependent on the command. If the shuttle valve does not shift, or is not sensed as having shifted (via magnetic proximity switches) after a period of time, it activates an alarm on the bridge console.

In this case, the proximity switches were found to be faulty and needed replacement. Although the rudder moved as expected in the tests, the lack of properly functioning proximity switches combined with a complacent attitude had 'trained' the crew to ignore the alarm.

- The management of nuisance alarms should be addressed in the company's safety management system.
- If an alarm has become a nuisance, find out why and correct the situation.
- Never pin or otherwise secure an alarm acknowledgement button or switch in order to silence the alarm.
- Nuisance alarms can, over time, desensitise an operator to real problems that may be indicated by an alarm.

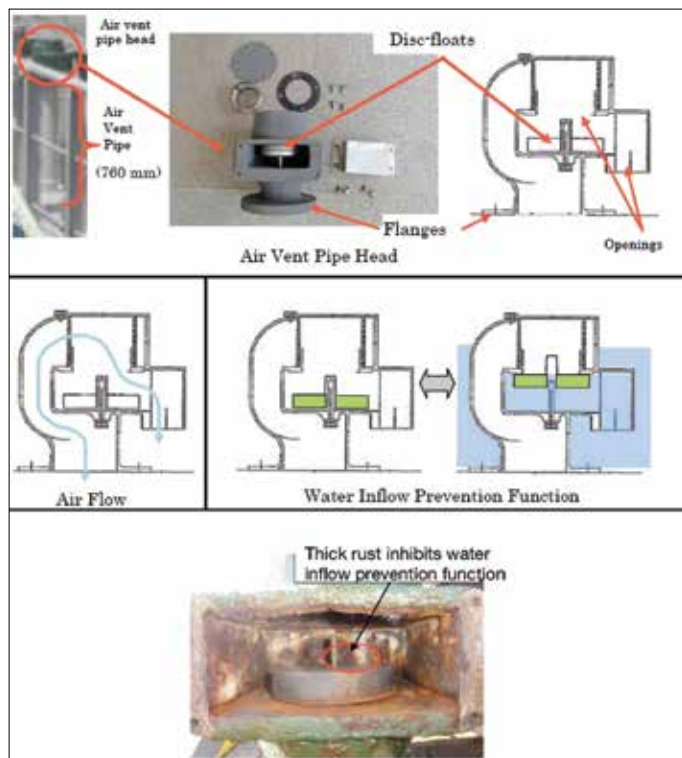
Waves from the port quarter were washing on to the deck and seawater was submerging the air vent pipe heads of several ballast tanks on the port side. It is assumed that water was being taken on in these ballast tanks via the air vents, but the crew were not able to deballast the water as access to the pump room was on deck and awash.

- Research on air vent pipe heads has found that when the casting section of the vent head is rusty (see photo) the movement of the disc float can be impeded and the vent head is no longer able to prevent water inflow – that is, it allows water to enter the tank.

- It is likely that faulty water inflow protection floats allowed seawater to enter the port ballast tanks, which eventually destabilised the vessel to the point of capsizing.

- If the water inflow prevention floats had been working properly, only 0.6 litres of seawater per wave would have flowed into each air vent. However, if the floats were not working, 16 to 20 litres of seawater would have flowed through each air vent into the ballast tanks each time a wave struck the ship.

- Defects, especially any that may affect the seaworthiness of the vessel, should be reported to the company and class and corrected immediately.
- Keep your air vent heads in good condition and check that the water inflow prevention device, if fitted, is working properly.

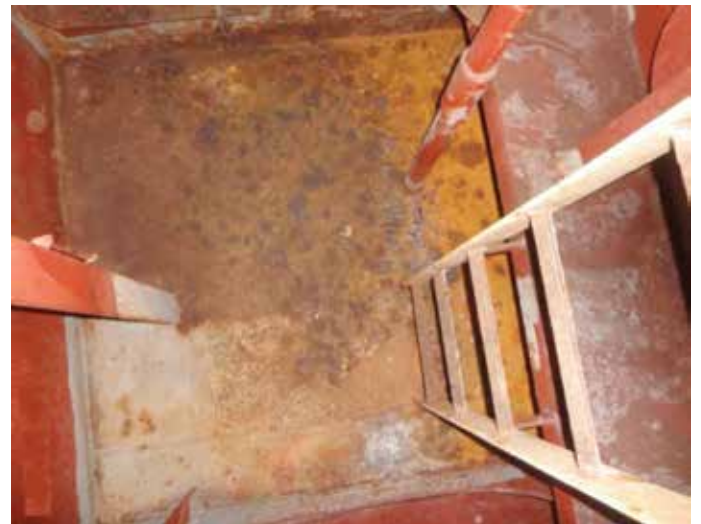
View of part of the hold access ladder

- A contributing factor to the accident was the perceived absence of threat within the enclosed space that contained the hold ladder.
- Despite posted safety signs warning crew to confirm oxygen content of the space before entering, this procedure was not followed.

- Some enclosed spaces, such as a hold access ladder, may seem less risky to mariners due to their familiarity. Never fall into this trap. Treat all enclosed spaces equally by testing for oxygen content before entering and deploying the full enclosed space procedure each time.
- Identify all enclosed spaces on board your vessel and mark them as such.

- Warning signage is a preliminary barrier to protect against risks in enclosed spaces, but it is not sufficient on its own. Correct entry into enclosed spaces must be an integral part of the culture in the company and on the vessel.
- Never rush into a confined space to rescue a crew member who has collapsed. Call for help and put your enclosed space rescue routine into effect.

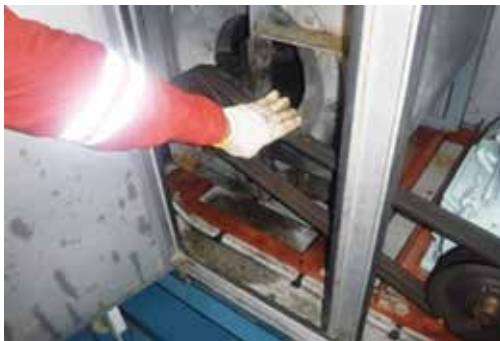
The blower door was opened for inspection and team started checking the V-belts for tightness. As they were finishing their inspection the vessel took a roll due to the sea state. Both men lost their balance, and in an attempt to hold on to something the electrical officer's left hand fell on the blower's V-belt. As his weight came to bear on the belt it caused the belt to move, trapping his hand between the V-belt and the blower pulley wheel. The victim was able to extricate his hand but not without negative consequences. Two fingers and his thumb were badly injured. After receiving first aid he was evacuated from the ship by helicopter.

His fingers fell on the belt

- Crews should take vessel movements into consideration in their risk assessments before undertaking a task. Less essential tasks should be done when there is minimal vessel movement.
- In this instance there was no securing arrangement to prevent the door from moving when it was open. A securing hook arrangement was fabricated for the doors in order to secure them while open.

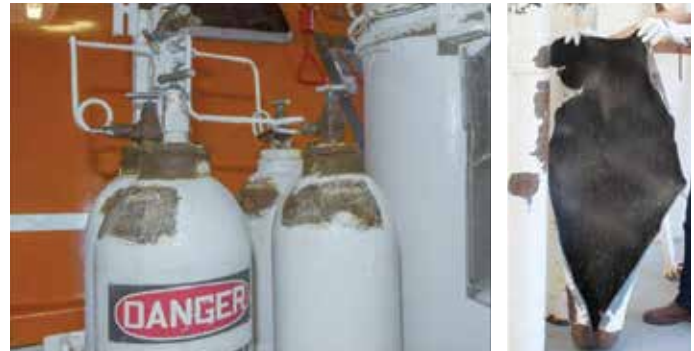
Typical arrangement of four cylinders

Ruptured cylinder

- The burst cylinder had become severely corroded on the exterior, reducing the cylinder wall thickness by 75% at the point of rupture.
- Several other cylinders on board the vessel were found to be exhibiting similar levels of exterior corrosion.
- The current inspection regime for such cylinders may not be adequate to detect unsafe cylinders.

- Although the cylinders were inspected annually, the surface rust does not seem to have raised suspicions about the structural integrity of the units. Cylinder wall thickness measurements may be a necessary step to control risks.
