Mariners' Alerting and Reporting Scheme

MARS Report No. 312 October 2018

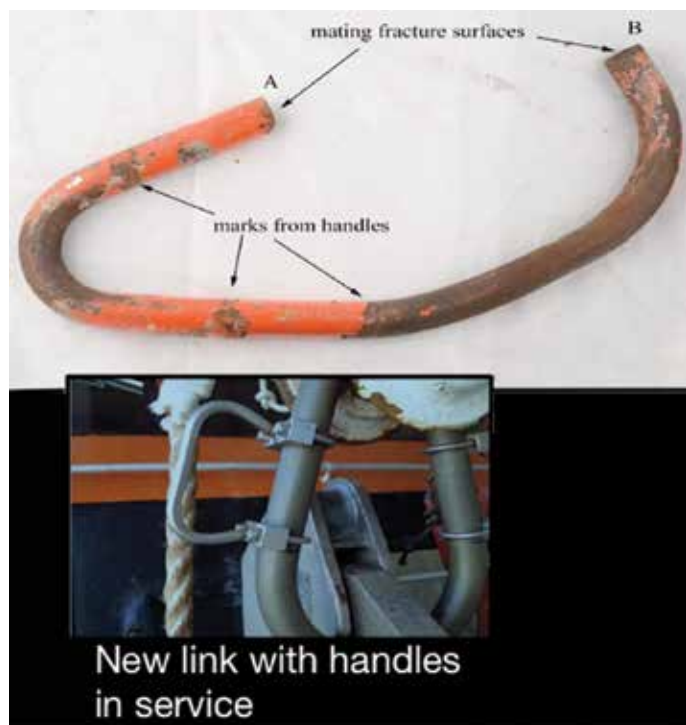
Inspection failure precedes link failure

The fall was caused by the catastrophic failure of the link that connects the fall block to the release gear hook. The investigation found that, among other things, the actual measured safety factor of the link was less than 5:1. This was well below the required minimum safety factor of 6:1 as specified by the LSA Code. Notwithstanding this less than adequate condition, the immediate cause of the failure was found to be a fatigue fracture.

The initiation of the fracture was attributed to the location of the stainless steel handle which was attached to the straight part of the link. The likely mechanism for the fracture was either corrosion fatigue (galvanic corrosion) or fatigue initiated from a minor indent at the surface.

- Non-destructive testing should be carried out regularly to verify the condition of gear such as links.
- Items such as bolted-on handles should be removed to ensure links can be given a full visual inspection.
- During inspections the dimensions of the connecting links should be measured to ascertain whether there has been any reduction in diameter as a result of corrosion.
- When possible, avoid connecting two metal parts that have different galvanic (sea water environment) values.

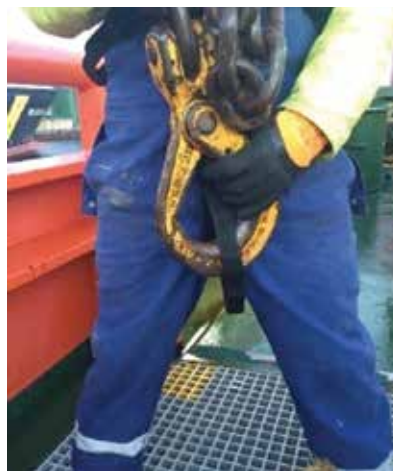
→ A bulk hose was being transferred between a production platform and a platform supply vessel (PSV). The platform crane landed the hose on the PSV's deck and one of the ABs approached to release the hook from the lifting sling. As the AB released the hook it slid inside the bight formed by the crotch strap on his lifejacket. Once he stood up the hook was caught, but the AB did not notice, and he signalled to the crane operator to 'hoist'.

The AB was lifted above the deck and out over the side of the vessel. His immediate, intuitive reaction was to hold on to the pennant wire to relieve the crotch strap tension. The crane operator and a second deck crew member quickly became aware of the situation and were able to land the AB safely back on deck. The duration of the incident, from the AB being lifted and then returned to deck, was about 11 seconds.

- Ensure your garments and personal protective equipment (PPE) are not a hazard in and of themselves.
- Keep your situational awareness about equipment, yourself and your workmates sharp.
- Never signal to hoist unless you are sure all is clear.

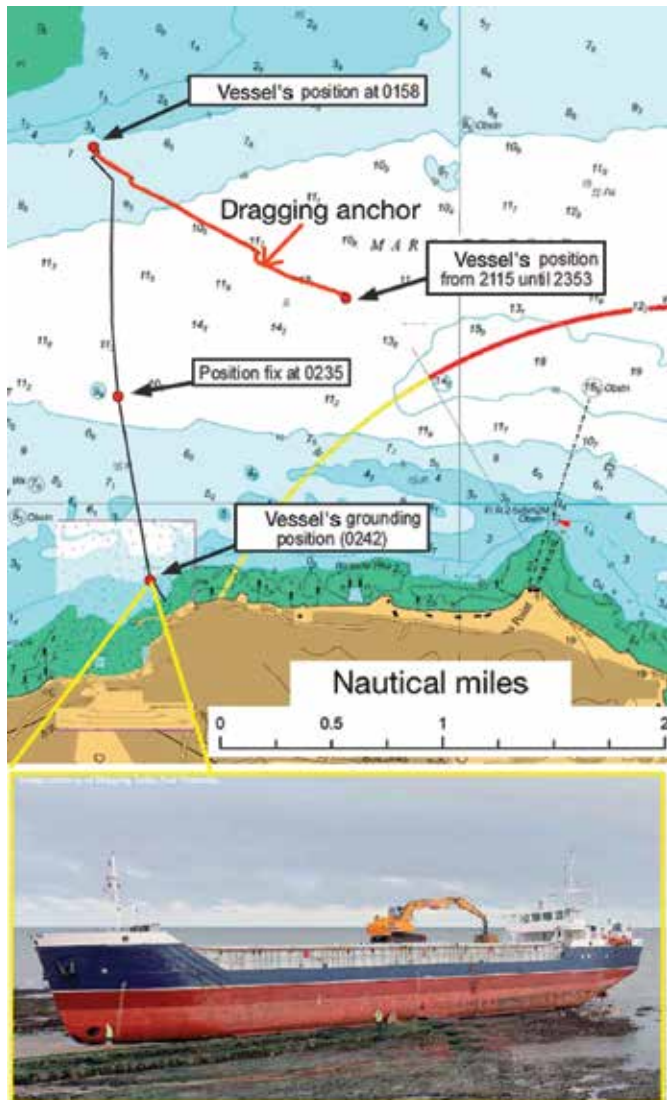
The OOW was navigating visually, apparently without using the radar although at 02.35 he did put a position on the chart using GPS. When the OOW ordered the anchor dropped the vessel was already in trouble. At 02.42, the vessel grounded as it crossed the 0m depth contour. The vessel's Master was woken up by changes in engine noise and vibration. When the Master arrived on the bridge, he attempted to refloat the vessel by using astern propulsion, but his attempts were unsuccessful.

The wind was from the north-west at Beaufort force 6. While the vessel was at anchor, the predicted tidal stream set to the west and decreased from approximately 1.8kt at 23.50 to 0.8kt at 02.00 the following morning.

- When anchoring, enough scope must be given to accommodate a rising tide.
- Anchor watch is just as important as a navigation watch. An OOW's primary duty is to keep a sharp lookout, monitor the vessel's position and maintain situational awareness.
- If your vessel is dragging anchor, call the Master.

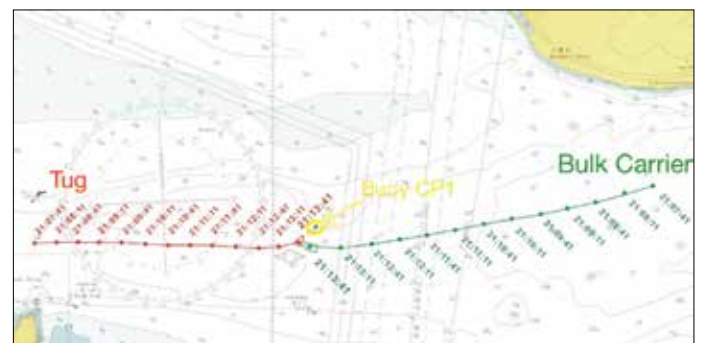
Pilot A then gave a helm order of starboard 10, but the bow of the bulk carrier struck the starboard quarter of the tug. The collision impact was heavy and the bulk carrier was brought to a stop. Shortly after the collision the tug listed to starboard and sank. Seven persons were rescued from the tug, but 18 crew were trapped and drowned inside the vessel.

- Never make small course alterations when faced with an ambiguous meeting or crossing situation.
- Make your intentions known by using a large course alteration, preferably to starboard as per the collision regulations.
- When in doubt, slow down.

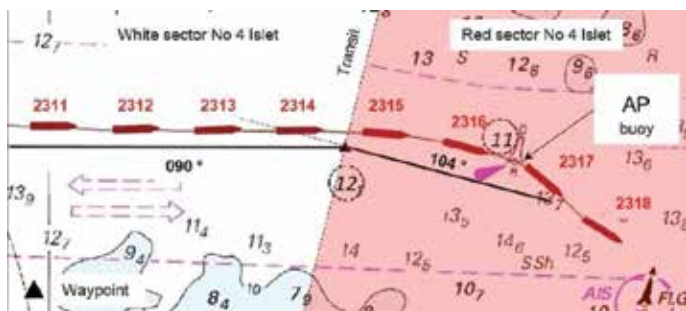
The position plotted on the chart indicated that ship was about half a cable (100m) north of the charted track and the Master observed aloud that the AP buoy was right ahead. About 10 seconds later, the Master asked how the buoy was, followed 11 seconds later with 'will we touch the buoy?' The pilot said 'no' and shortly after ordered starboard 10°, followed 16 seconds later by starboard 20° and then 'hard a starboard'. In spite of some more helm applications the port quarter of the ship's hull contacted the buoy.

- Even though the OOW was somewhat integrated into the pilot's operations by informing him at 7 cables to each waypoint, neither he nor the rest of the bridge team possessed the same mental model as the pilot for the transit.
- There was a PPU on the bridge showing the vessel's position in real time, but the bridge team were not using this tool and were preoccupied with other aspects of the pilotage.
- In darkness a person's visual perception is not the same as in daylight, so objects may appear closer than they actually are. Because accurate depth perception is very difficult, especially at night, it is important that human abilities are always supplemented by the use of all other navigational and electronic aids.
- The Master's comments were too little too late. He was not in a position to challenge the pilot properly as he was using only his visual acuity to sight the buoy.

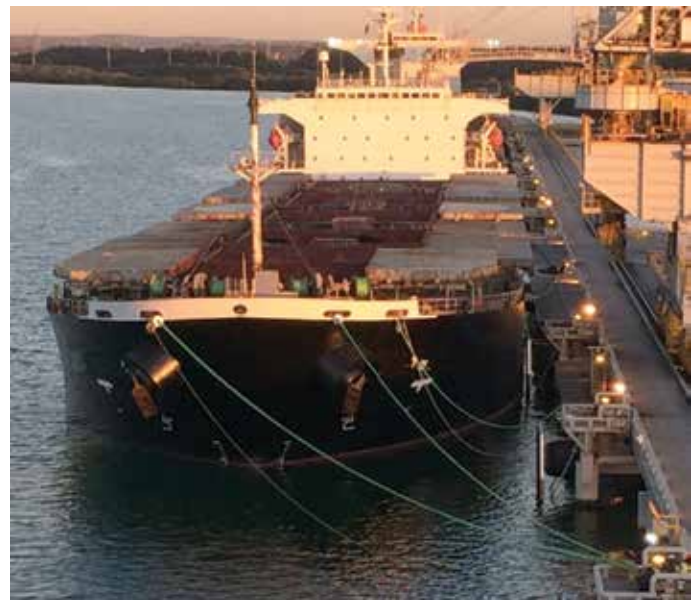
➔ This photograph was sent to us by a mariner. Is this an accident waiting to happen? The mooring lines visible in the photo are quite slack and of unequal tension.

- Keep an eye on your lines and, when securing, equalise the tension in all lines.
