Issued March 16, 2022

MIR-22/07

Contact of Tanker *Riverside* with Moda Ingleside Energy Center No. 4 Loading Dock

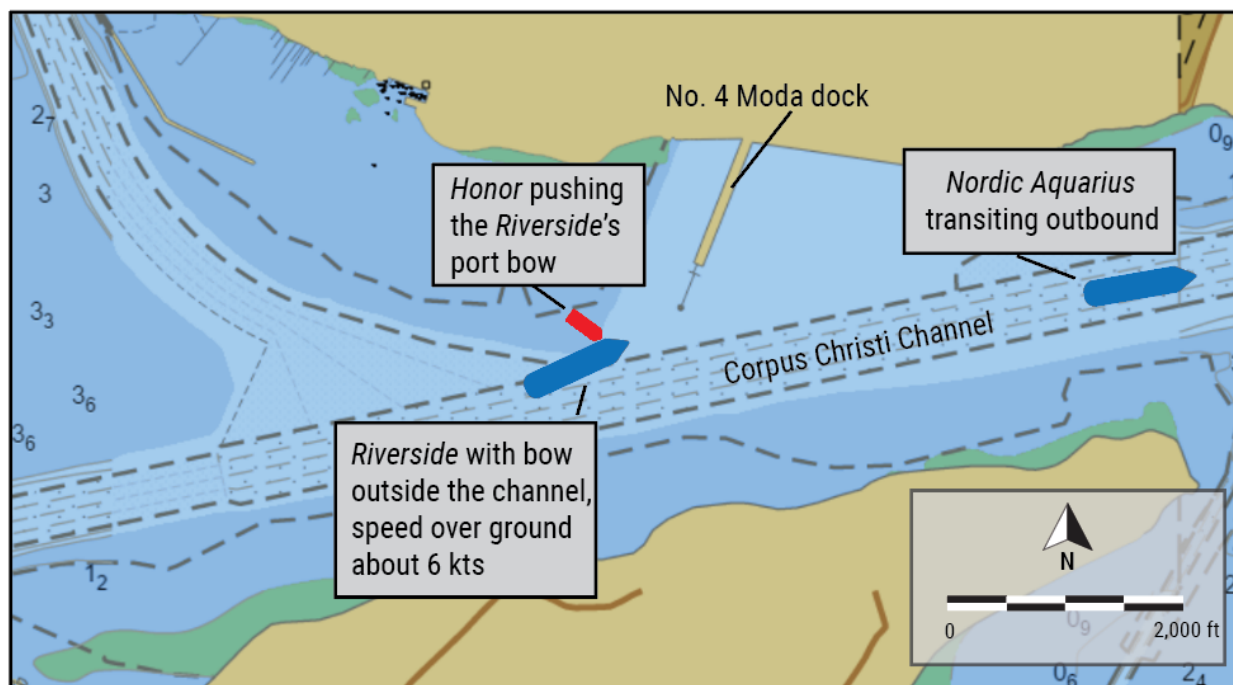
Figure 4. Approximation of *Riverside* at 1300, just before the contact with the no. 4 Moda dock dolphin and catwalk, with the tug *Honor* pushing its port bow; the *Nordic Aquarius* has departed the no. 4 Moda dock and is transiting outbound. (Background source: NOAA)
