Risk Alert

RA110 – Work Safety – Adverse Weather

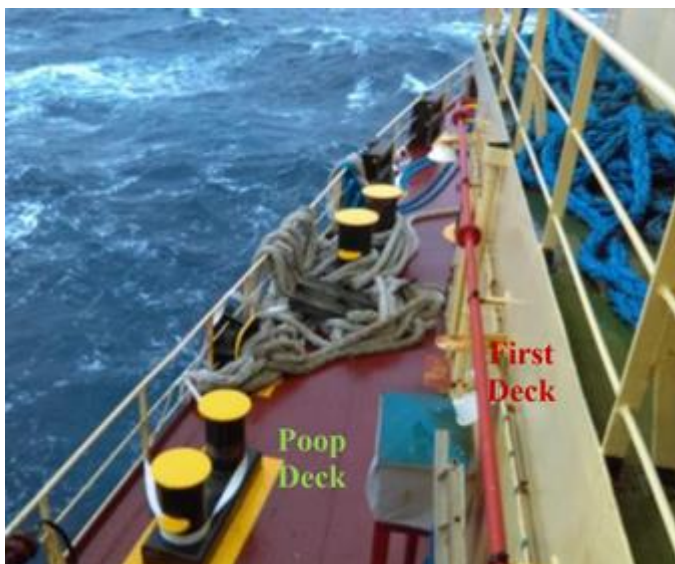
It was noticed that mooring ropes stored on the poop deck had moved, with some mooring ropes now hanging over the vessel's guard rails.

Starboard side, two ropes secured to poop deck railings the other end of one rope hauled onto the first deck - (Ref: TMSI Report: 01/2021)

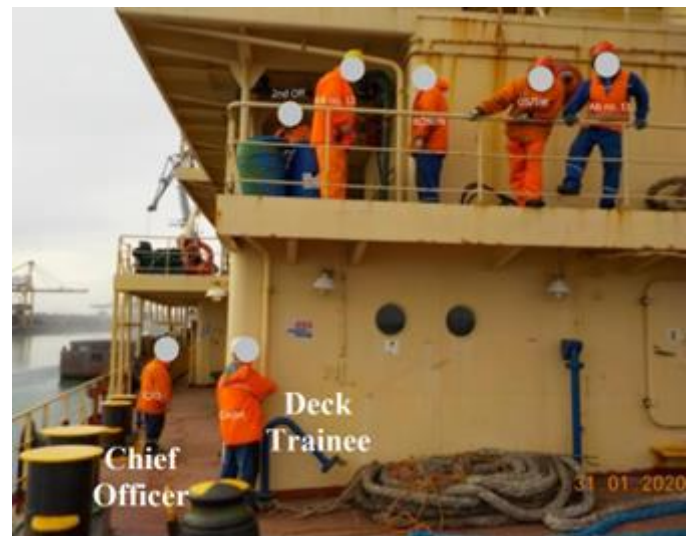
At one point, two large waves washed over the poop deck washing the C/O and deck trainee overboard.

Simulated crew positions at the time of the incident - (Ref: TMSI Report: 01/2021)

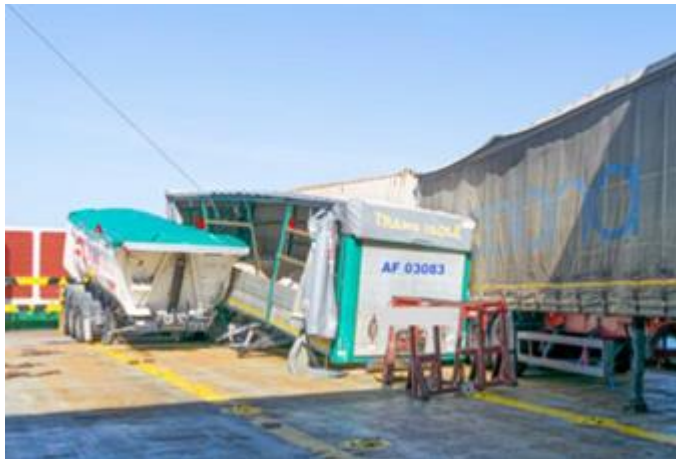
Master altered the vessel's course to about 335°, with the intention of reducing the rolling motions. The bosun reported to the bridge that the trestles and landing gear of two trailers on the forward-starboard side were damaged and that consequently, these trailers had collapsed.

Damage to trailers behind deckhouse- (Ref: TMSI Report: 17/2020)

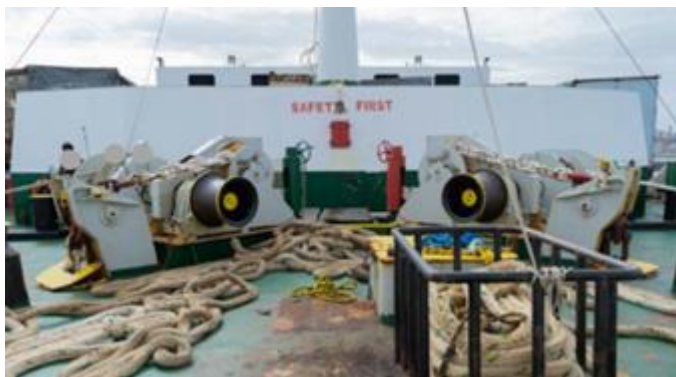
Looking aft - Forecastle deck / Deck house acting as wave breaker - (Ref: TMSI Report: 17/2020)

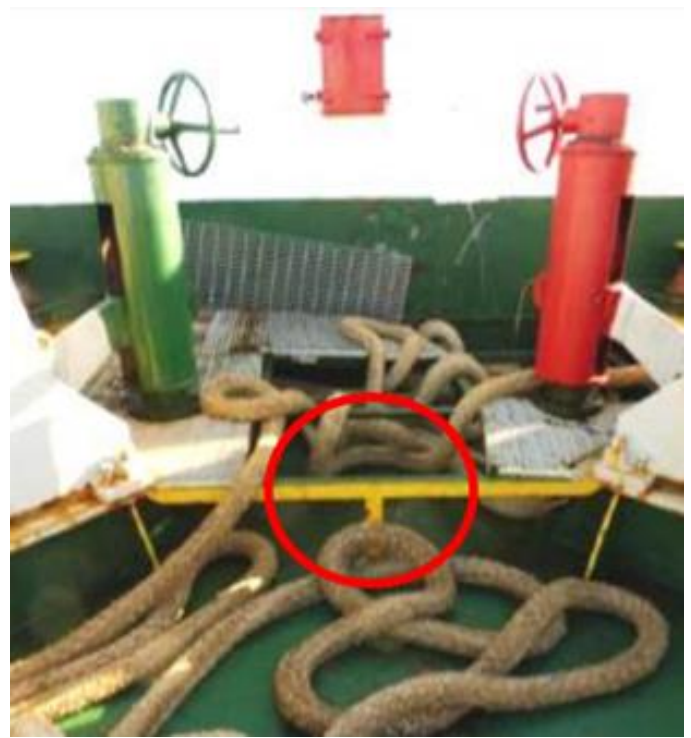
The C/O found AB1 lying face down and unresponsive between the two windlasses. He checked for vital signs and, on not noticing any, called for AB4. The C/O and AB4 carried AB1 towards the accommodation entrance.

Area (Red circle) where AB1 was found (Ref: TMSI Report: 17/2020))

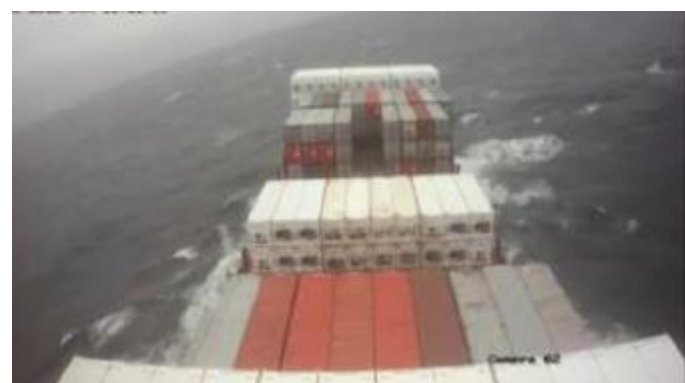
By noon, the wind was blowing steadily from Southeast and had reached BF 9. The vessel was on a course of 278° (T), with sea and swell from her port quarter, causing her to roll 30° to 35°.

Vessel rolling heavily to starboard – photo from bridge dome camera – ([Ref TMSI Report: 18/2019](#))

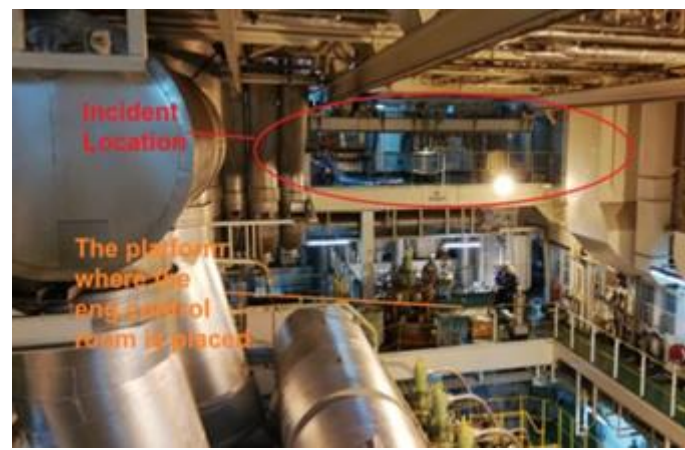
Platform where blowers were stowed (red) – ([Ref TMSI Report: 18/2019](#))

At 1235 following discussion, the master and several of the ships staff proceeded to the engine-room. It was discovered that the free, spare auxiliary blower had ruptured the stern-tube gravity tank, from where oil had spilled making the deck slippery. Furthermore, it was noticed that several items had also broken loose from their securing arrangements and were moving freely around the deck creating obstacles for the crew.

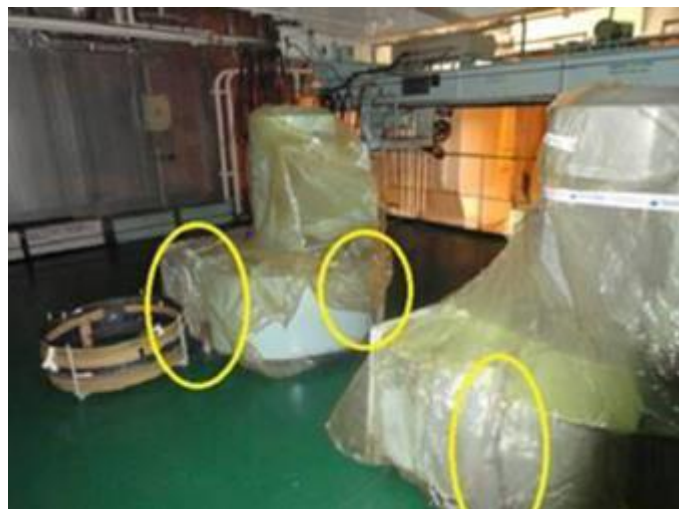
Lashed spare auxiliary blowers in the engine-room [TMSI Report: 18/2019](#)

- Immediate cause of the accident was failure of the lashings securing spare equipment.
- Weather reports received did not give cues of the inclement weather developing in the vessels path.
- Having identified the developing situation the master ordered all works suspended and that heavy weather precautions be taken.

- Dunnage was not placed below the blowers to prevent them from sliding.
- The vessel suffered excessive angular velocity due to a high GM, causing violent rolling motions and excessive acceleration stresses on lashings.

- Safe Working Loads of the lashings were not known and possibly not appropriate for securing the blowers.
- Vessel exposed to stern quartering seas and violent motions quickly developed being indicative that the vessel might have experienced parametric rolling.

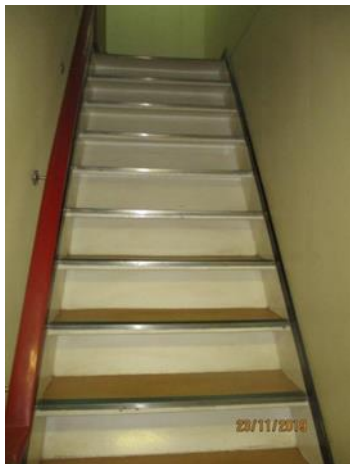
Stairway (Ref: TMSI Report: 22/2020)

- The stairway was fitted with a handrail, its risers were evenly spaced, and it was reportedly well lit and free of defects and slippery substances.
- Shoes worn by the EE were in good condition, with the treads free of wear.
