The Importance of ECDIS Training and Familiarisation, and Good Watch-Keeping Practice

Risk Alert

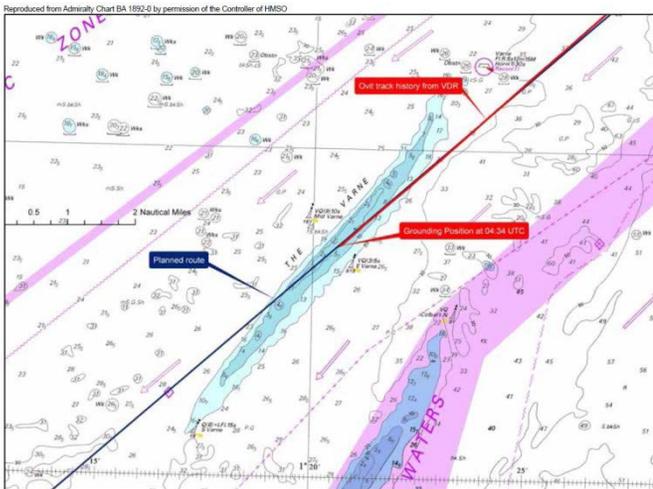
As may be expected, the presence of the Varne Bank as a navigational hazard is identified by navigational marks. The north-eastern extremity of the bank is marked by a Light Float/Vessel with an all-round red flashing light, at a height of 39 feet having a range of 15 nautical miles. The other limits of the bank are marked by east, south and west cardinal marks with lights of the appropriate characteristics. A simulation of the incident undertaken by the MAIB using the prevailing weather conditions established that the Varne Light Float was visible at a range of 10 nautical miles, and the cardinal marks at a range of 5 nautical miles.

At the time of the grounding the chief officer was assisted on the bridge by a cadet acting as lookout. Seventeen minutes before the grounding, the vessel passed close by the Varne Light Float. That navigational mark appears not to have been either noted, or its significance appreciated. Whilst the cadet observed the white flashing lights of the cardinal marks as the vessel approached the Varne Bank, he did not identify the lights nor report their sighting to the chief officer.
