The Importance of ECDIS Training and Good Watch-keeping Practices

Introduction

This Risk Alert supplements our earlier Risk Alert published in November 2014, **RA 43 - [The Importance of ECDIS Training and Familiarisation and Good Watch-Keeping Practice.](#)**

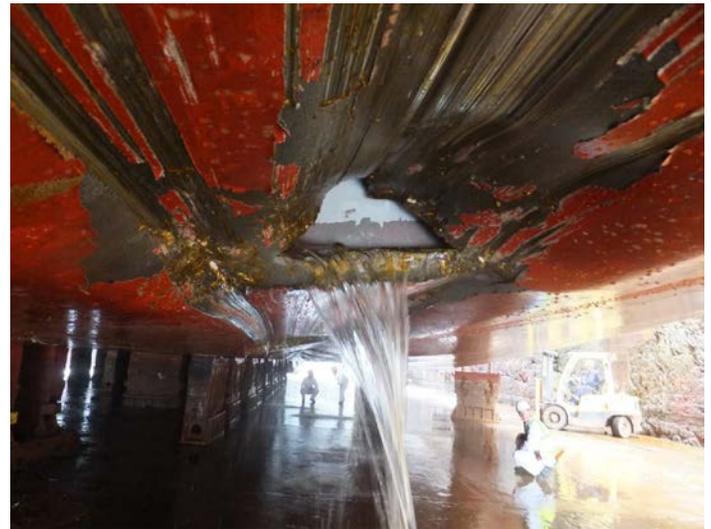
The vessel grounded on a granite rock where it had been erroneously believed that sufficient depth of water would have been available. Had the bridge team produced a fully detailed berth to berth voyage plan, taking the chart accuracy into consideration, the area where the vessel grounded would have been identified as unsafe, and avoided at all costs.
