Tank Manhole Cover Securing

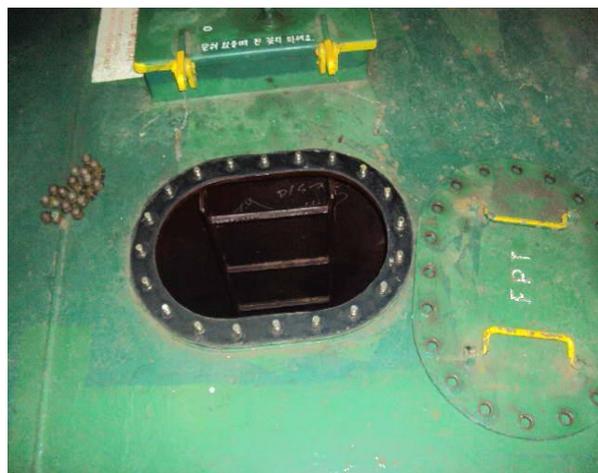
In one such incident a cargo hold was flooded with bunkers that was discovered only when the hold bilge alarm was triggered. One of the manholes of a bunker tank had not been refitted after a tank inspection. The location of the manhole in this case was such that it was not easily accessible or visible from the regular operational areas of the vessel; as a result the missing cover went unnoticed.

Top side manhole cover

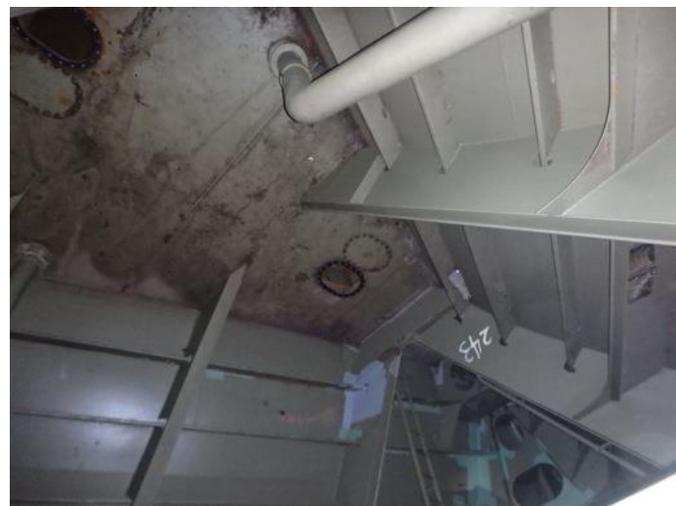
Manhole covers on vertical bulkheads, such as those on wing tanks or side tanks of container ships, are generally located close to the bottom of the tank meaning that leakage from the cover is found only after the tank has been filled to a certain head. This makes it even more difficult for the manhole cover to be secured until the contents of the tank have been transferred from the tank to stop the leakage.

Inaccessible side tank covers

The extent of damage caused in such a case will often depend on how quickly the leakage is identified and the scope for quickly transferring out the contents. Side tanks are particularly difficult in this regard as leakage may go unnoticed due to their location being obscured by cargo.

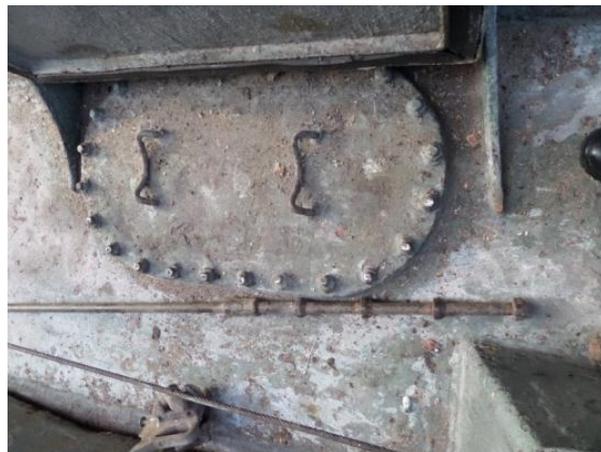
Poor condition of tank cover

It should include the manhole cover number, its location along with the checks required for assessing the condition of the manhole cover, sealing gasket, sealing surface, fasteners etc. Sufficient inventory of spares should be available on board.

The crew should be familiar with the required manhole cover standards as stated on the ship tank arrangement plan and use only the prescribed spares.

Control measures should also include hydrostatic pressure testing of the tank upon completion of the work. The permit to work should not to be closed until the tank has been secured and the hydrostatic pressure testing has been completed. In case of transfer of responsibility, handing over notes should highlight all open permits to work forms and the current status.
