# RISK ALERT

## Work Safety - Adverse Weather

Written by  
**Nahush Paranjpye**  
Loss Prevention

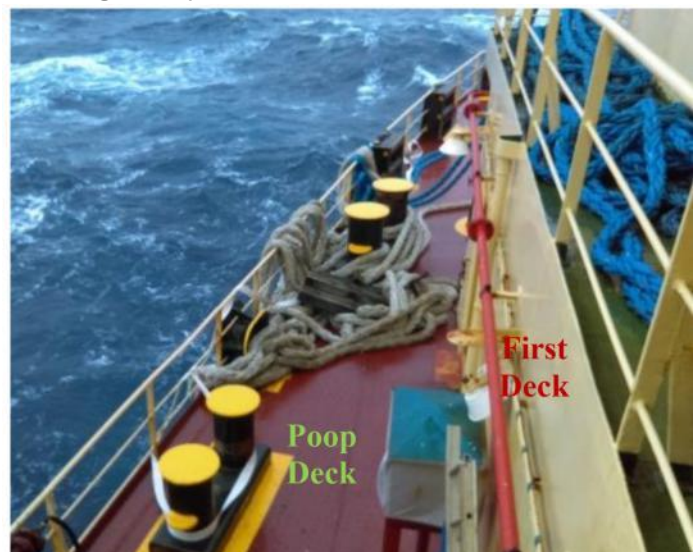
It was noticed that mooring ropes stored on the poop deck had moved, with some mooring ropes now hanging over the vessel's guard rails.

Starboard side, two ropes secured to poop deck railings the other end of one rope hauled onto the first deck - (Ref: TMSI Report: 01/2021)

- The C/O and deck trainee were not secured to the vessel.
- Immersion in, and exposure to cold water may have shortened the survival time of the C/O and deck trainee.
- A regular rope was used instead of a safety harness.
- The C/O and deck trainee released the line which they were using to secure themselves.
- Crew members not wearing lifejackets in adverse weather conditions while working on exposed deck.
- Identification of alternative stowage arrangement of mooring ropes was not considered safety critical.
- Securing method for mooring ropes did not suffice to prevent the ropes from scattering around the poop-

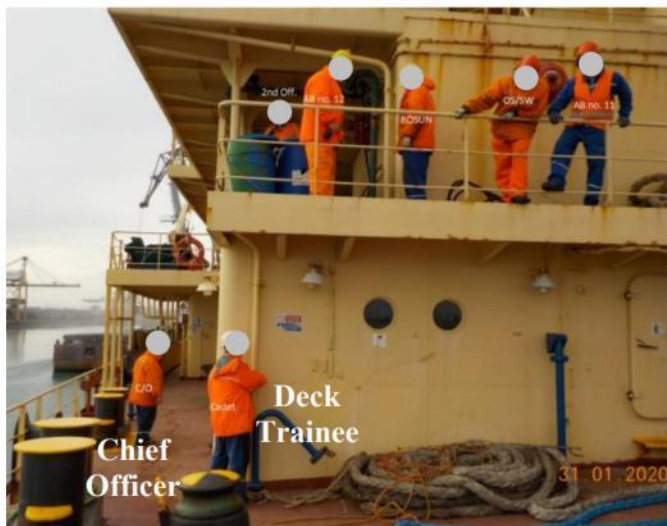
[Simulated crew positions at the time of the incident - \(Ref: TMSI Report: 01/2021\)](#)

Reportedly, during the securing operations, the C/O was heard telling the deck trainee that he needs to be secured with a rope. The C/O and trainee were both observed with ropes tied around their waists. Once it was understood that the operation was now complete the C/O and deck trainee started making their way back from the poop deck. At this moment, a large wave is reported to have washed over the poop deck from the starboard to port side. Within seconds of the first a second, larger wave, then washed on board from the same direction. Soon after the second wave struck, several crew members noticed orange, winter jackets floating in the water at which time it became clear that both the C/O and the deck trainee had been washed overboard.

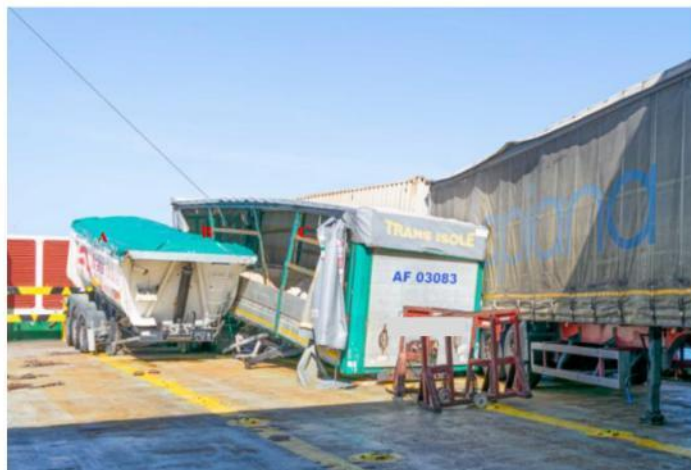
Master altered the vessel's course to about 335°, with the intention of reducing the rolling motions. The bosun reported to the bridge that the trestles and landing gear of two trailers on the forward-starboard side were damaged and that consequently, these trailers had collapsed.

Damage to trailers behind deckhouse- (Ref: [TMSI Report: 17/2020](#))

- The vessel was inherently 'tender' and susceptible to water being shipped onto her deck.
- The motions of the vessel in heavy weather conditions, shifting of the cargo within the trailers due to the same and the subsequent strain on the cargo securing devices, along with the probability of an overweight trailer, was likely to have resulted in the failure of some trailer supports which, in turn, led to further cargo shifting and subsequent damages to some trailers.

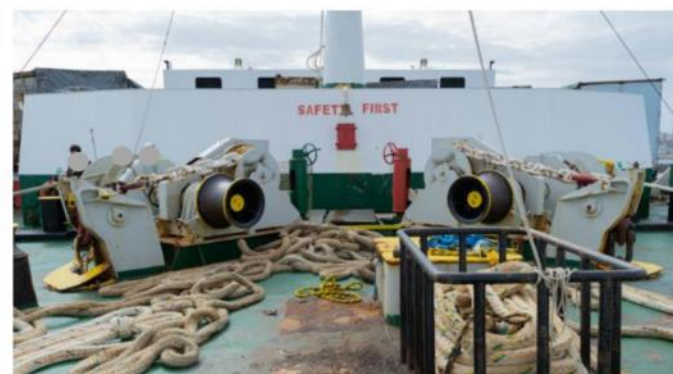
Looking aft - Forecastle deck / Deck house acting as wave breaker - (Ref: [TMSI Report: 17/2020](#))

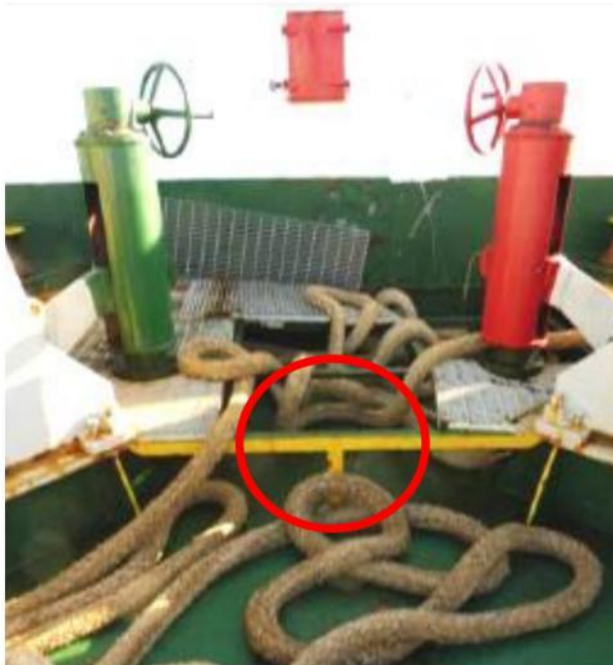
The C/O found AB1 lying face down and unresponsive between the two windlasses. He checked for vital signs and, on not noticing any, called for AB4. The C/O and AB4 carried AB1 towards the accommodation entrance. C/O then noticed that the bosun and the other two ABs had managed to walk back.

[Area \(Red circle\) where AB1 was found \(Ref: TMSI Report: 17/2020\)](#)

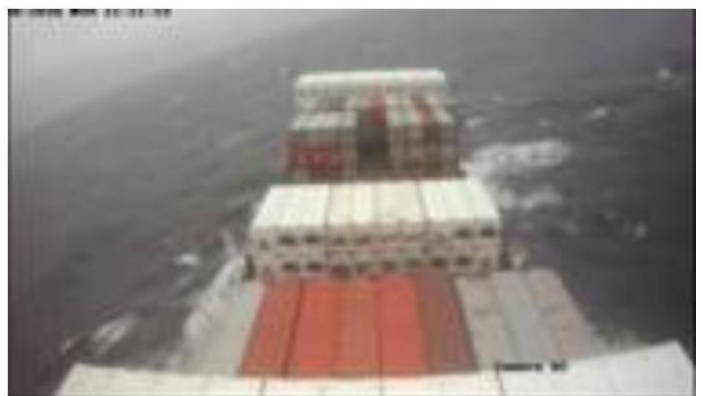
By noon, the wind was blowing steadily from Southeast and had reached BF 9. The vessel was on a course of 278° (T), with sea and swell from her port quarter, causing her to roll 30° to 35°.

[Vessel rolling heavily to starboard – photo from bridge dome camera – \(Ref TMSI Report: 18/2019\)](#)

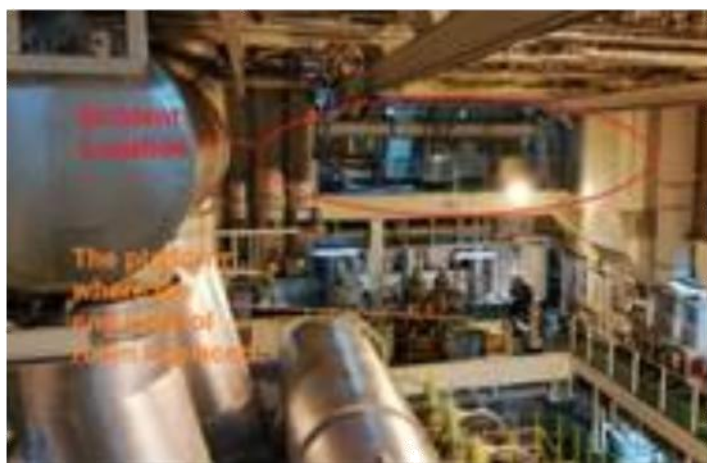
At 1235 following discussion, the master and several of the ships staff proceeded to the engine-room. It was discovered that the free, spare auxiliary blower had ruptured the stern-tube gravity tank, from where oil had spilled making the deck slippery. Furthermore, it was noticed that several items had also broken loose from their securing arrangements and were moving freely around the deck creating obstacles for the crew.

[Platform where blowers were stowed \(red\) – \(Ref TMSI Report: 18/2019\)](#)

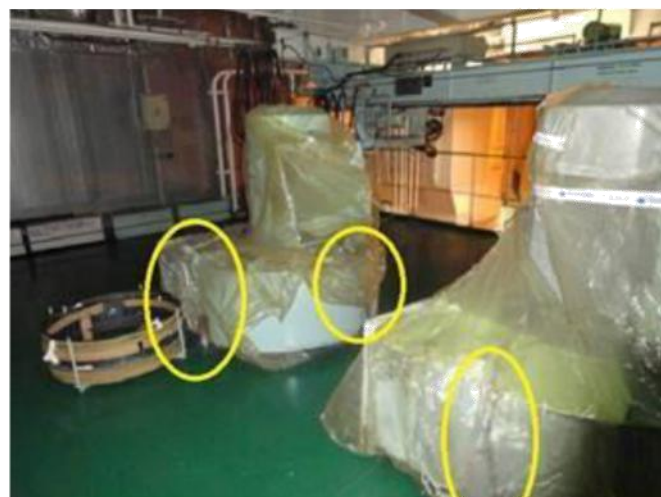
[Lashed spare auxiliary blowers in the engine-room TMSI Report: 18/2019](#)

- Immediate cause of the accident was failure of the lashings securing spare equipment.
- Weather reports received did not give cues of the inclement weather developing in the vessels path.
- Having identified the developing situation the master ordered all works suspended and that heavy weather precautions be taken.
- Dunnage was not placed below the blowers to prevent them from sliding.
- The vessel suffered excessive angular velocity due to a high GM, causing violent rolling motions and excessive acceleration stresses on lashings.
- Stability of the vessel could not be further improved.
- SMS did not seem to address the engine-room space and the need to recheck and/or re-tighten items that were already lashed.

- Safe Working Loads of the lashings were not known and possibly not appropriate for securing the blowers.
- Vessel exposed to stern quartering seas and violent motions quickly developed being indicative that the vessel might have experienced parametric rolling.
- The crew appear to have acted in the belief that it was important to intervene as quickly as possible for fear that the moving blowers could fall onto the decks below, causing further damage.
- Alteration of course not an available option, this would have placed the vessel closer to danger of grounding and could have resulted in even more violent motions.
- Shelter as an option would only have been available about three to four hours after the accident.

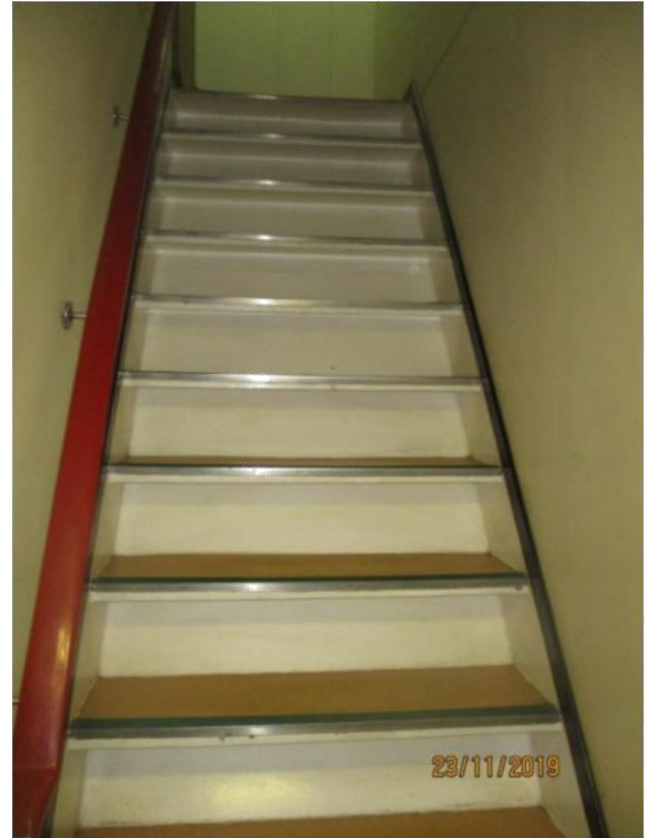
## **Stairway** (Ref: [TMSI Report: 22/2020](#))

- The stairway was fitted with a handrail, its risers were evenly spaced, and it was reportedly well lit and free of defects and slippery substances.
- The shoes worn by the EE were in good condition, with the treads free of wear.
- The EE records of hours of work/rest did not indicate any excess of the limits prescribed by MLC 2006.
- Death was caused by a severe head trauma

- In the absence of witnesses, it was not possible to determine why the EE was using the stairway.
- The EE either lost his footing or balance due to the rolling and pitching motions of the vessel, and subsequently fell down the stairway
- The EE may not have been holding the handrail while descending the stairway.
