# RISK ALERT

## Work Safety - Adverse Weather

Written by  
Nahush Paranjpye  
Loss Prevention

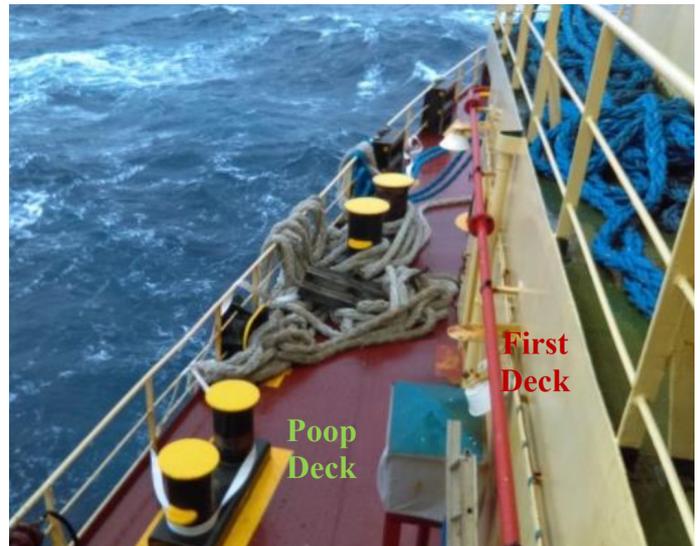
It was noticed that mooring ropes stored on the poop deck had moved, with some mooring ropes now hanging over the vessel's guard rails.

Starboard side, two ropes secured to poop deck railings the other end of one rope hauled onto the first deck - (Ref: [TMSI Report: 01/2021](#))

- The C/O and deck trainee were not secured to the vessel.
- Immersion in, and exposure to cold water may have shortened the survival time of the C/O and deck trainee.
- A regular rope was used instead of a safety harness.
- The C/O and deck trainee released the line which they were using to secure themselves.
- Crew members not wearing lifejackets in adverse weather conditions while working on exposed deck.
- Identification of alternative stowage arrangement of mooring ropes was not considered safety critical.
- Securing method for mooring ropes did not suffice to prevent the ropes from scattering around the poop-deck and over the rails

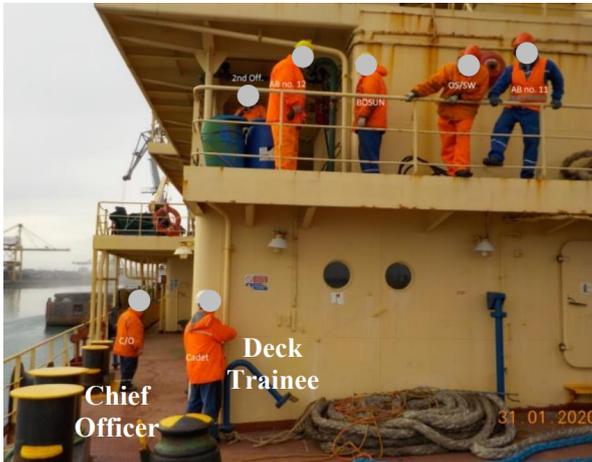
Simulated crew positions at the time of the incident - (Ref: [TMSI Report: 01/2021](#))

Reportedly, during the securing operations, the C/O was heard telling the deck trainee that he needs to be secured with a rope. The C/O and trainee were both observed with ropes tied around their waists. Once it was understood that the operation was now complete the C/O and deck trainee started making their way back from the poop deck. At this moment, a large wave is reported to have washed over the poop deck from the starboard to port side. Within seconds of the first a second, larger wave, then washed on board from the same direction. Soon after the second wave struck, several crew members noticed orange, winter jackets floating in the water at which time it became clear that both the C/O and the deck trainee had been washed overboard.

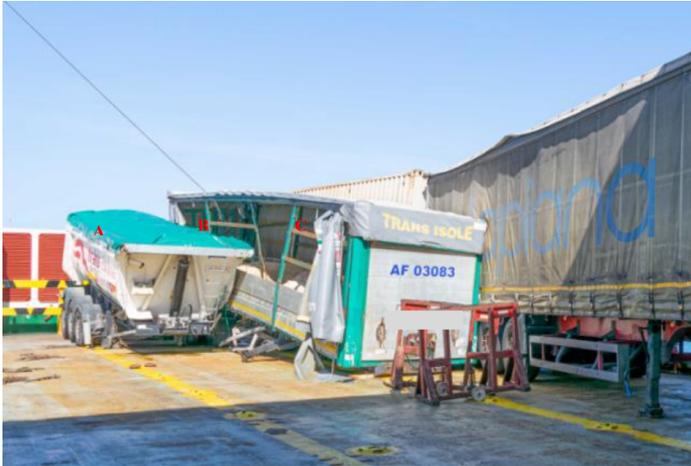
Master altered the vessel's course to about 335°, with the intention of reducing the rolling motions. The bosun reported to the bridge that the trestles and landing gear of two trailers on the forward-starboard side were damaged and that consequently, these trailers had collapsed.

Damage to trailers behind deckhouse- (Ref: [TMSI Report: 17/2020](#))

- The vessel was inherently 'tender' and susceptible to water being shipped onto her deck.
- The motions of the vessel in heavy weather conditions, shifting of the cargo within the trailers due to the same and the subsequent strain on the cargo securing devices, along with the probability of an overweight trailer, was likely to have resulted in the failure of some trailer supports which, in turn, led to further cargo shifting and subsequent damages to some trailers.

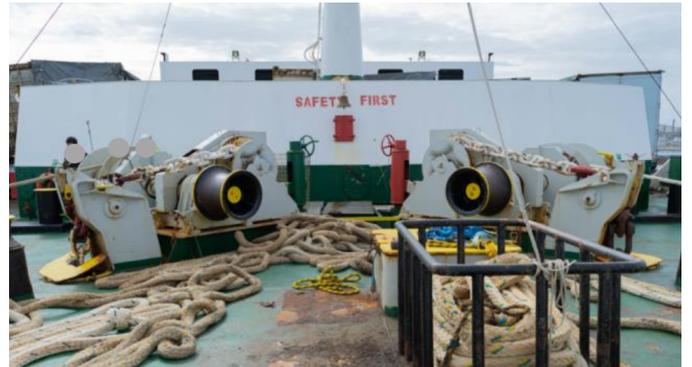
While on the forecastle deck the bosun noted that the anchor lashings were loose (they were not secured in compliance with the company's procedures) and started walking back towards the ramp to call for assistance. At around this time a large wave washed over the vessels bow.

Looking aft - Forecastle deck / Deck house acting as wave breaker - (Ref: [TMSI Report: 17/2020](#))

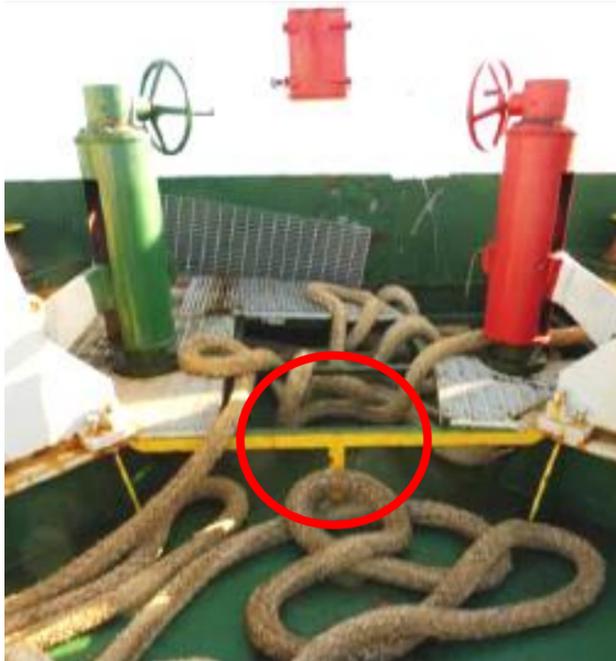
The C/O found AB1 lying face down and unresponsive between the two windlasses. He checked for vital signs and, on not noticing any, called for AB4. The C/O and AB4 carried AB1 towards the accommodation entrance. C/O then noticed that the bosun and the other two ABs had managed to walk back.

Area (Red circle) where AB1 was found (Ref: [TMSI Report: 17/2020](#))

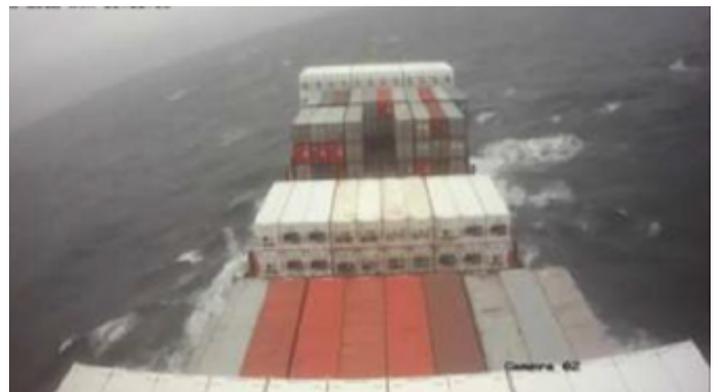
By noon, the wind was blowing steadily from Southeast and had reached BF 9. The vessel was on a course of 278° (T), with sea and swell from her port quarter, causing her to roll 30° to 35°.

Vessel rolling heavily to starboard – photo from bridge dome camera – ([Ref TMSI Report: 18/2019](#))

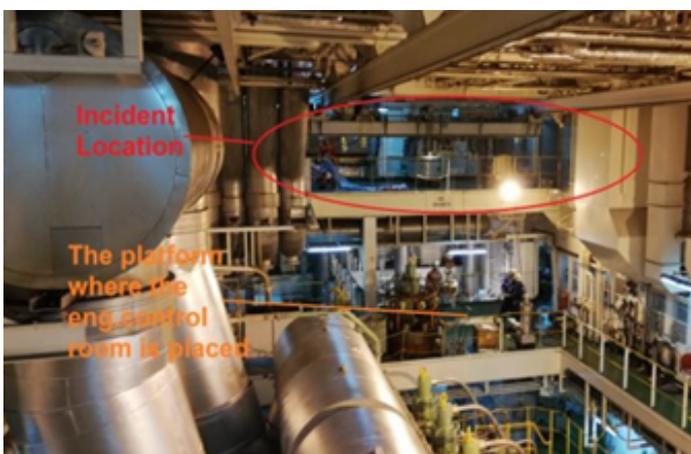
At 1235 following discussion, the master and several of the ships staff proceeded to the engine-room. It was discovered that the free, spare auxiliary blower had ruptured the stern-tube gravity tank, from where oil had spilled making the deck slippery. Furthermore, it was noticed that several items had also broken loose from their securing arrangements and were moving freely around the deck creating obstacles for the crew.

Platform where blowers were stowed (red) – (Ref [TMSI Report: 18/2019](#))

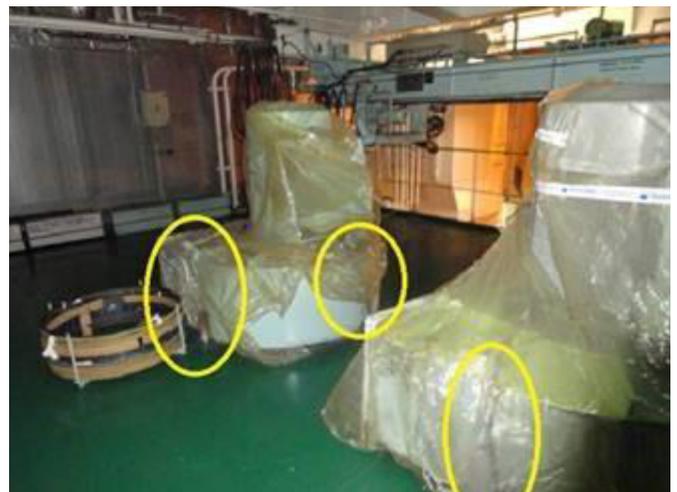
Lashed spare auxiliary blowers in the engine-room [TMSI Report: 18/2019](#)

- Immediate cause of the accident was failure of the lashings securing spare equipment.
- Weather reports received did not give cues of the inclement weather developing in the vessels path.
- Having identified the developing situation the master ordered all works suspended and that heavy weather precautions be taken.
- Dunnage was not placed below the blowers to prevent them from sliding.
- The vessel suffered excessive angular velocity due to a high GM, causing violent rolling motions and excessive acceleration stresses on lashings.
- Stability of the vessel could not be further improved.
- SMS did not seem to address the engine-room space and the need to recheck and/or re-tighten items that were already lashed.

- Safe Working Loads of the lashings were not known and possibly not appropriate for securing the blowers.
- Vessel exposed to stern quartering seas and violent motions quickly developed being indicative that the vessel might have experienced parametric rolling.
- The crew appear to have acted in the belief that it was important to intervene as quickly as possible for fear that the moving blowers could fall onto the decks below, causing further damage.
- Alteration of course not an available option, this would have placed the vessel closer to danger of grounding and could have resulted in even more violent motions.
- Shelter as an option would only have been available about three to four hours after the accident.

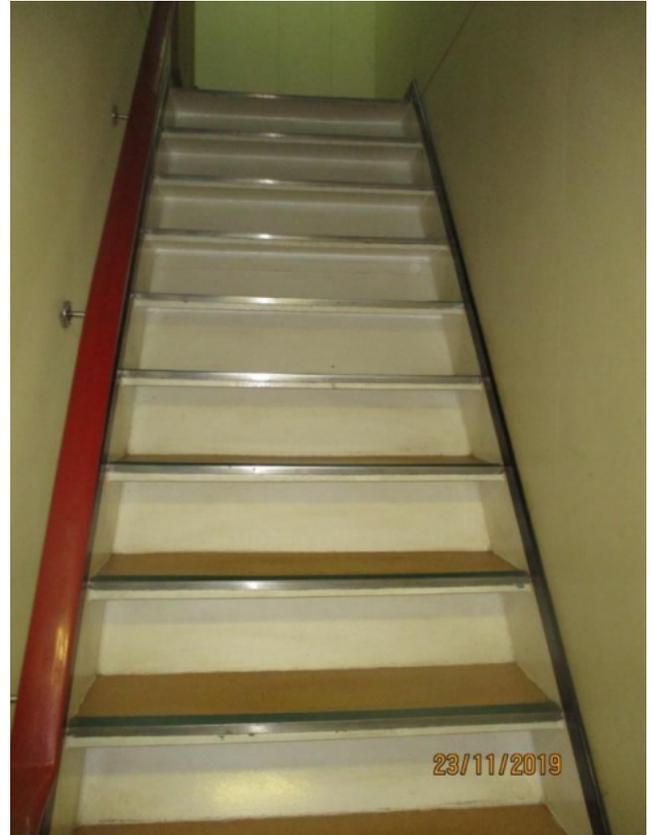
## Stairway (Ref: [TMSI Report: 22/2020](#))

- The stairway was fitted with a handrail, its risers were evenly spaced, and it was reportedly well lit and free of defects and slippery substances.
- The shoes worn by the EE were in good condition, with the treads free of wear.
- The EE records of hours of work/rest did not indicate any excess of the limits prescribed by MLC 2006.
- Death was caused by a severe head trauma

- In the absence of witnesses, it was not possible to determine why the EE was using the stairway.
- The EE either lost his footing or balance due to the rolling and pitching motions of the vessel, and subsequently fell down the stairway
- The EE may not have been holding the handrail while descending the stairway.
