**Report of investigation  
into the fatal accident on board  
Hong Kong registered container ship  
“CSCL SAN JOSE” at the port of  
Jakarta, Indonesia  
on 19 July 2016**

**The Hong Kong Special Administrative Region  
Marine Department  
Marine Accident Investigation Section**

13 September 2018

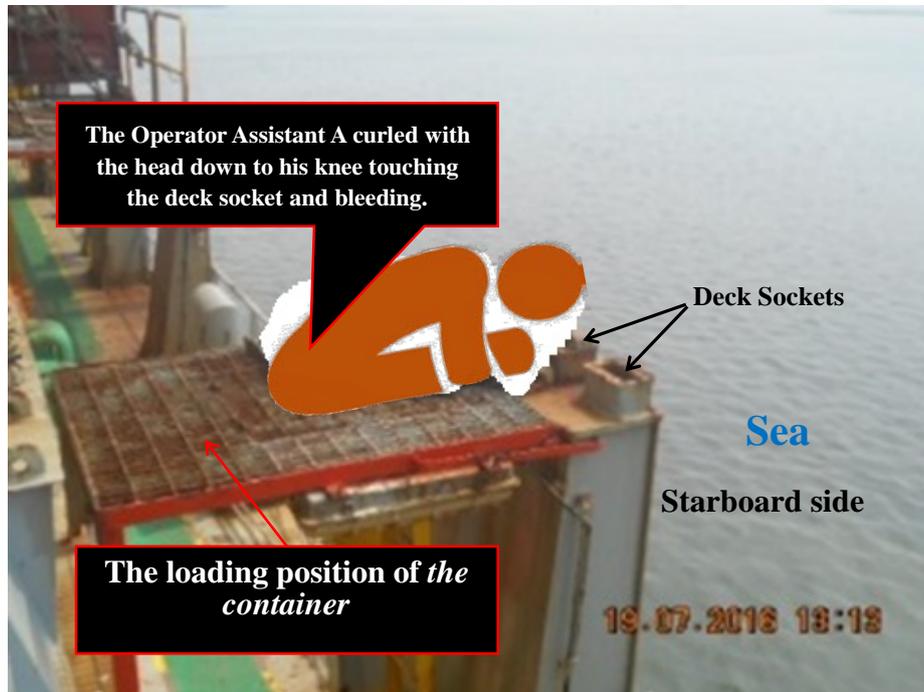
- 1.3 As a result, the Operator Assistant A was trapped under *the container* and was found in a curling position with his head bent forward touching a deck socket. He was taken by an ambulance but declared dead on the way to the hospital.

- 4.4 At about 1154 hours, the third officer noticed shouting of *the stevedore*. At about 1155 hours, the third officer went to the site and saw that the body of the Operator Assistant A was in a curling position with the head down to his knee touching a deck socket without any movement (Figure 2).

Figure 2 The scene of the accident

- 5.4 Based on the photos taken at the accident scene, the Operator Assistant A did not wear reflective vest and safety helmet. It is common safety practice that persons handling container on board ship should wear suitable safety gear to protect their bodies.
- 5.5 Both the Operator Assistant A and the Crane Operator A were provided with radio communication devices which were switched on and functioned properly. Although radio communication devices were in function, the communication between the Operator Assistant A and the Crane Operator A was obviously not maintained properly in the sense that the Operator Assistant A did not inform the Crane Operator A that he would go to the loading position to release twist lock.

- 5.7 As stated by the container terminal's accident investigation report, the stevedores from contractors were responsible for releasing twist locks rather than operator assistants. It was probably that the Operator Assistant A without wearing safety helmet and reflective vest was trying to release a twist lock at the loading position through his own initiative but without informing the Crane Operator A.

- 5.8 When the Crane Operator A was handling *the container*, he had a restricted view of the loading position. In accordance with the "Code of practice on safety and health in ports" published by the International Labour Organization (ILO), crane operator with restricted view operation environment should be provided with a signaler to assist in cargo operation. However, he was not provided with a signaler to assist him in his work. Further to this, he was also not aware of the presence of the Operator Assistant A at the loading position due to communication breakdown. As a result, the Operator Assistant A was trapped underneath *the container* and died.

- (i) persons engaged in shipboard container handling should wear appropriate personal protective equipment including but not limited to reflective vest and safety helmet;
- (ii) persons engaged in shipboard container handling should keep a safe distance from the travelling paths of containers in suspension at all times during working on board;
- (iii) unless the crane operators have an unrestricted view of cargo operation, signalers should be provided to assist crane operators' work; and
- (iv) the communication between crane operators and operator assistants should be maintained properly and effectively at all time during cargo operation.
