Risk Alert

Work safety - Container cargo operations

Written by
Nahush Paranjpye
Loss Prevention

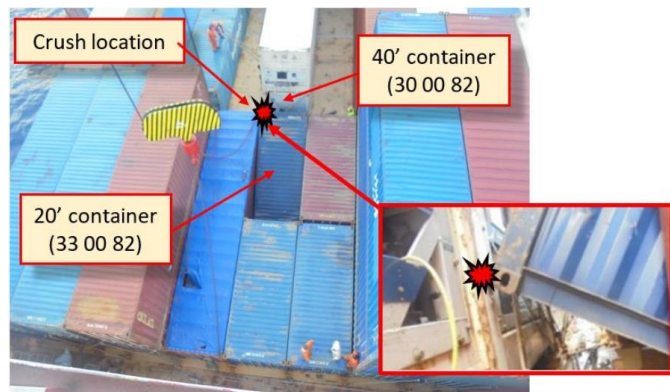
While the Bosun was performing a gas-cutting task trying to free a twistlock that was stuck between a 20' and 40' container. The 20' container swung out and hit an Able Seafarer Deck (ASD) who was in the vicinity, causing fatal injuries.

Ref: Top view of accident site and location where ASD was crushed. [TSIB report - MIB/MAI/CAS.046](#)

The investigation revealed that the lifting force acting on the containers had compromised the integrity of the corroded locking edges permitting the 20' container to break away.

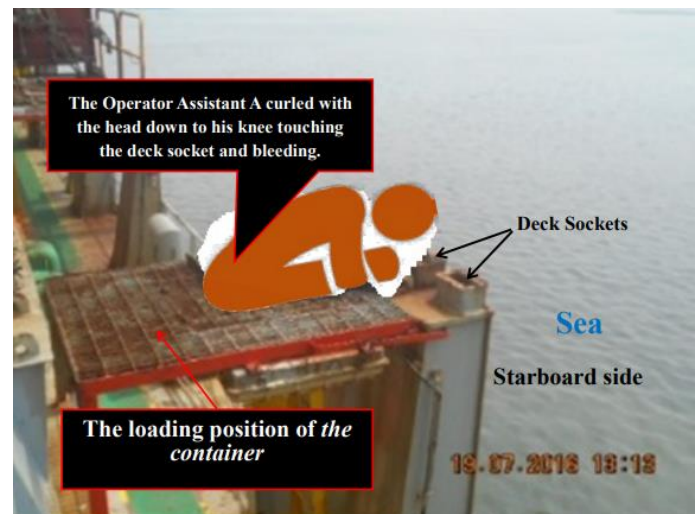
While trying to release a twist lock from a deck socket at the loading position **without notifying the quay crane operator**, the operator assistant was trapped a 40-foot container when it was loaded by the quay crane. He was discovered only later in a curled position (his head bent forward touching a deck socket) after a stevedore noticed the container had not been positioned properly on the loading location.

Ref: Scene of the accident [MAISSPB Report Dated 13 Sep 2018](#)

The investigation noted the **crane operator had a restricted view** for container handling but was not provided with a signalman. Both the crane operator and the operator assistant had functional walkie talkies but there appeared to be a **lack of communication** of the intent to release the twistlock from the loading position. Further, the operator assistant was **wearing neither a reflective vest nor safety helmet**.

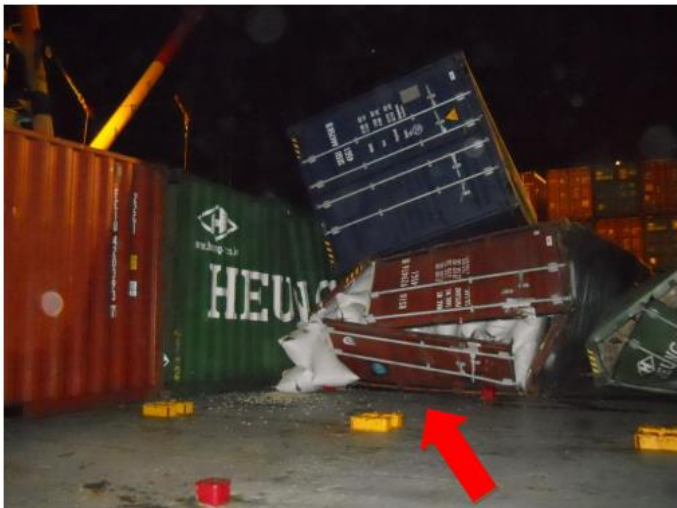
Containers were being transferred (using the barge derrick) from the vessel to the port side of the barge (causing the barge to list to port). Later, when lifting a 20' container, the barge **listed further to port** causing all of the top tier 40' containers stacked aft of the barge to **topple and fall on to the cargo hold area** of the container vessel.

An able-bodied seaman (AB), working on the starboard side of the cargo hatch cover was hit and fatally crushed by the toppling/falling containers. The victim was crushed under two fully loaded containers, it was not possible to assist him, a shore rescue team being required.

Ref: AB was crushed under collapsed containers (red arrow) [MAISSPB Report Dated 29 Apr 2015](#)

Four containers fell onto the vessel deck; 10 containers fell into the water and others remained inside the cargo hold.

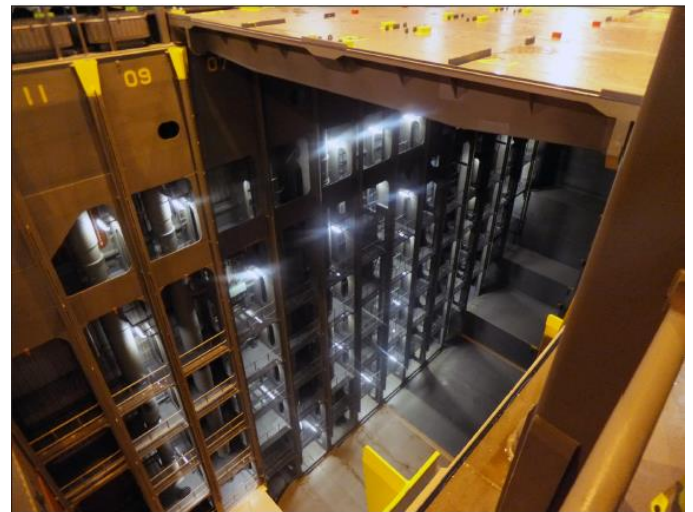
The AB probably **slipped on a patch of ice** while walking across a hatch cover of a **partially open hold** and fell approximately 25m - he died of multiple injuries.

Ref: View of the open cargo hold [MAIB Accident Report No 20/2012](#)

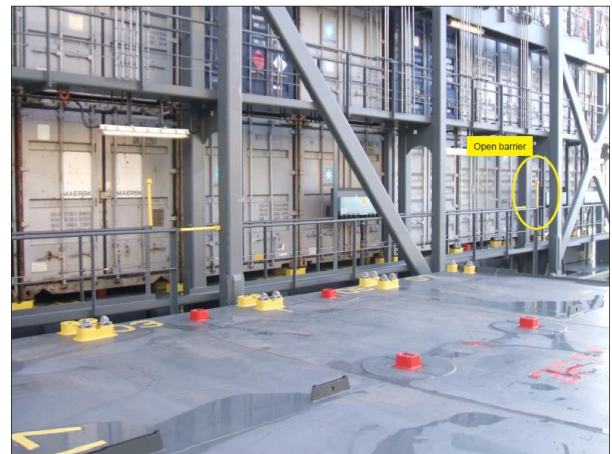
It is possible that the AB fell through an open barrier in railings adjacent to a walkway although this was thought unlikely on the basis of the site where the AB was found.

Ref: Open barrier at the railing of adjacent walkway [MAIB Accident Report No 20/2012](#)

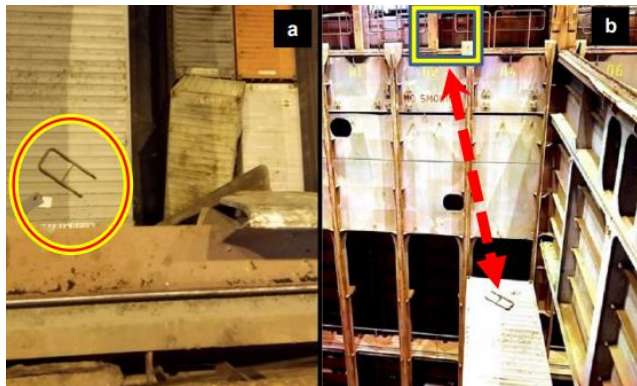
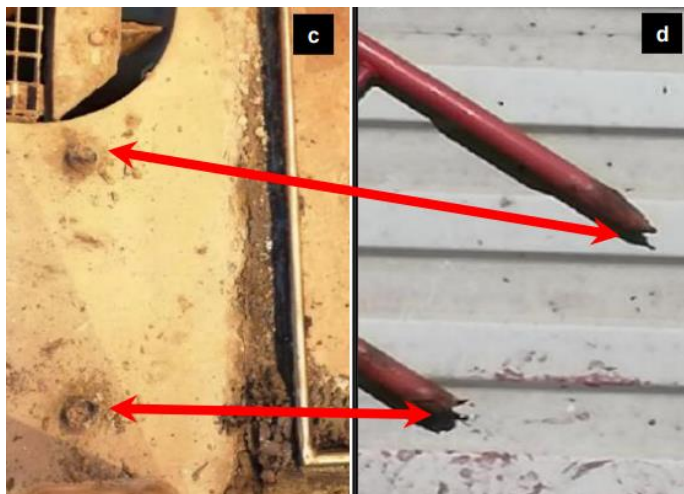
A container being discharged using the gantry crane fell into the cargo hold. The deceased stevedore had **likely leaned on a corroded safety railing** on the cross deck to check the condition of the container when the safety railing gave way.

Ref: (a) Location of recovered clipboard and broken railing, with fallen container in no. 3 cargo hold. (b) Original position of broken railing along cross deck. [TSIB report - MIB/MAI/CAS.069](#)

Ref: (c) and (d) remaining parts of broken railing on cross deck [TSIB report - MIB/MAI/CAS.069](#)

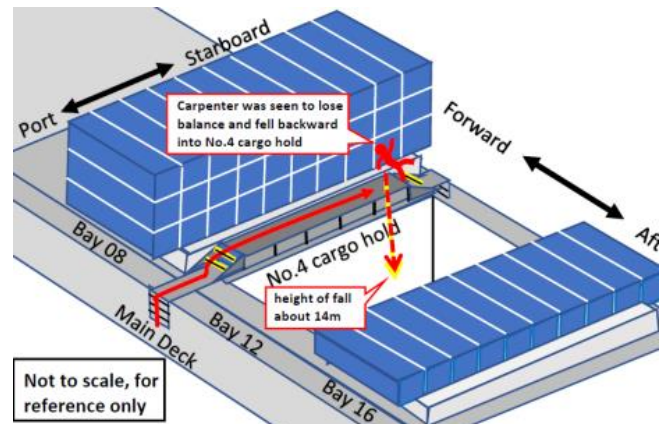
While walking on a catwalk **cluttered with loose lashing gear**, the crew member slipped, lost his balance, and fell backwards (about 14m) into the open cargo hold which **did not have any safety railings or safeguards**. He was attended to by shore medical personnel and transferred to hospital but succumbed to his injuries.

Ref: Representation of accident location [TSIB report - MIB/MAI/CAS.028](#)

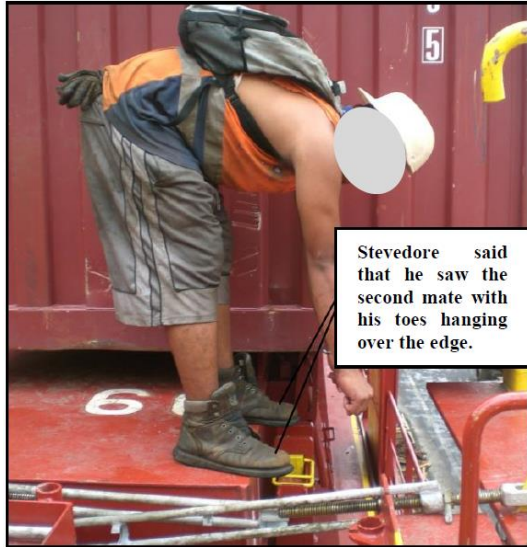
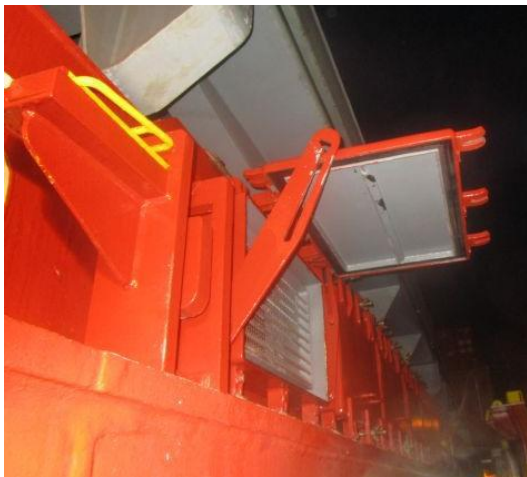
The second mate tried to close the ventilation flap of a hatch cover from atop the hatch cover, **bending over to pull the louvre board up** before letting it go to close. He lost his balance, flipped over, and fell on the side railings of the vessel and eventually overboard on the jetty side.

Ref: Hatch cover vent (close to shipside) [Transport Malta - Safety Investigation Report – 05/2016](#)

Ref: A typical hatch cover vent flap [Transport Malta - Safety Investigation Report – 05/2016](#)

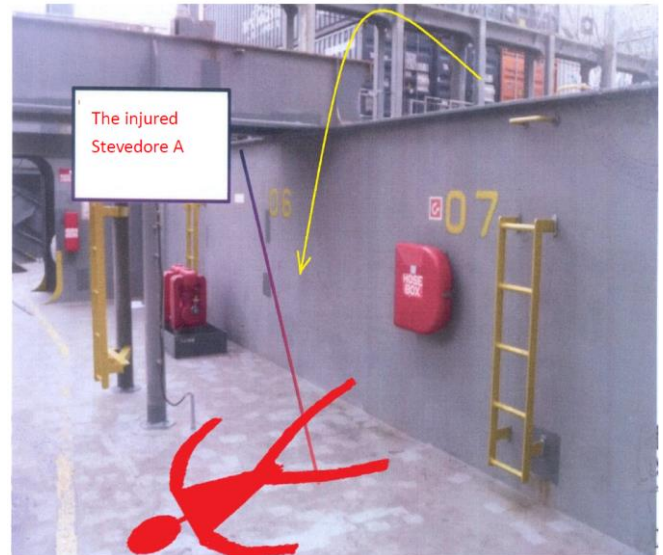
A stevedore fell about 2 metres from the top of a hatch cover onto the deck passage. He was spotted lying on the deck passage by a crane operator and was seen to raise his hand but was unable to answer a walkie talkie. He was found unconscious, conveyed to the hospital and subsequently succumbed to his injuries.

Ref: Location of fall [MAISSPB Report Dated 28 July 2015](#)

There were no witnesses to the incident, however an investigation and CCTV footage later revealed that he was working alone and that this probably contributed to the loss of valuable time in receiving immediate medical treatment as his fall was unobserved.

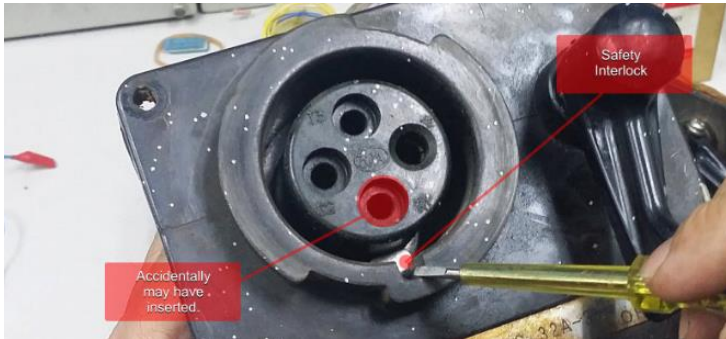
During routine cargo operations onboard a feeder containership a crew member was subjected to a fatal electric shock. In **attempting to by-pass the safety interlock** of a faulty electrical reefer socket, the crew

member accidentally inserted a screwdriver into the reefer socket.

Ref: Faulty socket and mechanism [MPA SRS e-Bulletin 2015/ISSUE 03](#)

Wet ambient conditions caused the current flowing through the ship's power supply (440V) to the reefer socket into the crew member's body, causing his death due to a heart attack. Autopsy revealed the Blood Alcohol Content (BAC) of the deceased was 90mg/100ml, more than 3 times the limit prescribed in STCW Convention and the company's Drug & Alcohol Policy

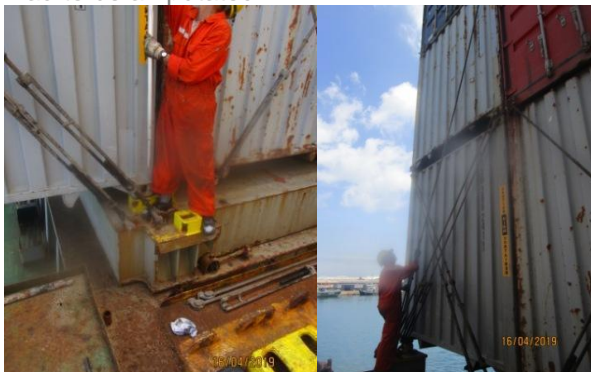
The lower end of a long lashing bar fell onto the seafarer's right foot, cutting through his safety footwear. One toe on the seafarer's right foot was severely injured and had to be amputated.

Ref: Crew member demonstrating hooking and connecting a long bar to a turnbuckle [Transport Malta - Safety Investigation Report – 04/2020](#)
