# **Pilot Ladders – Error Enforcing Conditions and Deficiencies**

### CHIRP Maritime Advisory Board – Insight Article:

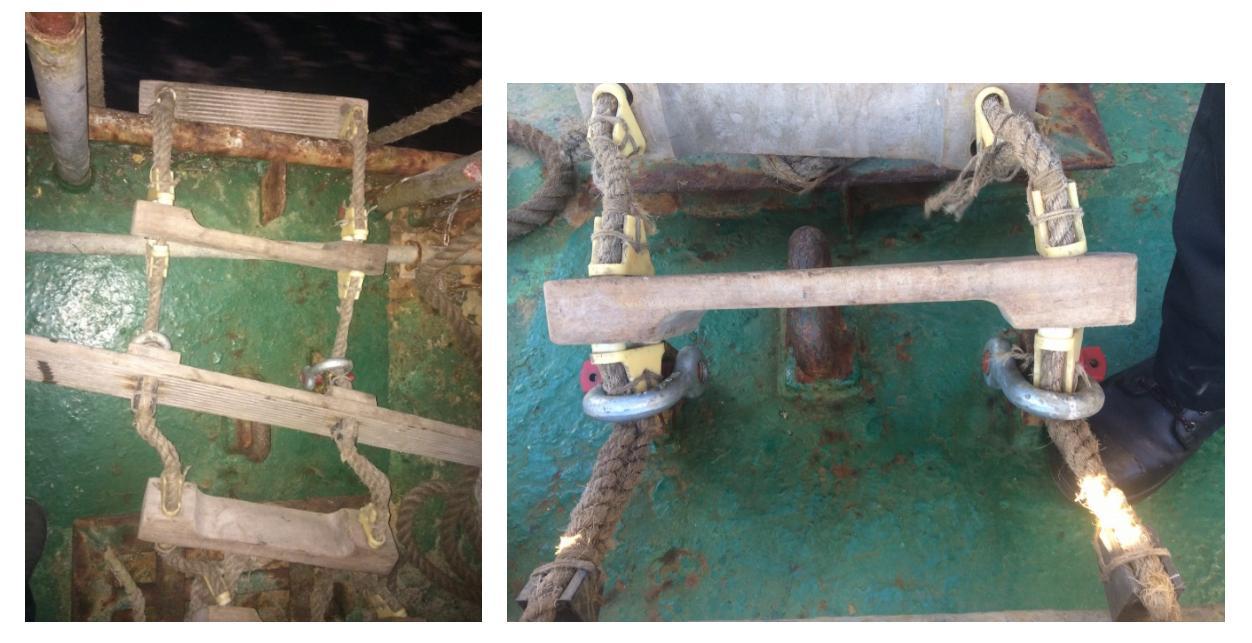
Figure 1 – Well-worn ladder with shackles impacting against the side chocks

In this example, the ladder had its weight effectively taken by the chocks. Whether they are plastic or wooden, chocks can be damaged if the shackles take the weight of the ladder directly against them. As it happens this example also resulted in the ladder being secured at the deck level in a manner which caused the steps to lie at an uneven angle. A cursory glance at the photo should be enough to tell you that this ladder is not fit for purpose and is (probably) not certified.

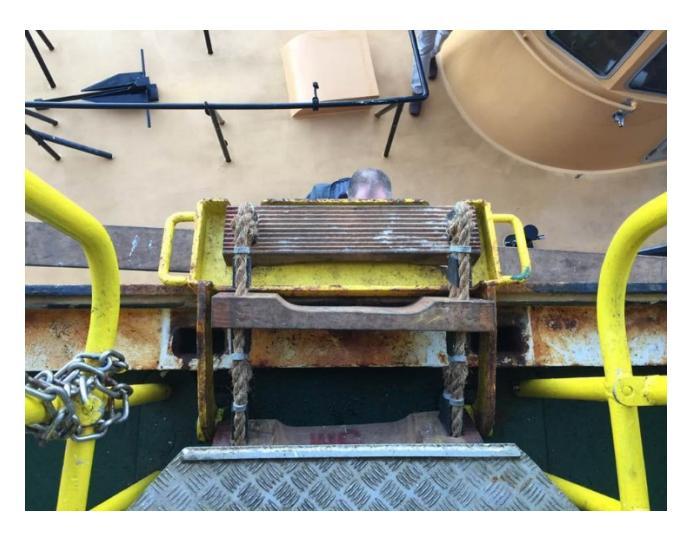
Figure 2 – Ladder weight supported by a bracket which the step fits into

With Figure two, the weight is taken by an uncertified bracket and by the whippings around the chock above the step. Additionally, should the ladder jump for any reason there is the potential for a serious accident.

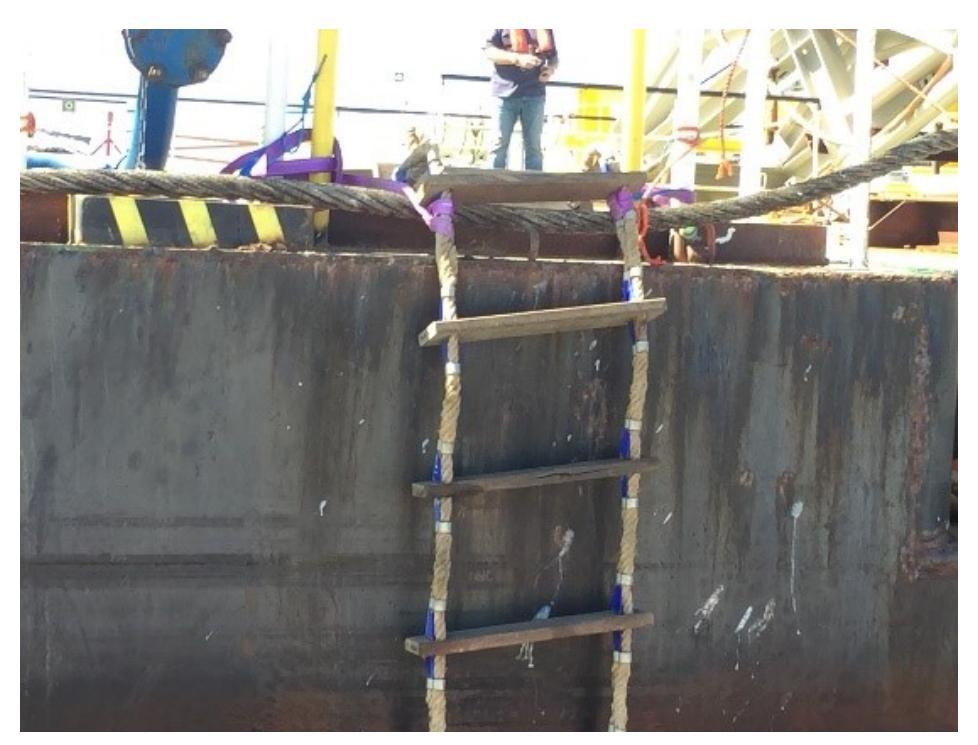
Figure 3 – Ladder supported by strops and not the side ropes

In addition to the lack of stanchions and the ladder running over a wire, it is important to note that the strops in figure 3 are purple (which signifies 1 tonne SWL). This is significantly less than the 24 kN required by regulation and again the ladder weight is not being taken by the side ropes.

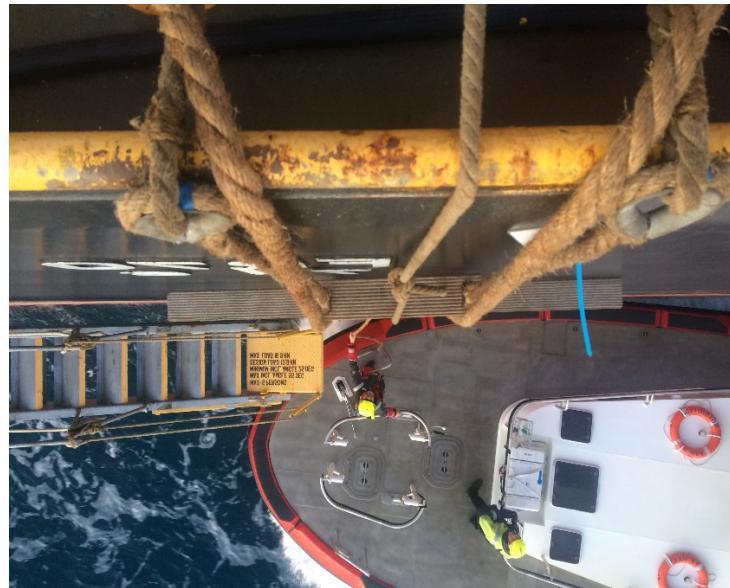
Figure 5 – Ladder weight is actually supported by the whippings of the thimbles

This picture show side ropes terminating at thimbles below deck level. Lines through these thimbles run up to the deck where shackles are used to support the ropes. This was pointed out to the crew on deck, but they stated that a single line leading down to the top step was taking the weight! Definitely not compliant and a longer ladder is required so that side ropes can be secured directly on deck.

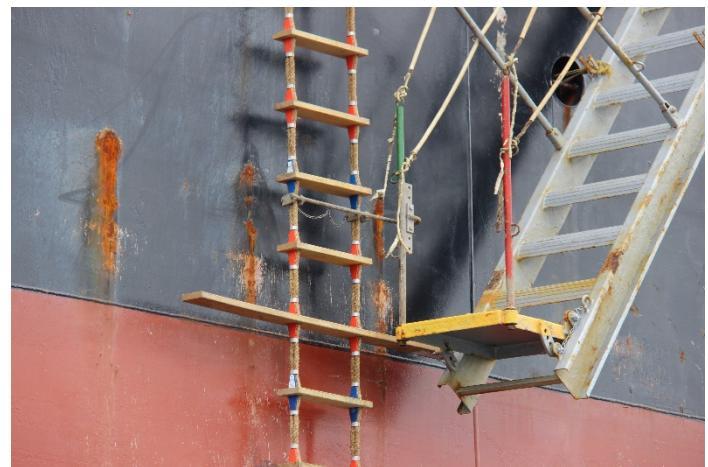
Figure 6 – Ladder not attached to hull

**CHIRP** has received many reports where a combination rig is non-compliant. For the most part these relate to the ladder not being attached to the ships side (with either magnets or purpose made lugs) and attaching the pilot ladder to the combination ladder. Reports have also been received relating to the security of the stanchions at the lower step of the accommodation ladder. In the figure above the vessel was not permitted to sail from the port until the deficiency was rectified.

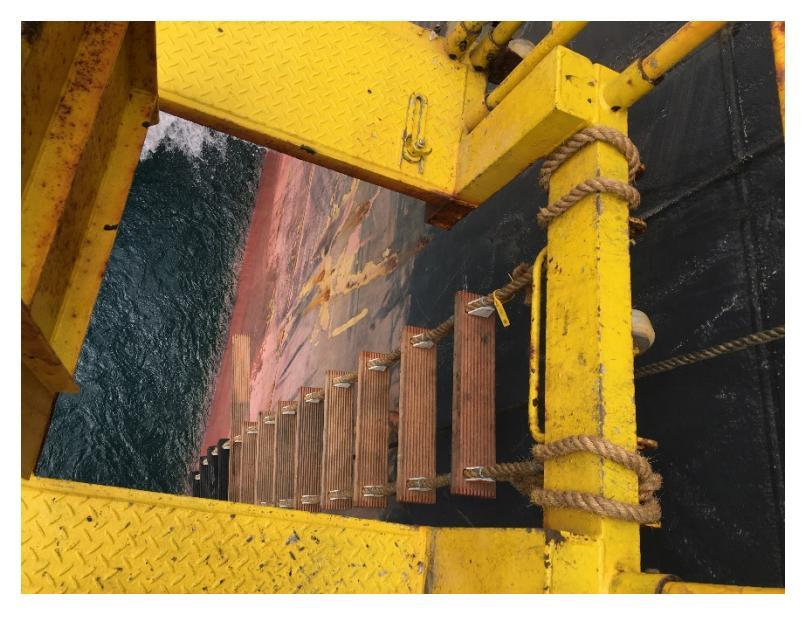
Invariably, problems are encountered when making the transition through the trapdoor with inadequate handholds. Ladders are found to have been rigged with the lower ladder attached directly to the accommodation ladder as shown below. This ladder did not extend 1.5 metres above the platform. Some vessels have made this a two-stage arrangement with a second ladder in order to try to achieve compliance, but this also poses issues.

Figure 7 – Ladder does not extend 1.5 metres above the trap door – how do you transit from ladder through the trap door?

A single length of ladder, lying flat against the hull and secured 1.5 metres above the accommodation ladder trapdoor is the requirement – this however often means that the pilot has to lean back in order to effect access through the trapdoor. This is illustrated in the following two pictures where the two-stage ladders are also non-compliant. Pilot ladders are suspended from the accommodation ladder frames rather than directly from their side ropes.

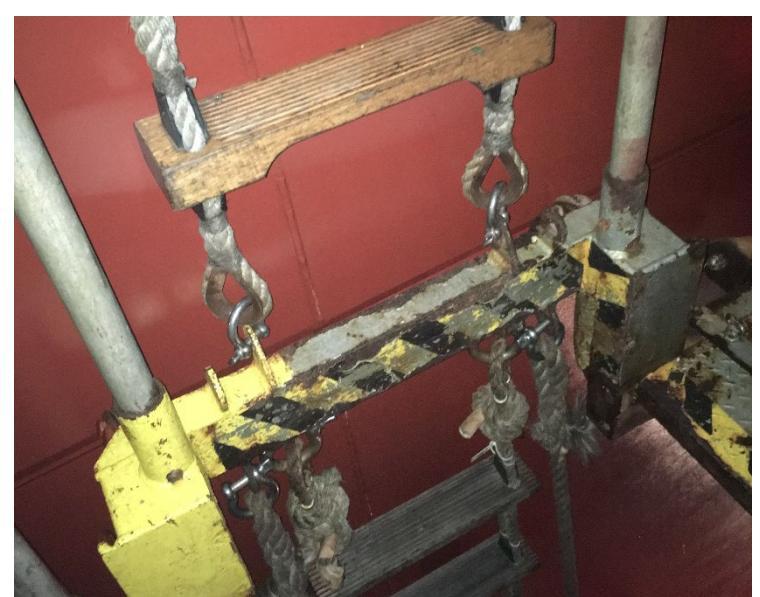
Figure 8 - Two stage non-compliant ladder – weight is not held by man ropes at all

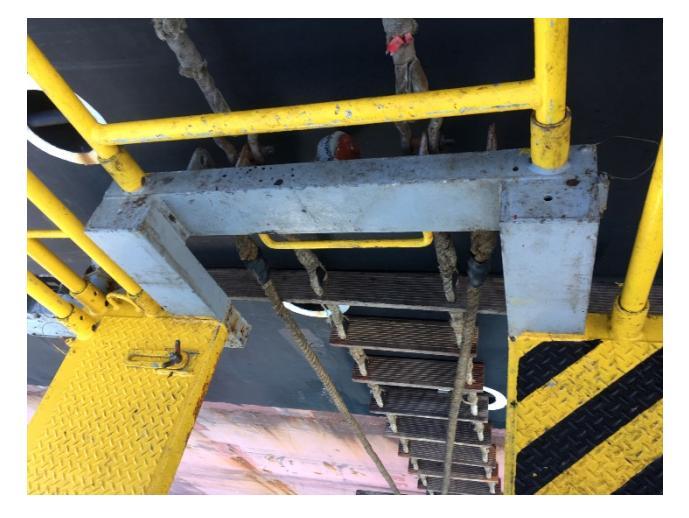
Figure 9 – Pilot has to lean back to gain access to trapdoor

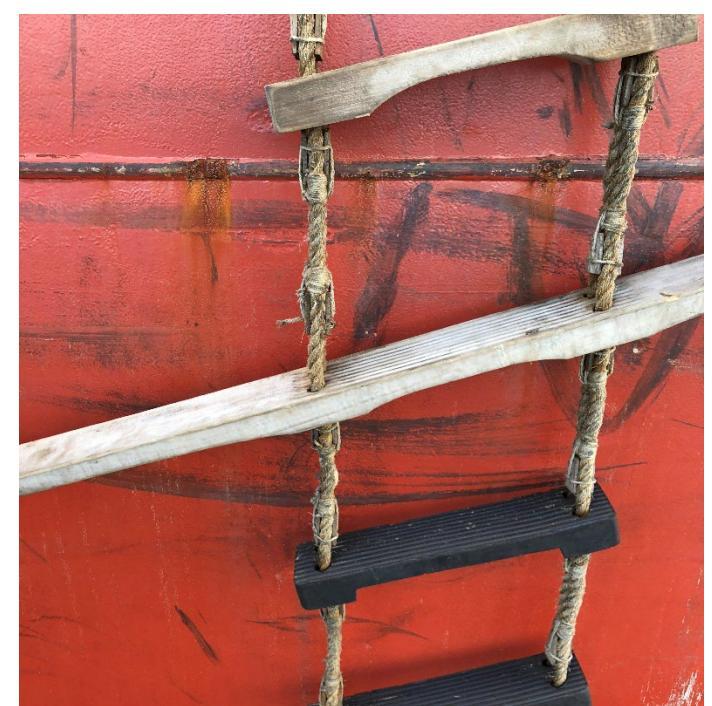
Figure 10 – Pilot ladder steps not horizontal, chocks missing. Ladder needs replacing

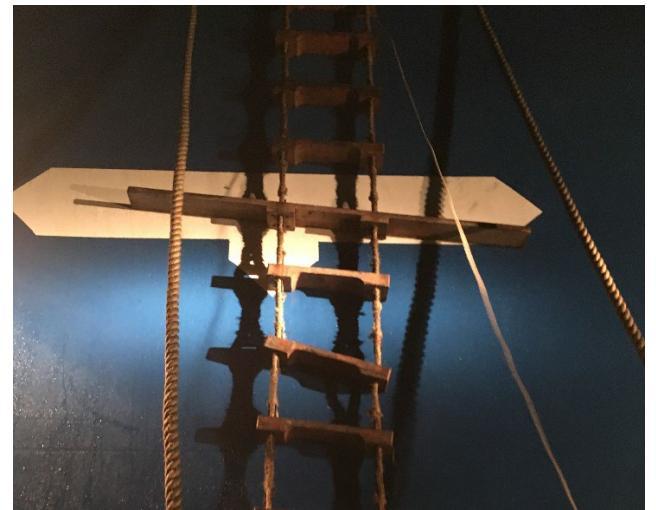
Figure 11 – The step on this ladder gave way whilst the Pilot was disembarking

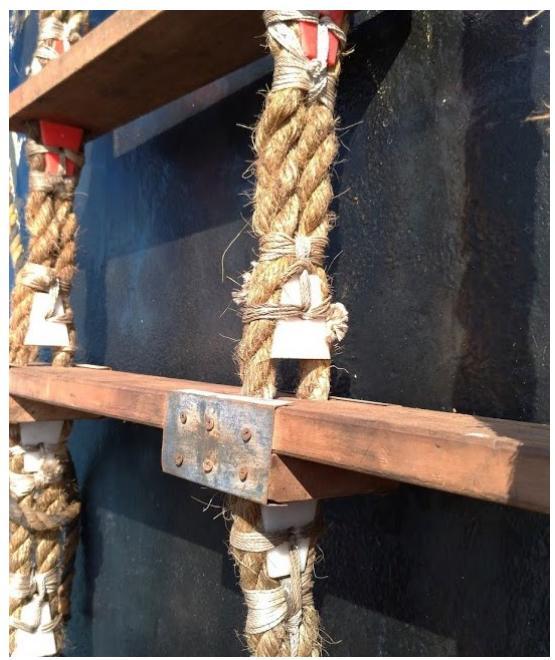
Figure 12 – loose chocks – spreader replaced and not constructed of one piece of wood

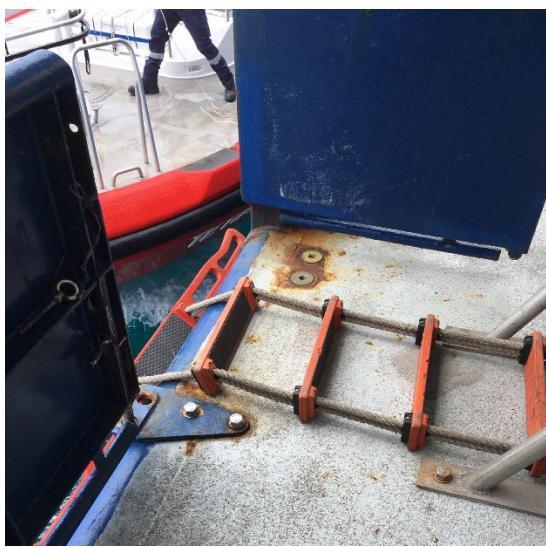
Figure 13 – No stanchions provided to assist pilot boarding

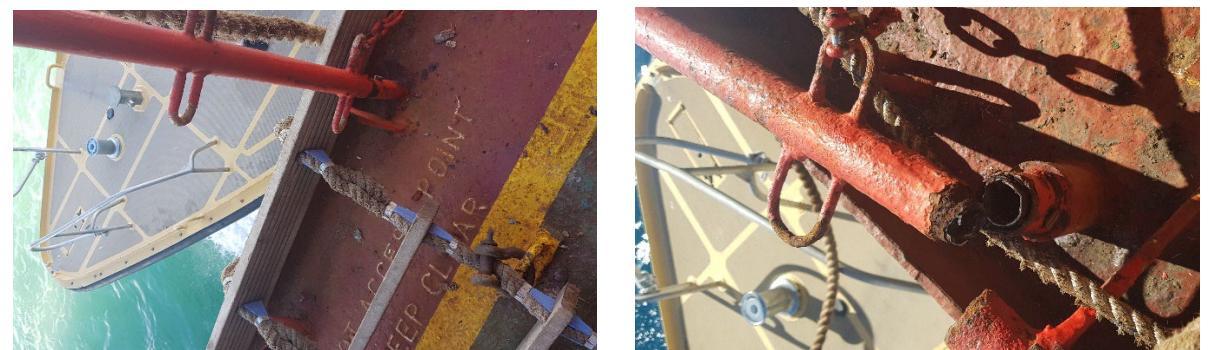
Figure 14 – Stanchion provided for manropes – but failed dramatically when crew on pilot cutter tested the weight

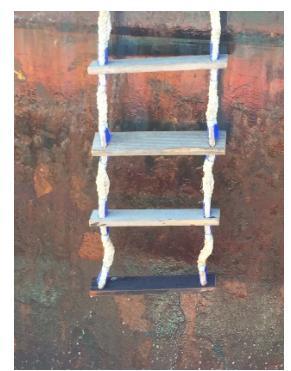
Cute - but dangerously non-compliant
