Seaways

The International Journal of The Nautical Institute

Mariners' Alerting and Reporting Scheme

MARS Report No. 303 January 2018

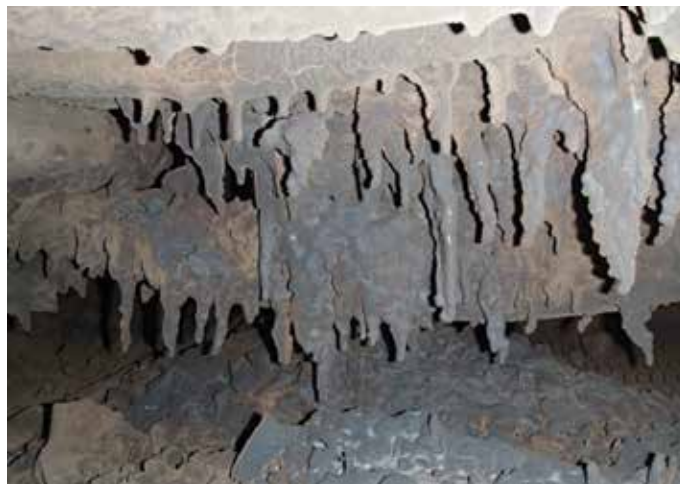
After an adequate cooling down period, crew opened the inspection door of the EGE and found extensive damage to the tubes, tube support and fins of the upper steam generator. Some of the tubes were cracked and deformed, and the fins were melted (see picture). Although temporary repairs were carried out to maintain operations, a large-scale permanent repair was scheduled for the next dry dock.

The company investigation suggests that inefficient soot blowing probably caused soot accumulation on the tubes, resulting in the soot fire. It appears that soot blowing was often carried out using air pressure but without increasing the engine load.

Fire damage to EGE

- Regular soot blowing should be carried out on board vessels with EGEs.
- When carrying out soot blowing, best practice is to increase engine load.
- Monitor soot accumulation on tubes by opening the manholes at regular intervals. Additionally, review the operational data on a daily basis (EGE draught loss, outlet temperature, steam damp valve openings, available power, etc).

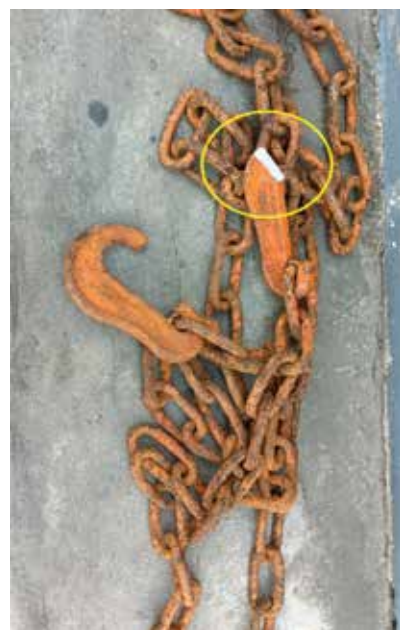
→ A vessel was at berth discharging a steel cargo and then loading containers. The containers were being lashed with chain slings. While one of the containers was being secured, a chain sling broke at its hook and hit the stevedore on the head; his helmet was cracked by the impact. The victim fell to the deck and was treated for his injuries. He received several stitches and 11 days of medical leave.

The chain was not very old, but on investigation it was found that no schedule of inspection or maintenance of the lashing equipment was available.

- Ships' crews need to adopt safety systems that allow inspection and documentation of tackle such as chain slings.
- It is good practice to visually examine a sling before using it.

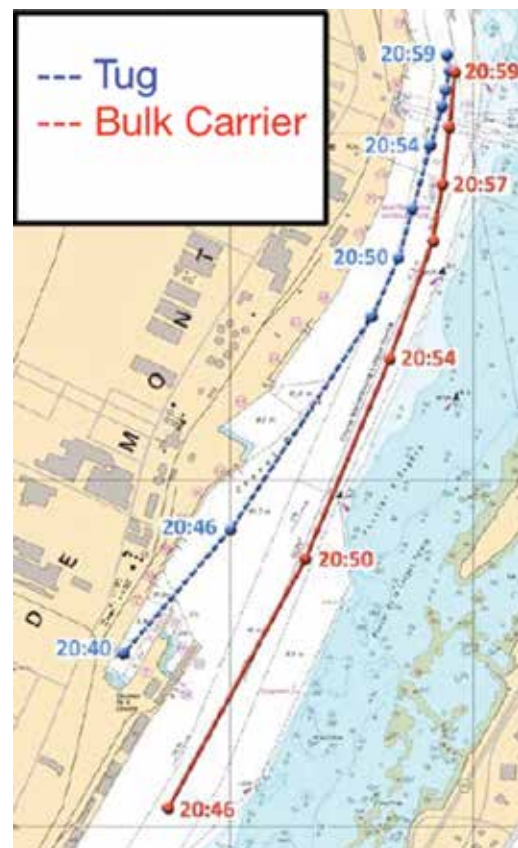
The damage sustained by the tug was sufficient to merit a dry dock and it was out of service for almost seven weeks. The bulk carrier was not damaged, but traces of black rubber from the tug's fenders were apparent on the hull.

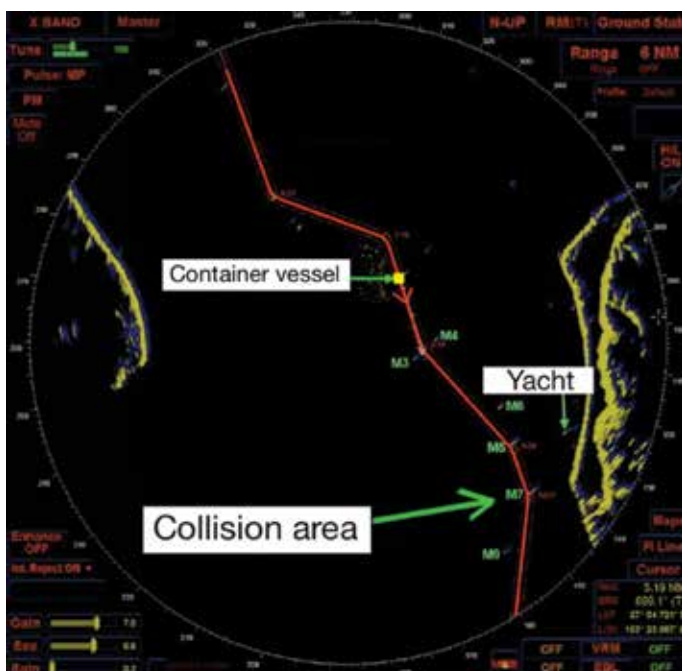
On board the container vessel no one had observed the yacht, either visually or by other means, and the crew were unaware of the collision. Yet, the investigation showed that the steel yacht appeared on the container vessel's radar at least 20 minutes before the collision, as shown below.

- No dedicated visual lookout was posted;
- Background shore lights made it difficult to distinguish the yacht;
- The bright lights of a nearby dredger caused distraction;
- Relatively low visual and radar detection range of the yacht;
- Yacht's radar echo was not identified and actively monitored;
- Bridge team workload (four course changes in 22 minutes before collision and watch change);
- Bridge team members focused on individual tasks during that period of high workload;
- Inattentive lookout for small craft, although these could reasonably be expected in this area.

Radar image 20 minutes before collision

- Small craft are notoriously difficult to detect on radar, but if constant and diligent attention is applied these vessels can usually be detected at the 2–3nm range.
- While some small craft are fitted with AIS transceivers, not all have them, nor are they required to do so.
