Report of Investigation into the Fatal Accident on board a Container Ship *"HEUNG-A SINGAPORE"* at North West Lamma Anchorage on 23 March 2014

Marine Accident Investigation Section Marine Department The Hong Kong Special Administrative Region

29 April 2015

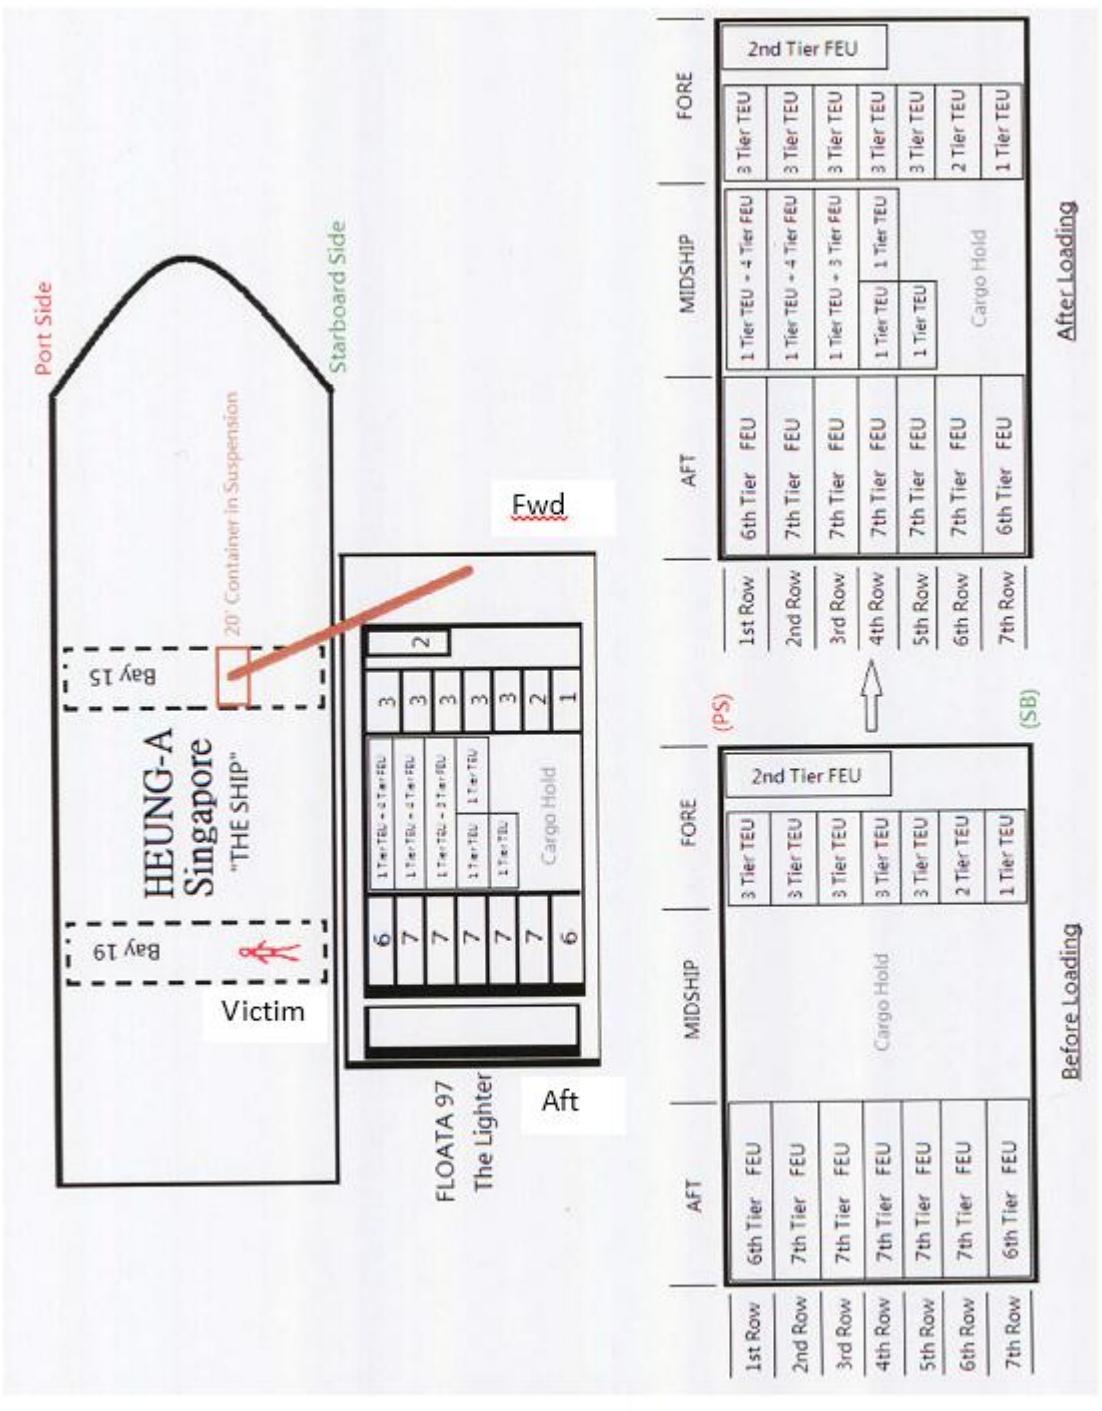
Figure 3.: Left hand side showing the mooring arrangement of *the Vessel* and *the DSL*; Right hand side showing the stowage of containers before and after the containers loaded from the *Vessel*.

- 4. 4 At about 0300, *the DSL* moored her port side to the starboard side of *the Vessel* at the *NWLA* in position about 22°15.01N 114°06.02E. Shortly afterward, *the DSL* started discharging containers from *the Vessel* into the middle part of her cargo hold as both the forward and the aft of the cargo hold had been loaded with containers (Fig. 3, before loading).

- 4. 5 Containers were loaded into the cargo hold of *the DSL* and stowed on the port side (Fig. 3, after loading).
- 4. 6 At about 0345, a 20' container was lifted up from cargo hold container bay no.15 near the midship of *the Vessel* approximately 2 feet high by the Crane Operator, who was the Person-in-Charge of Works (*PIC*) of *the DSL*. He then halted the lifting for a while to decide the position where the container should be placed in the cargo hold of *the DSL*. When the container was being lifted further up again, *the DSL* listed to her port side and caused almost all the top tier 40' containers at her aft fell onto the cargo hold container bay no. 19 of the Vessel.

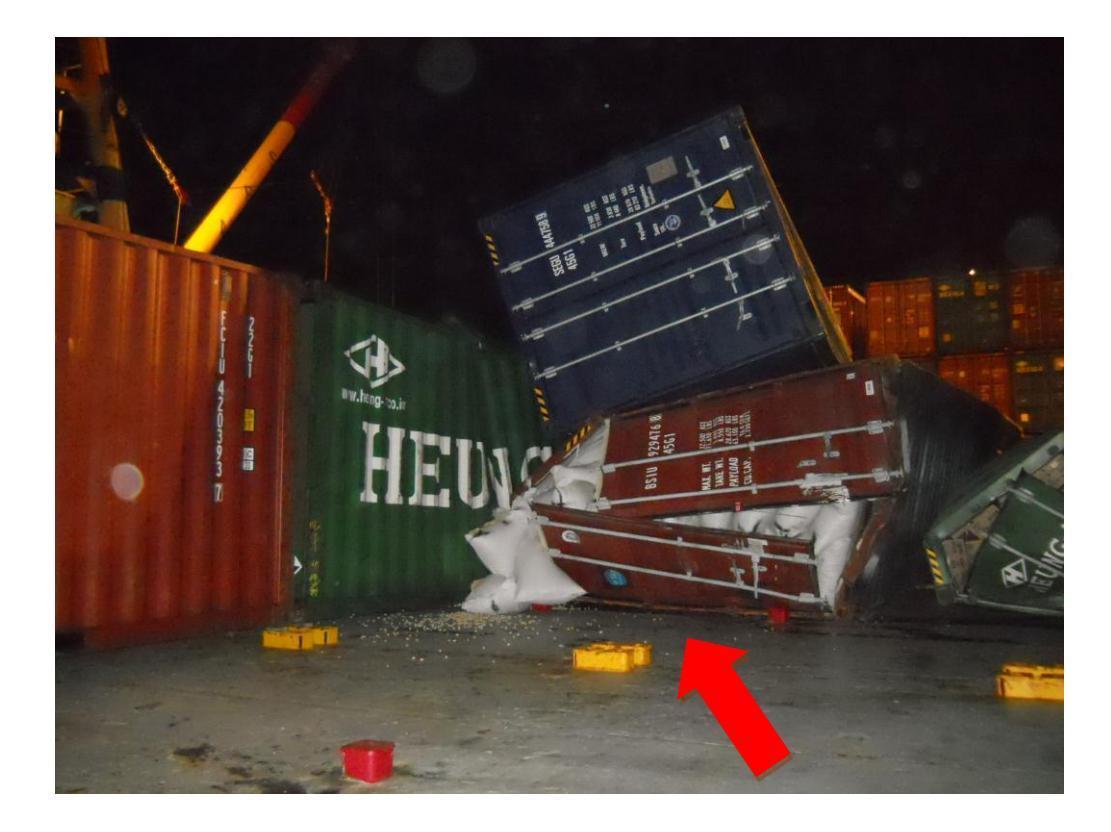
- 4. 7 At the material time, an able-bodied seaman (the *victim*) was working on top of a hatch cover at cargo hold container bay no.19, starboard side of *the Vessel*. He was unfortunately crushed by the falling containers. (See Fig. 4)

Fig. 4: *The victim* was crushed under the collapsed containers (Shown by red arrow)

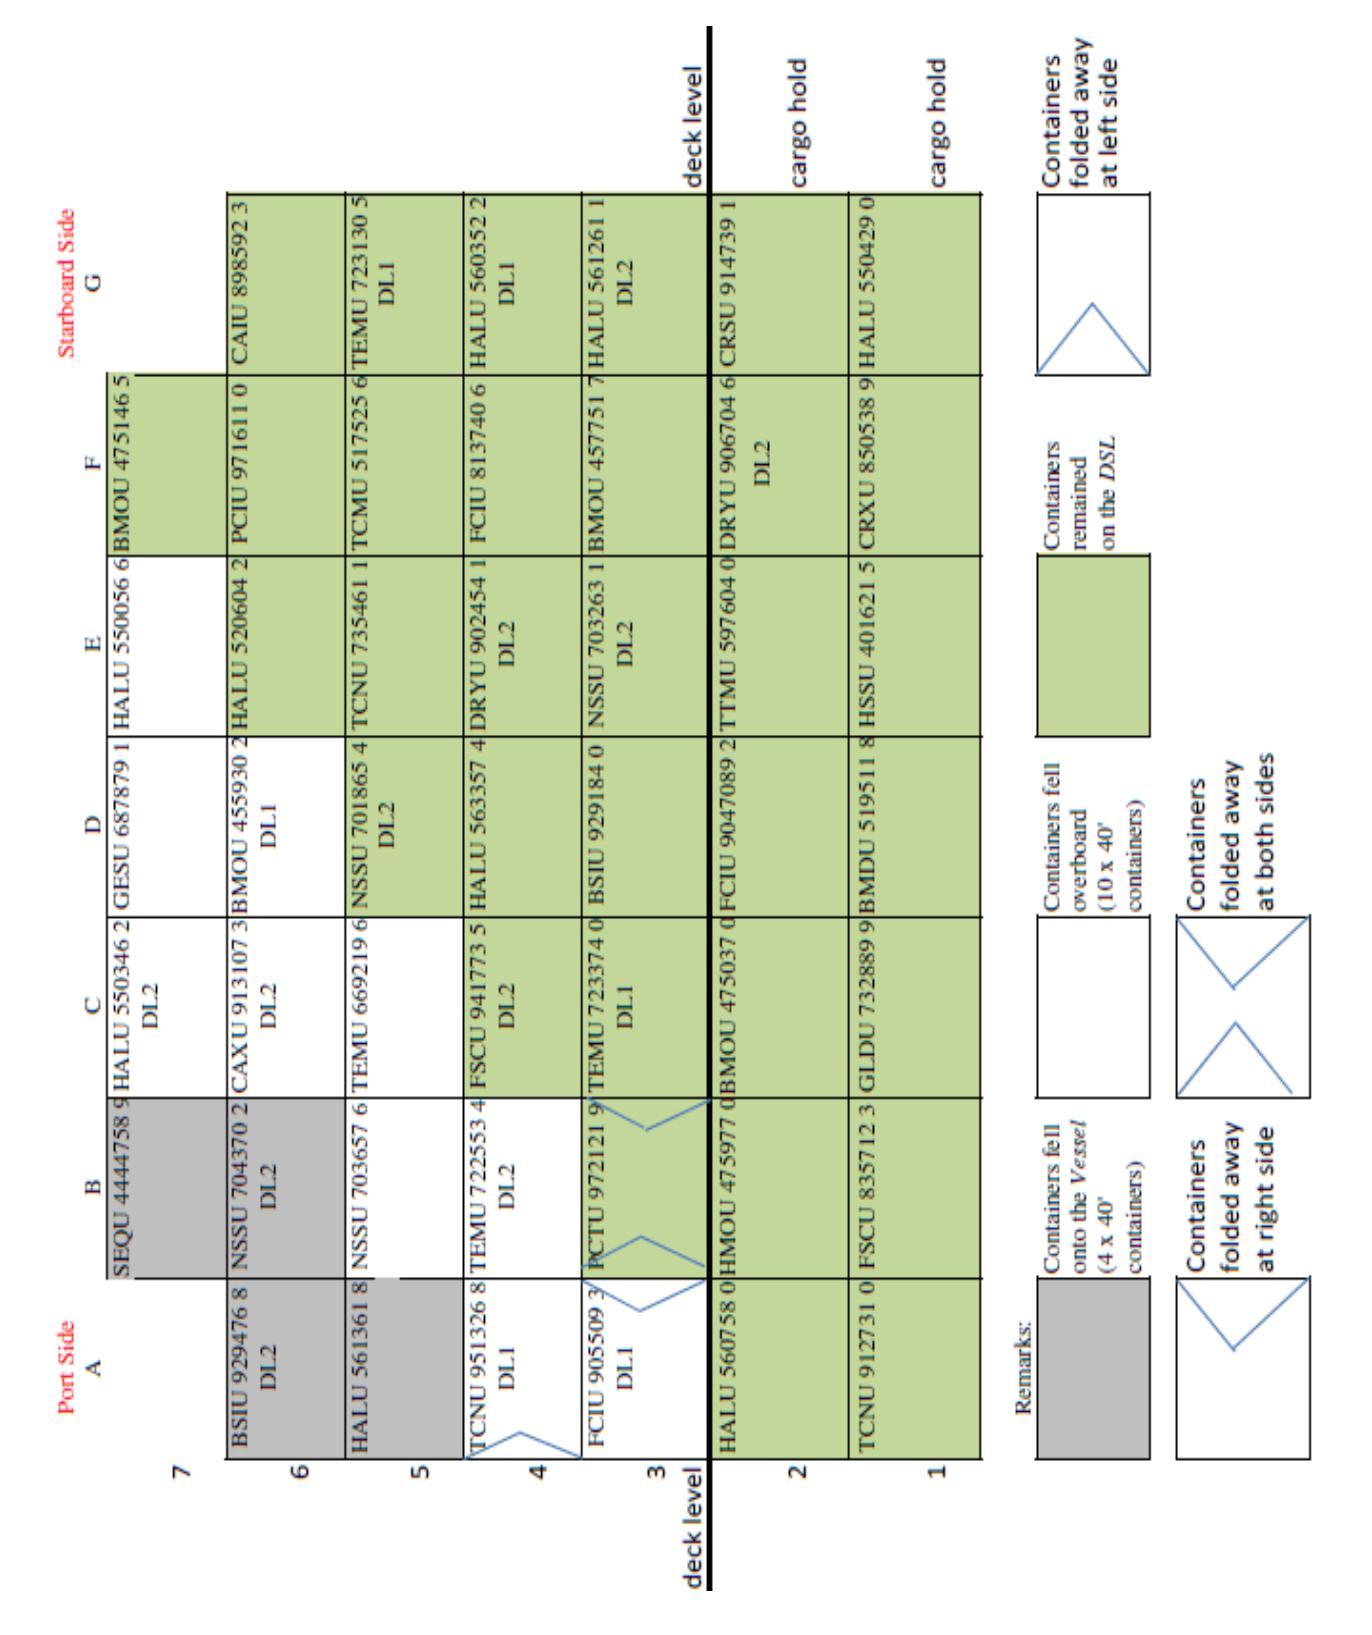
Fig. 5: The stowage condition of the aft row containers of *the DSL* (View from aft of *the DSL*)

- 5. 4. 1 Details of containers stowage at aft row on board *the DSL* was shown in Fig. 5. In the incident, four containers (marked in grey) fell onto the deck of *the Vessel*; 10 containers (marked in white) fell into water and the others (marked in green) remained inside the cargo hold of *the DSL*.

- 5. 4. 2 The aft row of containers were stacked to six to seven tiers high. While the first and the second tiers containers stowed inside the cargo hold whose side movements could be restrained by the side walls of cargo hold, the containers stacked above would shift due to ship rolling etc. if they were not properly lashed by lashing gears or restrained by twist-locks or stacking cones at the corner castings of the containers.

- 5. 4. 3 The aft row containers remained on board *the DSL* was found not properly stowed after the accident investigation. Most of them, especially those inboard containers, i.e. column B to column F were stacked with insufficient twist locks and stacking cones. As a result, the containers were not stacked in vertical alignment and rendered the weight of the containers being shifted considerably to the secondary structural members (corrugated walls and the attached stiffening members) of the containers but not mainly to the primary structural member (corner posts and side rails) of the containers. The latter were mainly to support the weight of containers as the load carrying capacity of the former was comparably lower. In the accident, some containers' beams and corrugated walls were buckled. Furthermore, when containers stacks were not aligned and failed to be fitted with twist locks and stacking cones, the containers were liable to slip sideways, due to ship movement and rolling etc that induced shear and side forces to the end row container stacks and resulted in the collapse of containers falling over the ship side (i.e. port side in this accident).

- 7.1 The Person-In-Charge of the Works and the owner of *the DSL* are required to review the procedures for container handling, incorporate risk assessments in order to:
 - ensure that stacked containers are adequately secured by twist-locks, stacking cones and lashing equipment; and
 - ensure the proper stowage of containers on a vessel, its loading capacity and stability must be carefully considered when in planning of works.
- 7.2 A copy of this report should be sent to the Shipping Division of Marine Department for their information and follow-up actions above with the Person-In-Charge of the Works and the owner of *the DSL*.

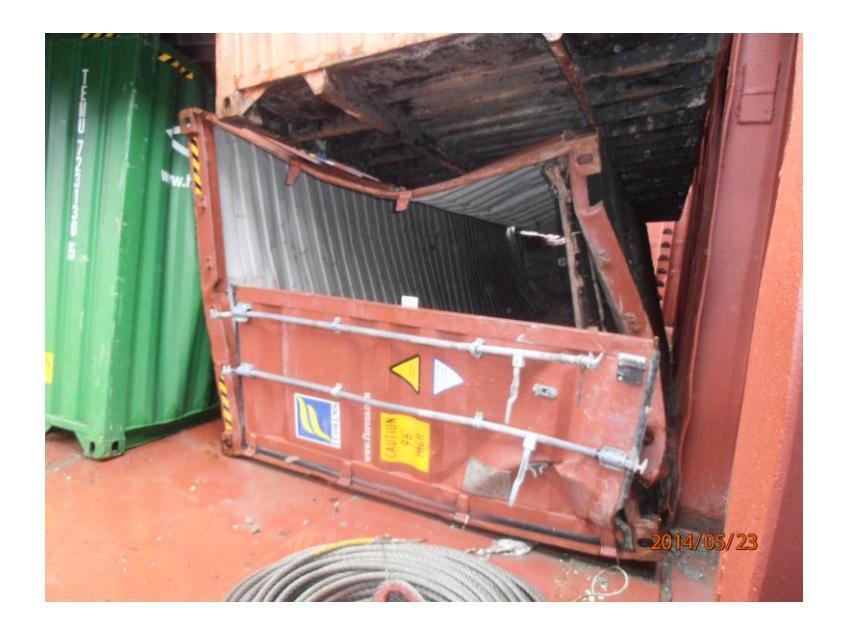
Fig. 6: The container A3

5.5.2 Fig. 6 showed a container which had been located at column "A" third tier (hereinafter named as A3) was recovered from water after the incident. One of the side walls, beams and posts were badly buckled. It indicated that A3 was not able to support the weight of containers stacked above it and sustained structural failure. Consequently, the containers stacked on top of A3 lost the support from A3, and fell down onto the deck of *the Vessel* after tearing off the connected twist-locks and stacking cones.

- 5.5.3 Although A3 was certified to support a stacked loading of 216,000 kg, which was much higher than the actual weight of the stacked containers weighing about 81,000 kg in total. However, A3 would yield when loading on its structures exceeded its capacity under one or a combination of the following conditions:

- i) listing of *the DSL* leading to uneven loading on the container structures;
 - iii) improper stacking of containers (misalignment, inadequate lashing, twist-locks and stacking cones etc.) resulted in slipping sideways of containers and leading to uneven loading on the container structures; and

- iii) dynamic loading of containers stacks due to ship movements arising from cargo operations and ship rolling, leading to increase in loading on the container structures.
