## Working at height in and around cargo holds

# Risk Alert

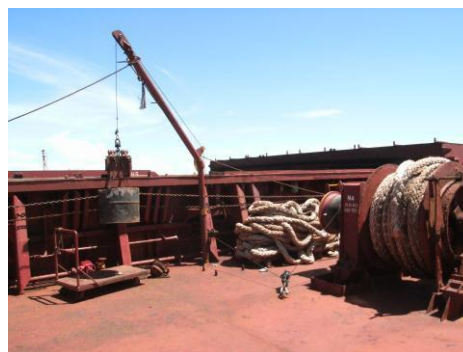
The deck crew of a 'Capesize' bulk carrier were all involved in hold cleaning while on a deep sea passage in the Indian Ocean. The weather was good with the vessel rolling only 2° or 3°. Several crew were sweeping cargo residues, some were shovelling it into buckets and the Bosun was on deck

operating the hold cleaning davit and winch.

Work was proceeding well until, after removing one lift from the hold and preparing to lower the empty bucket back down again, the winch wire jammed in the sheave at the davit head.

Rather than keep the davit over the deck and use a portable ladder to reach the sheave the Bosun placed the davit over the hatch coaming and then climbed on the coaming. The Bosun did not use a safety harness and, unfortunately, lost his balance and fell about 25 metres to the tank top where he died.

Even though he was an experienced seafarer the Bosun chose not to take even the simplest precautions. Perhaps he thought he would only be on the coaming for a few seconds; perhaps bringing the portable ladder would have taken a few minutes; perhaps the safety harness was in a deck store near the accommodation. Whatever the reason the outcome did not justify any of them.
