Report on the investigation of  
the cargo tank explosion and fire  
on board the chemical tanker

***Stolt Groenland***

Ulsan, Republic of Korea

28 September 2019

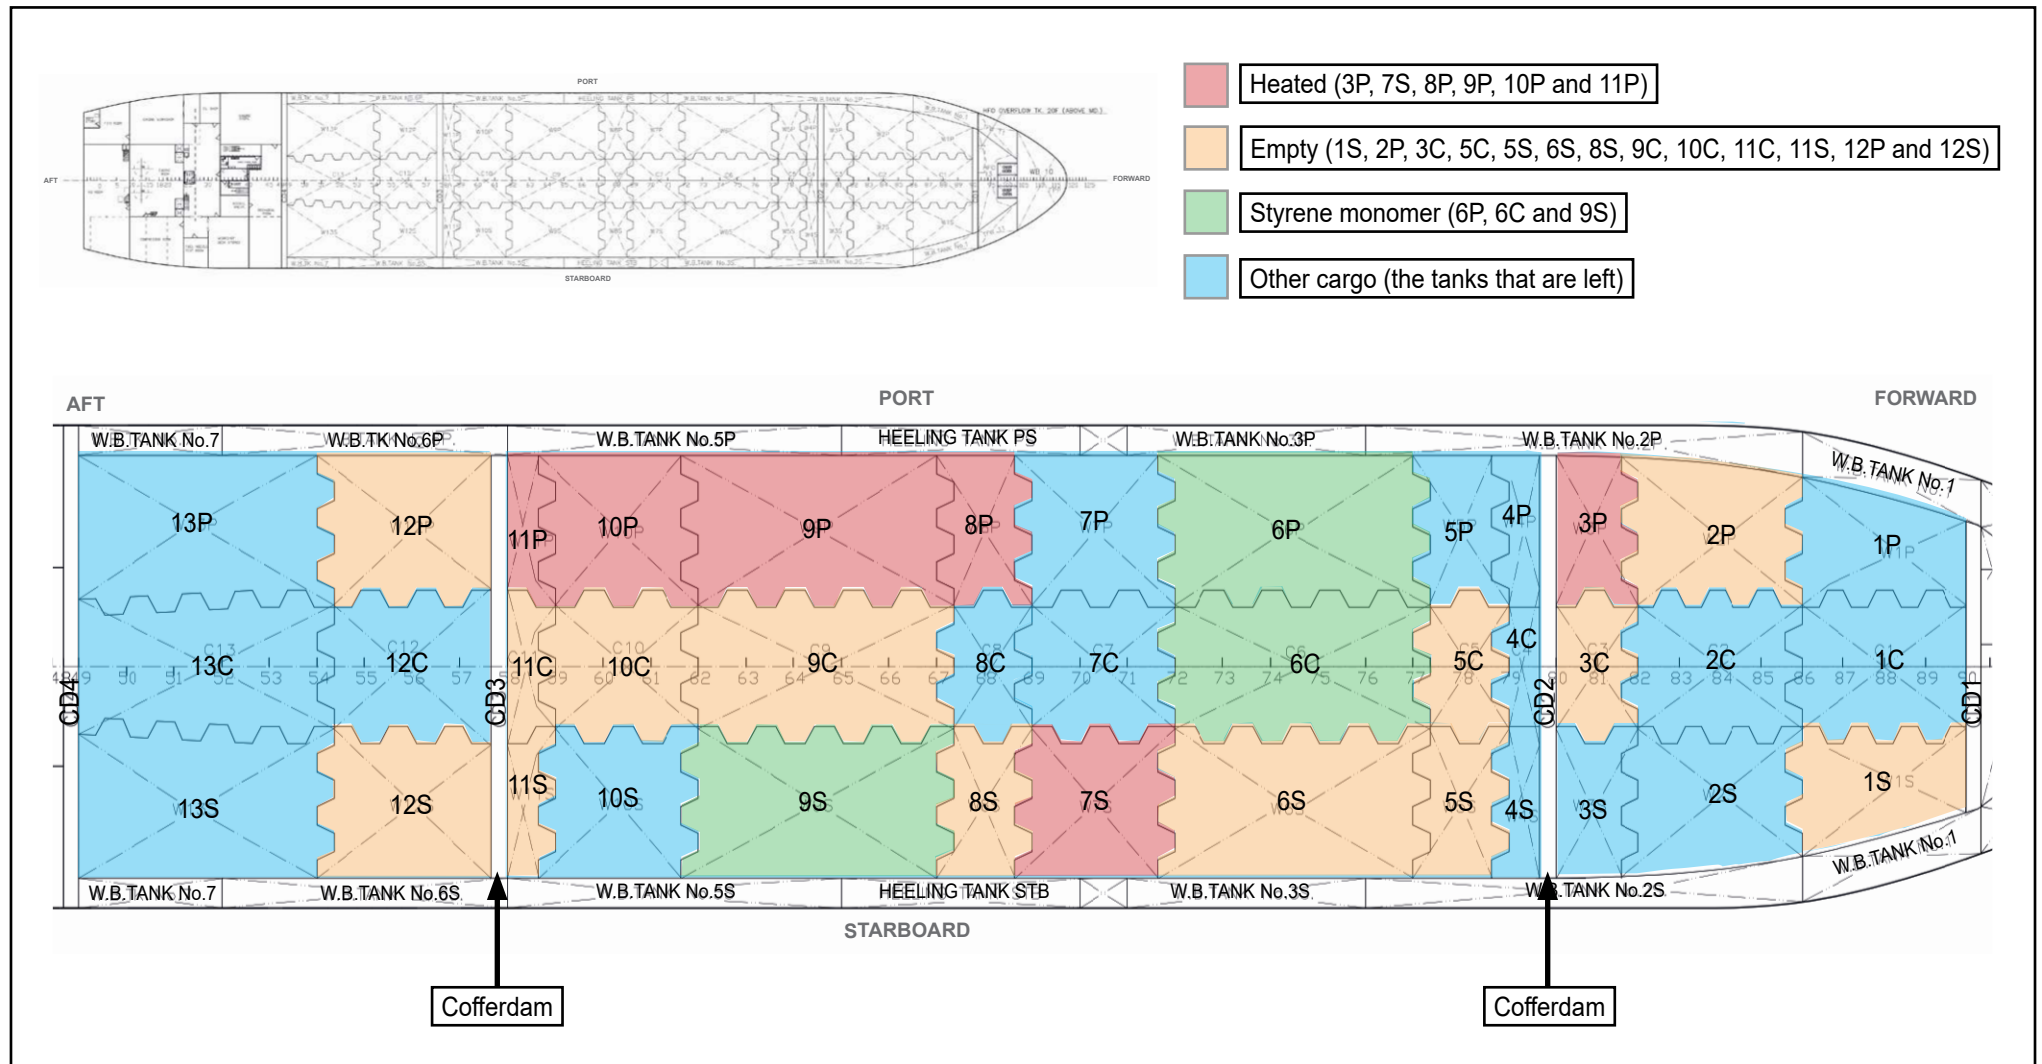
**Figure 2:** Cargoes remaining following discharge in Ulsan

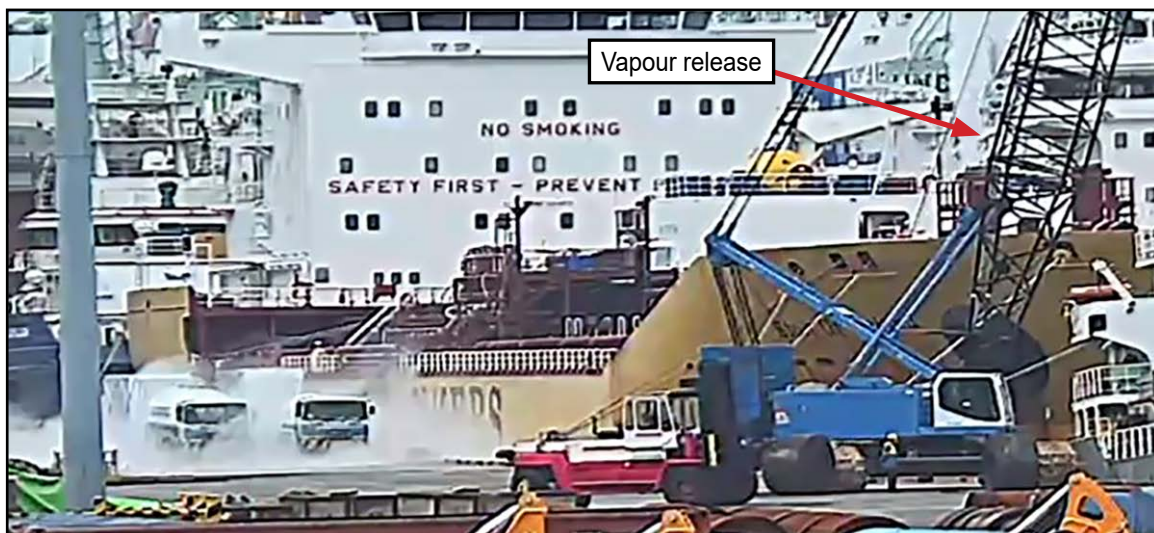
**Figure 3:** CCTV still showing vapour release from 9S p/v valve

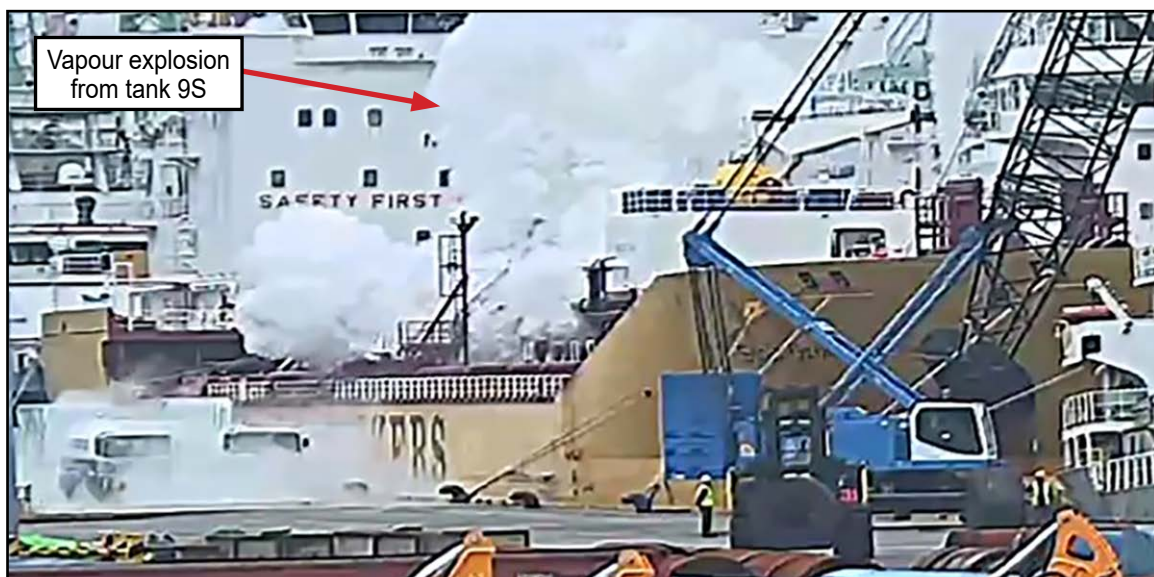
**Figure 4:** CCTV still showing tank rupture and vapour release

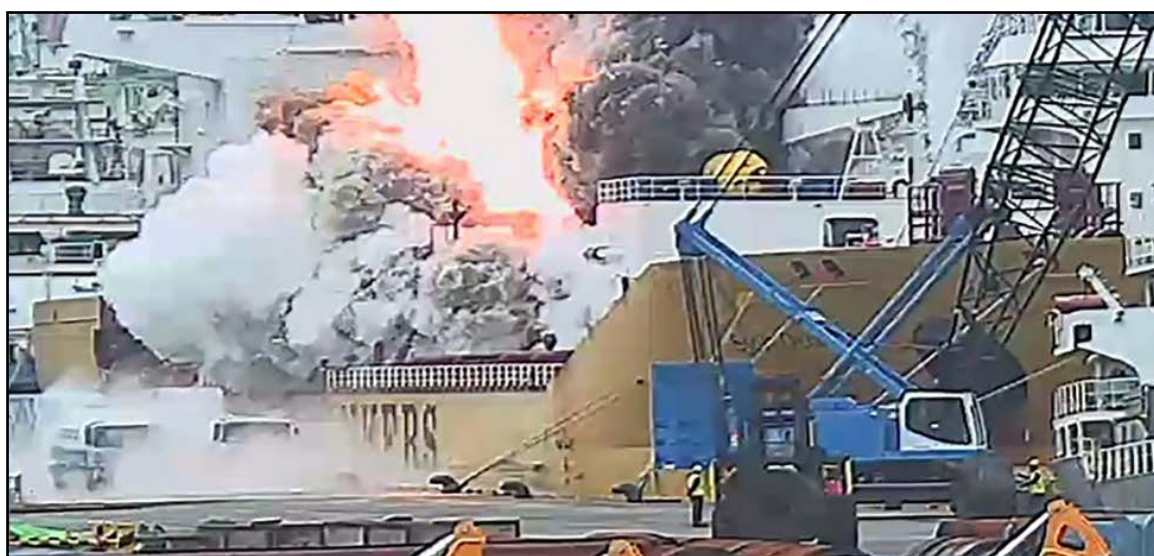
**Figure 5:** CCTV still showing vapour ignition

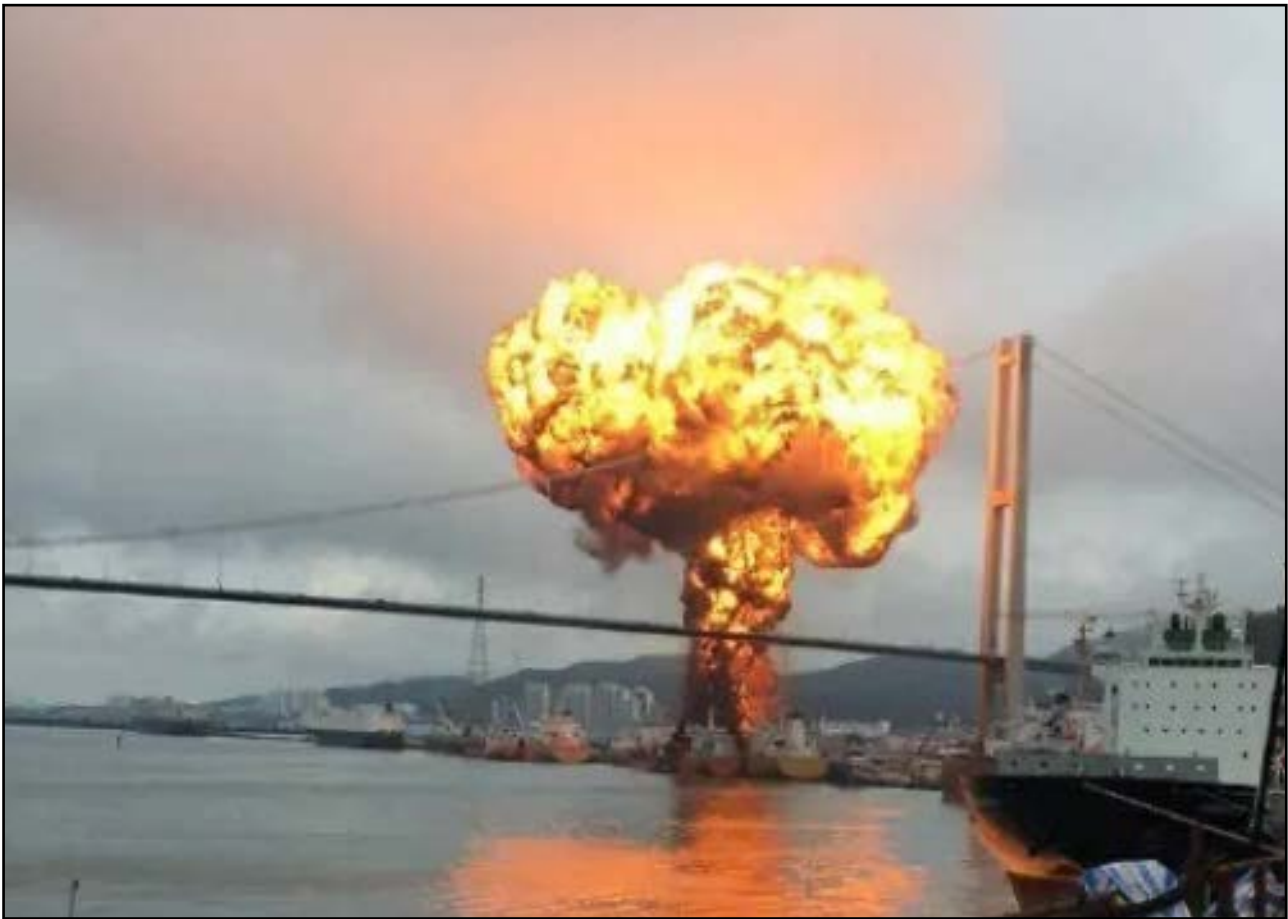
**Figure 6:** Fireball at Ulsan bridge

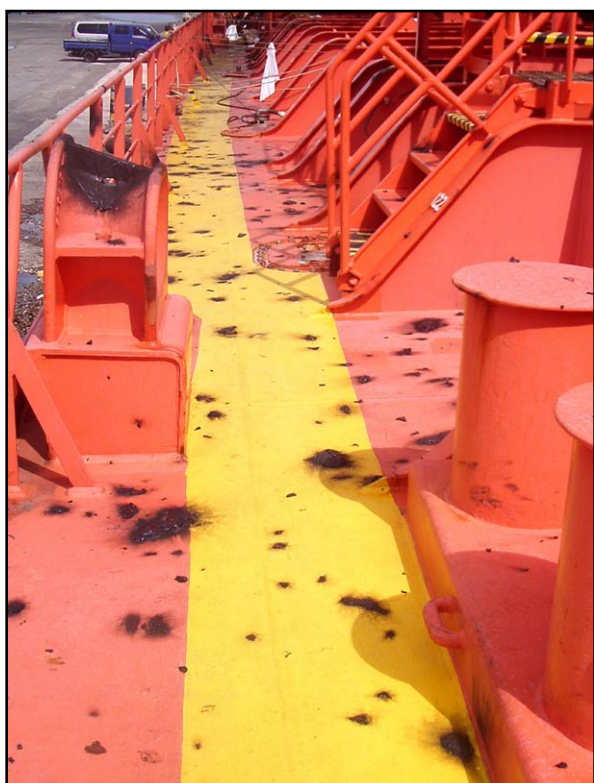
**Figure 7:** Bow *Dallian* main deck with burned styrene deposits

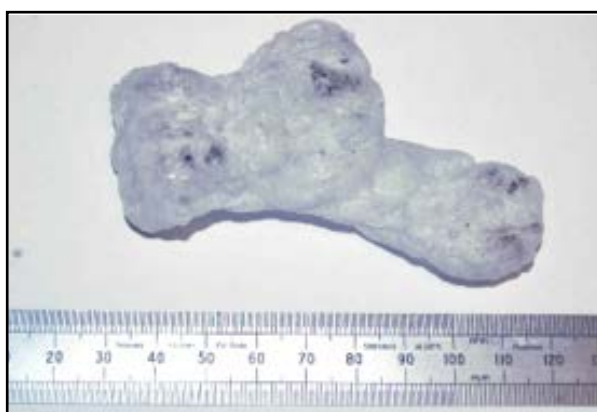
**Figure 8:** Styrene residue sample

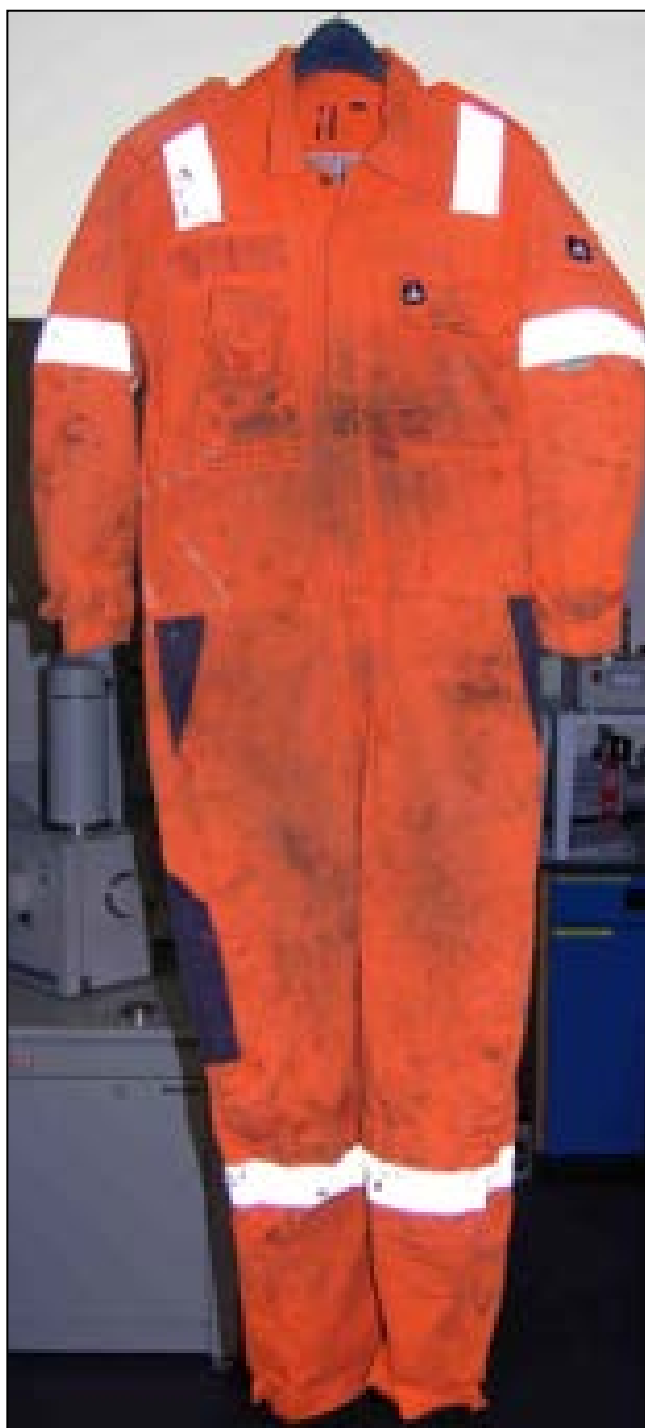
**Figure 9:** Overalls from *Bow Dallian* crewman

- *Styrene was identified on the overalls. This was observed in all areas but appeared more intense in areas of contamination.*
- *In high contamination areas (contaminated overalls) TBC was identified.*

- *If it is assumed that the styrene contamination of the overalls took place at the same time of the polymerization reaction and explosion was observed, then it can be stated that inhibitor was present, and detectable.*

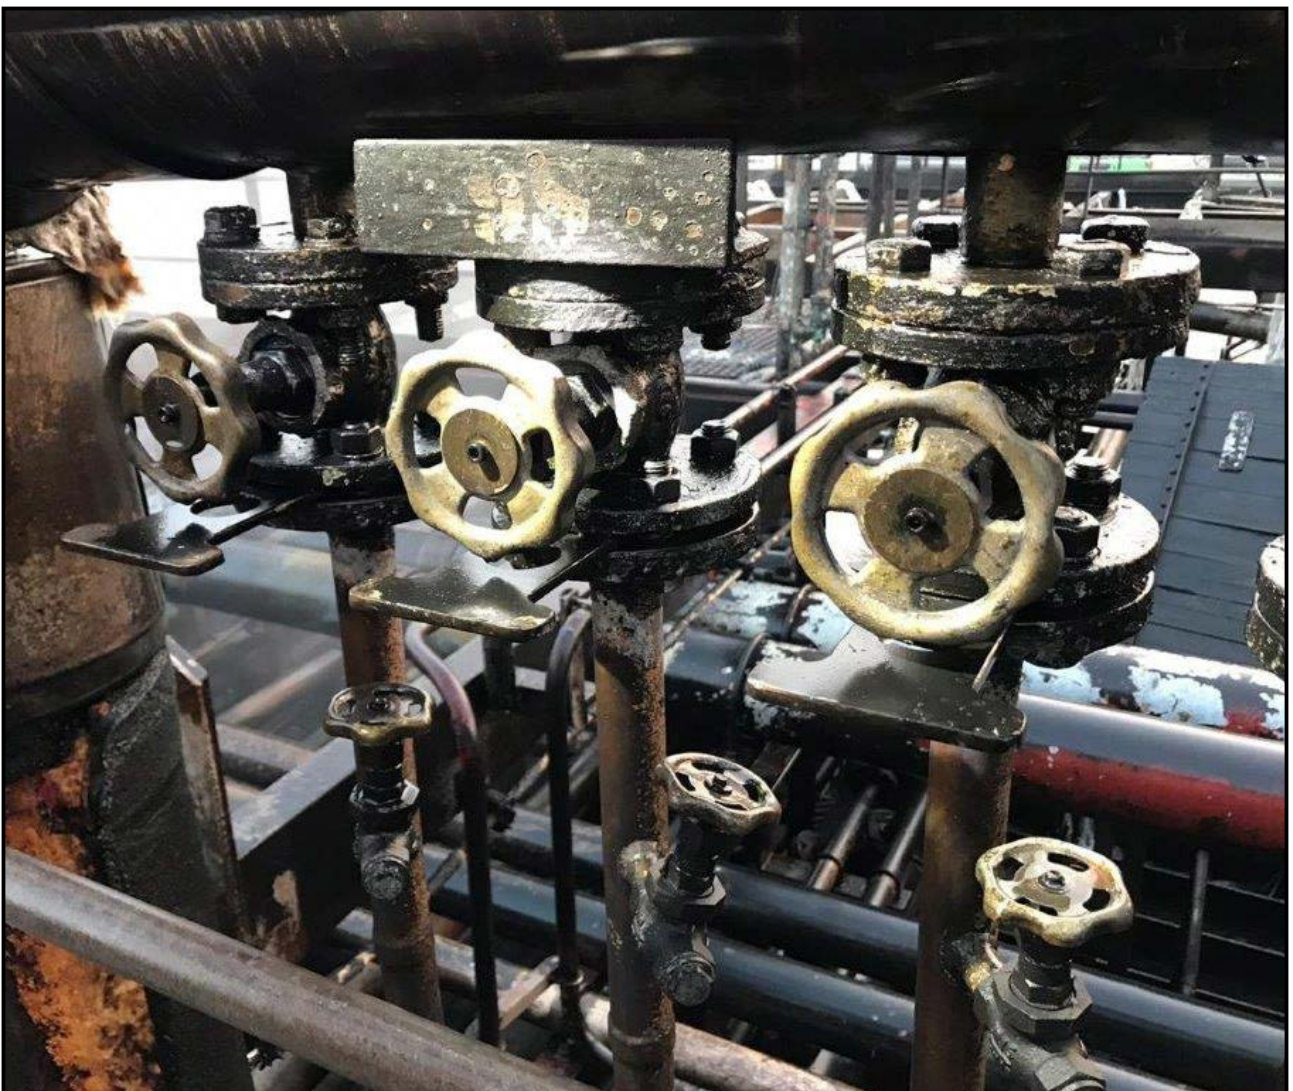
On 7 October, the analysis of samples of styrene monomer taken from *Stolt Groenland*'s cargo tanks 6C and 6P indicated that the concentrations of the inhibitor 4-tert-Butylcatechol (TBC) were 8 parts per million (ppm) and 7ppm respectively. The following day, MAIB inspectors were allowed access to the vessel. However, the presence of hazardous chemicals and fire damage limited the inspection to the main deck primarily. A further inspection on 12 November was co-ordinated by the Korea Coast Guard and the KMST. These inspections, and inspections conducted by or on behalf of Stolt, confirmed that the heating coils in 9C and 9S were closed and blanked (**Figure 10**), and that vapours released from the p/v valves for 9S and 9C had ignited.

**Figure 10:** 9S heating control valves

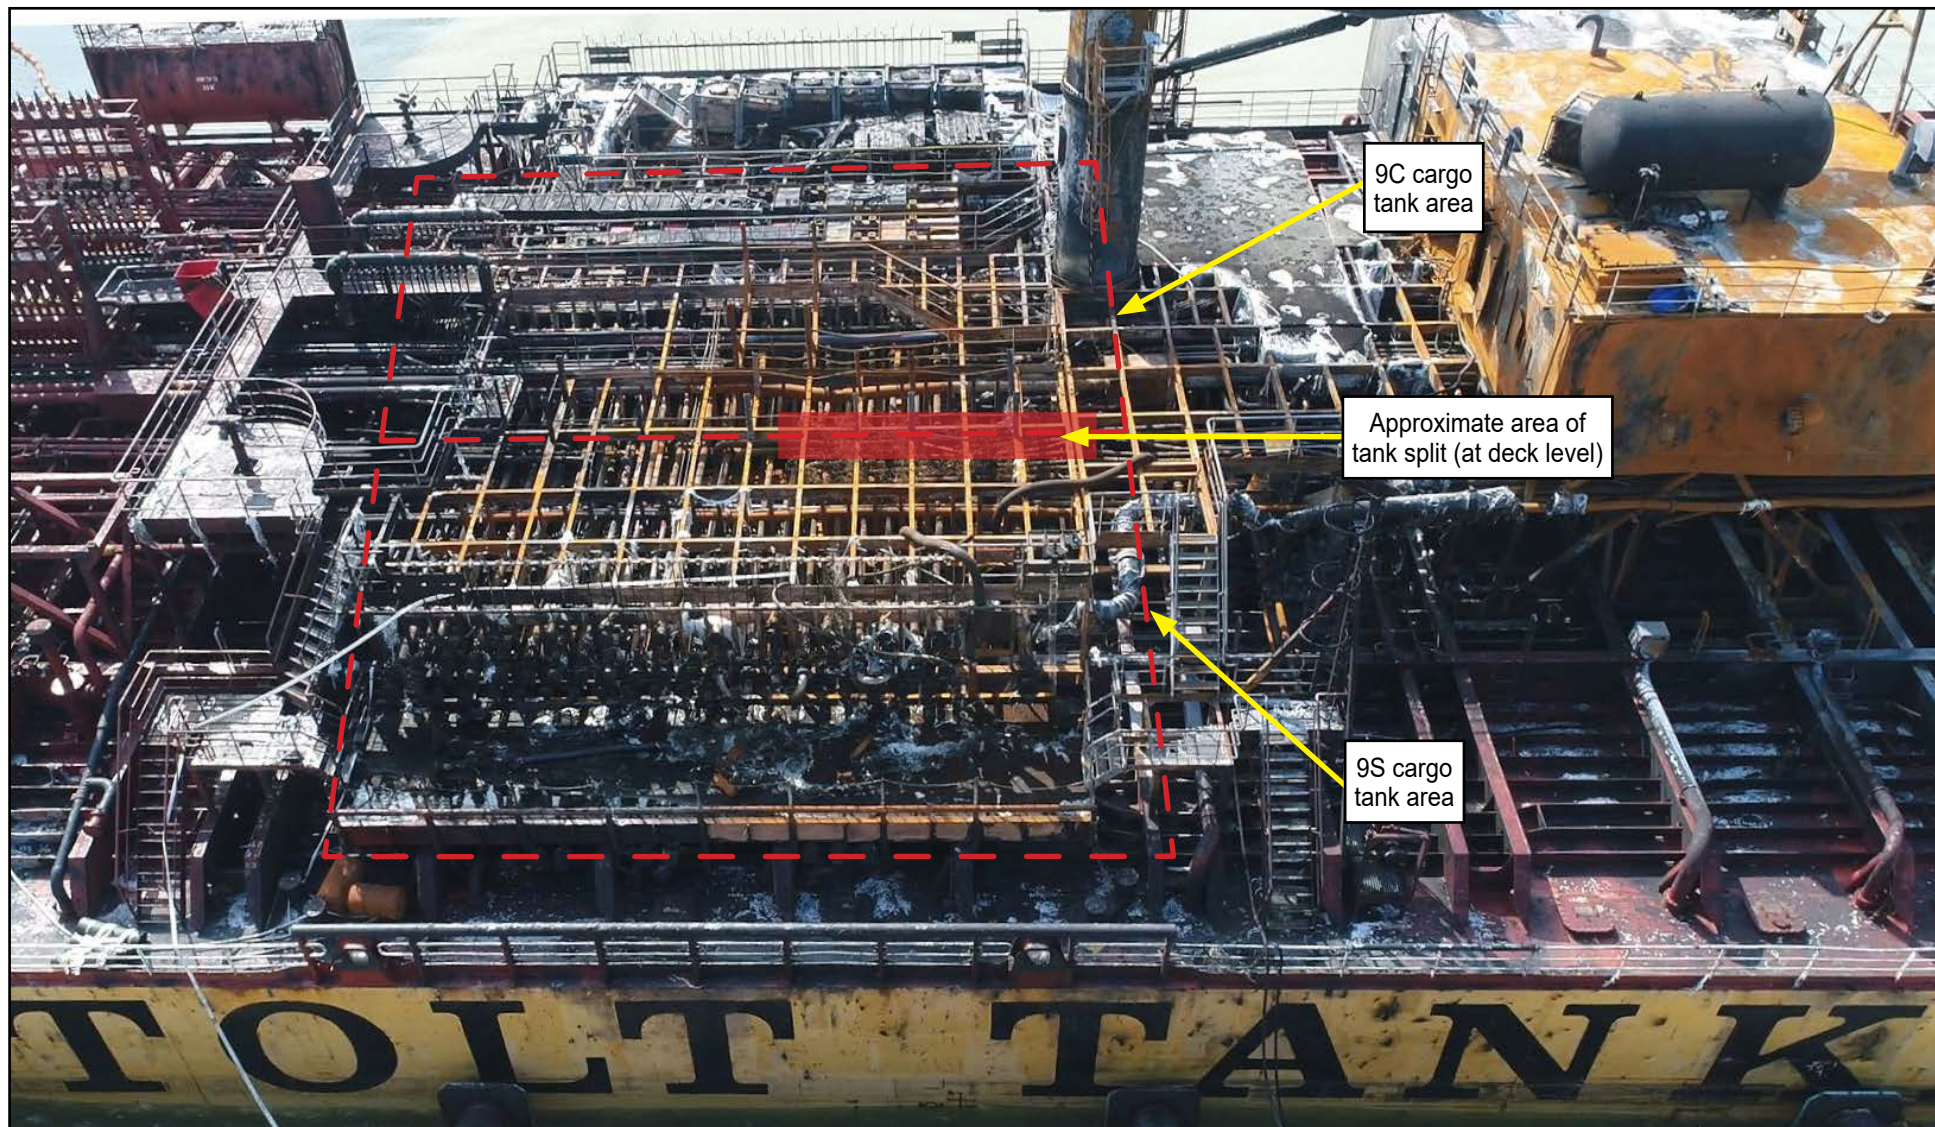
A large hole was found in *Stolt Groenland*'s main deck in way of cargo tank 9S and its common bulkhead with cargo tank 9C (**Figures 11 and 12**). The access hatch cover to 9S had also been blown off (**Figure 13**). The manifold area was fire damaged to varying degrees, and the midships deckhouse was burned out (**Figure 14**).

**Figure 11:** Aerial view of main deck and location of 9S

The runaway polymerisation resulted in the rapid volumetric expansion of the styrene monomer, which increased the pressure within 9S at a rate that exceeded the venting capacity of the tank's p/v valve. As a result, the tank ruptured through the main deck and the common bulkhead with the empty cargo tank 9C (**Figures 11 and 12**).

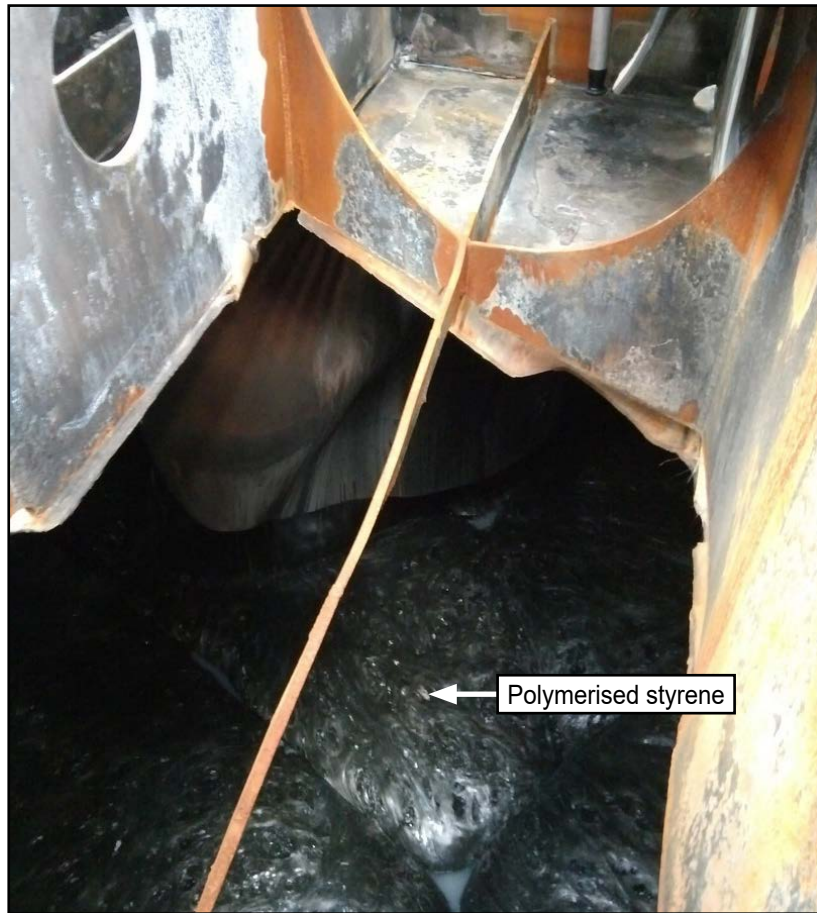
**Figure 12: 9S tank rupture**

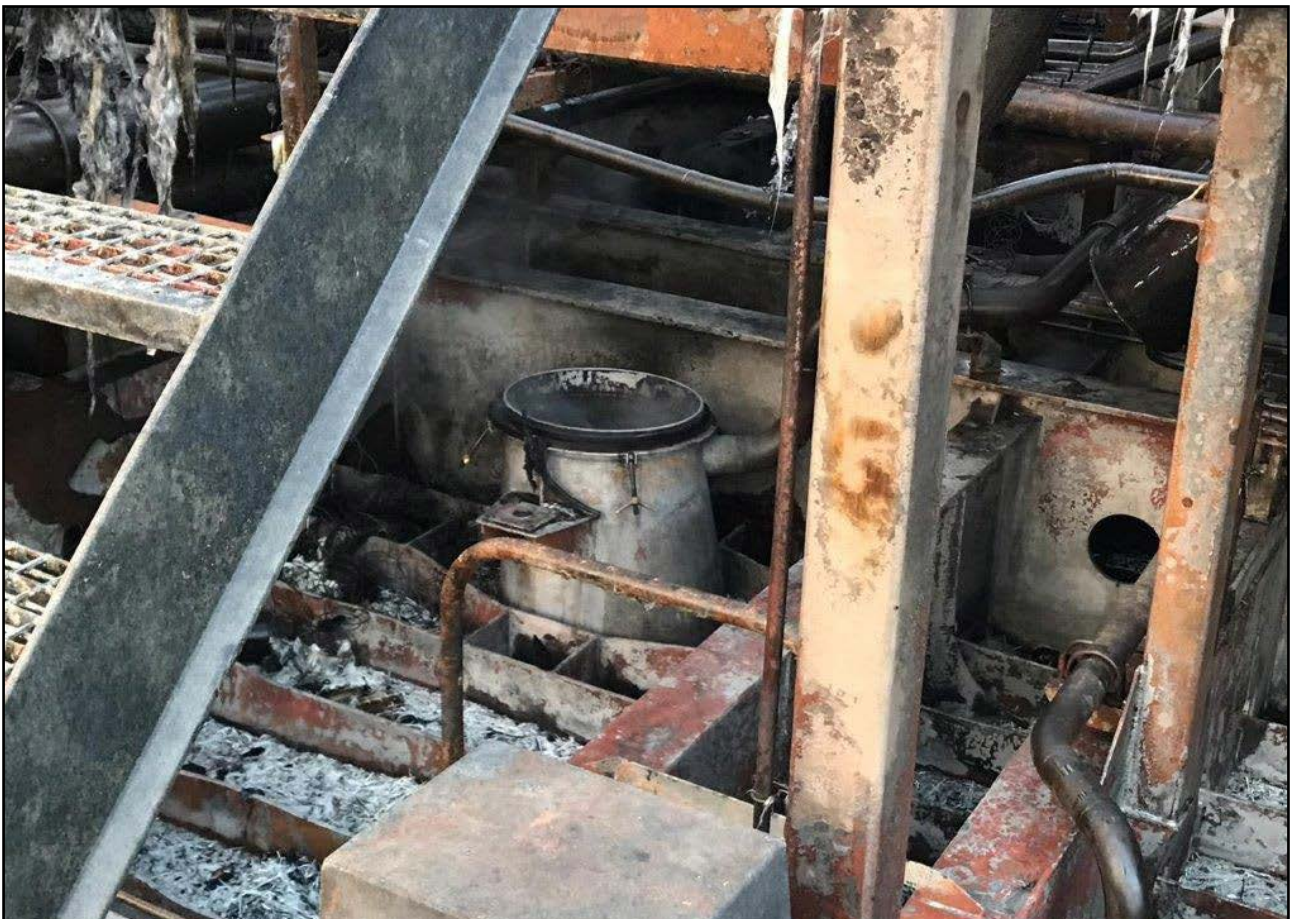
**Figure 13: 9S access hatch**

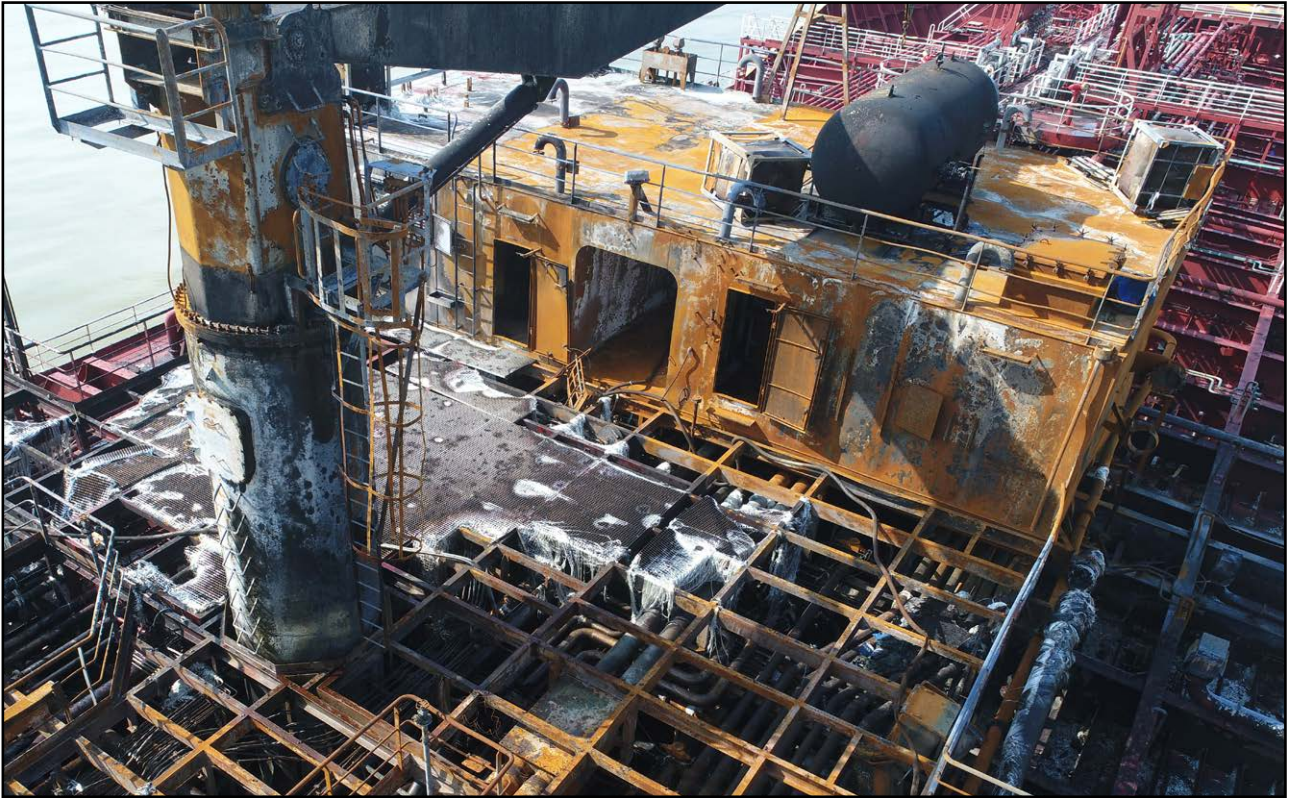
**Figure 14: Midships deckhouse**

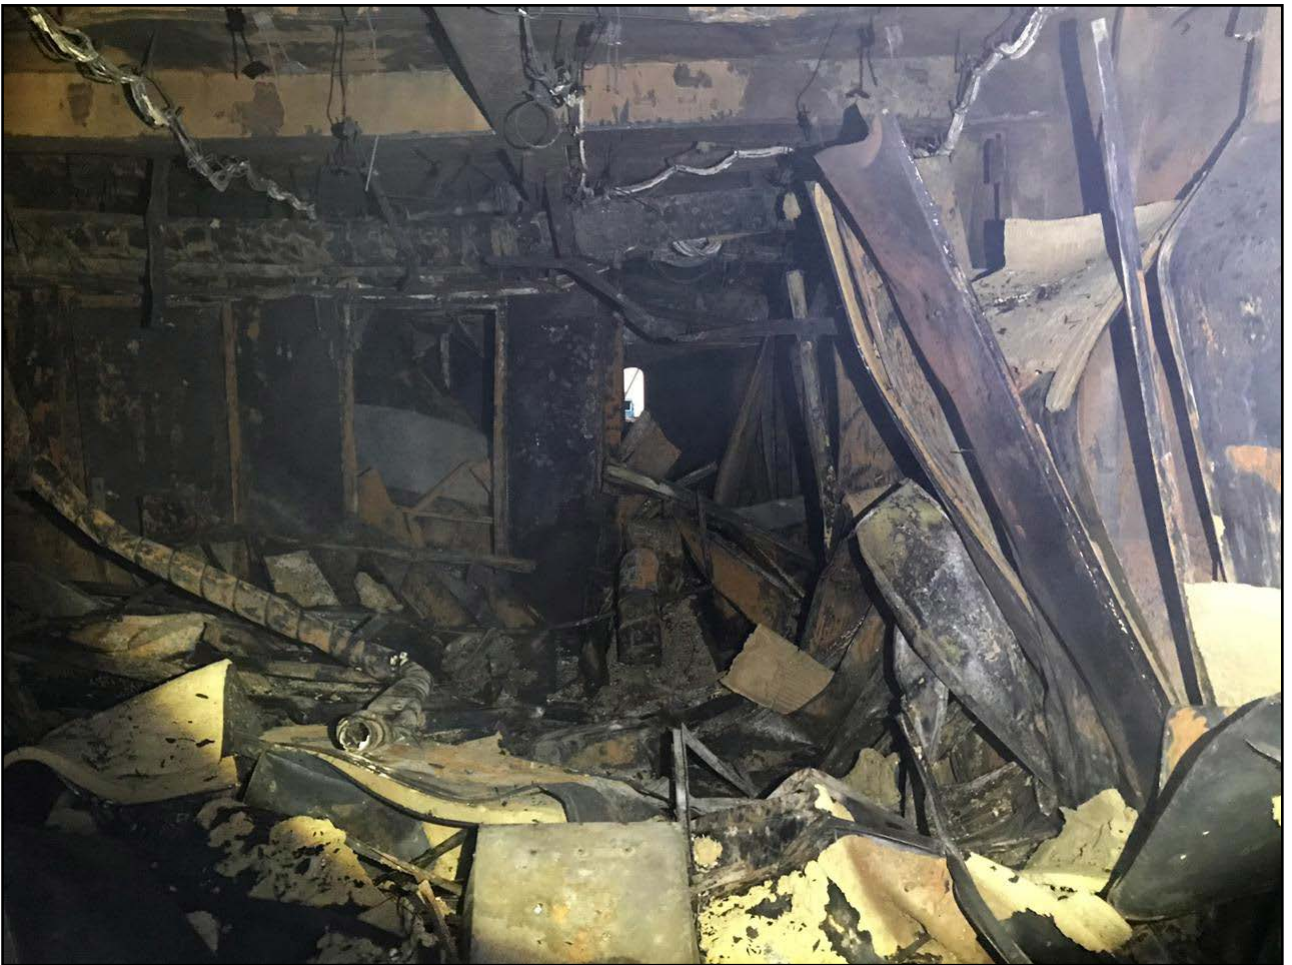
The tanker's accommodation block sustained extensive internal fire damage (**Figure 15**). The deck between the technical room and the CCR had collapsed, and both spaces were burned out. Heat and smoke had also penetrated the bridge and damaged much of its equipment. Other than broken windows, many of which were broken by firefighters during the emergency response, external damage to the front of the accommodation block was minimal (**Figure 16**).

**Figure 15: Accommodation interior**

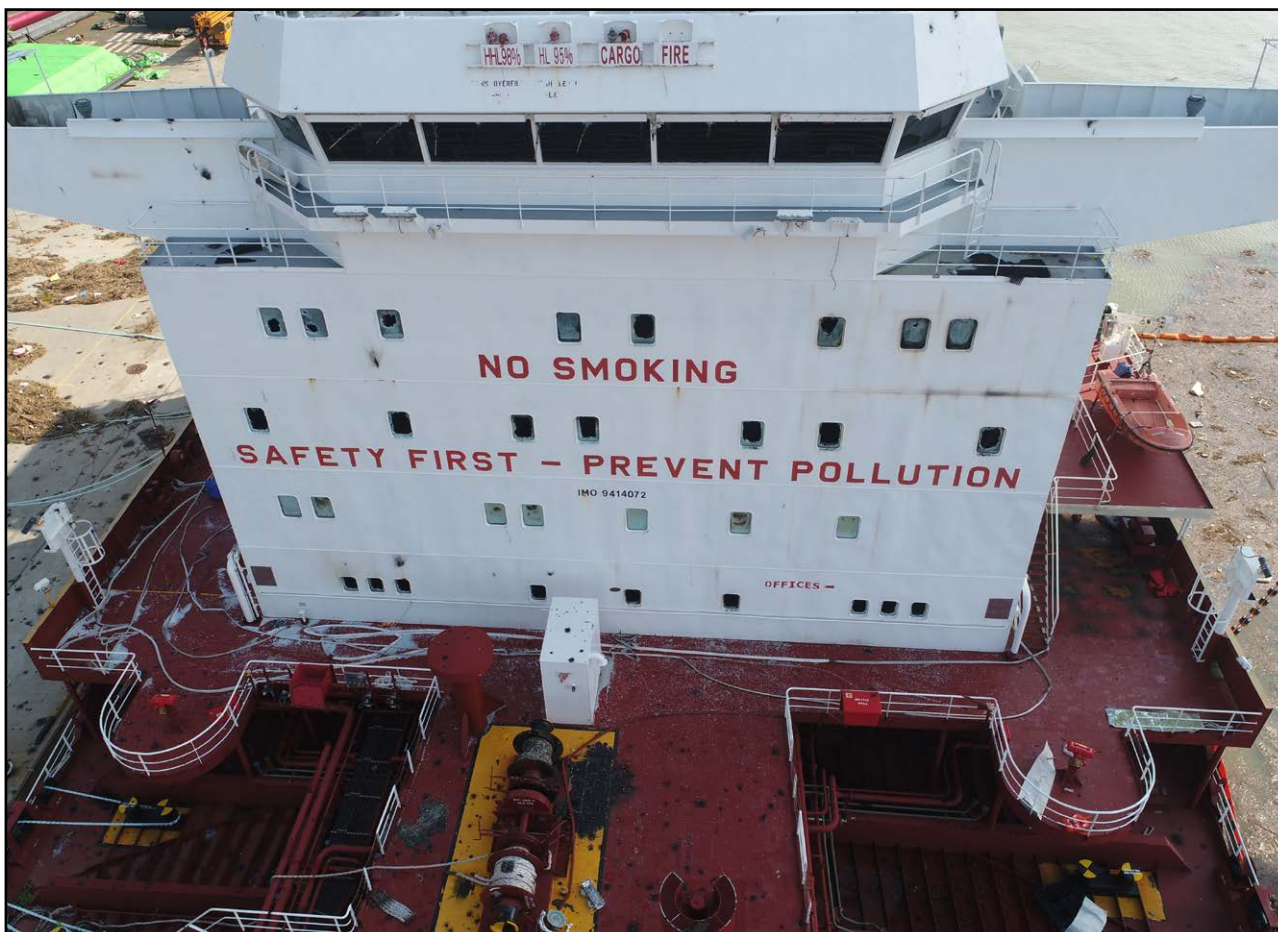
**Figure 16:** Accommodation front

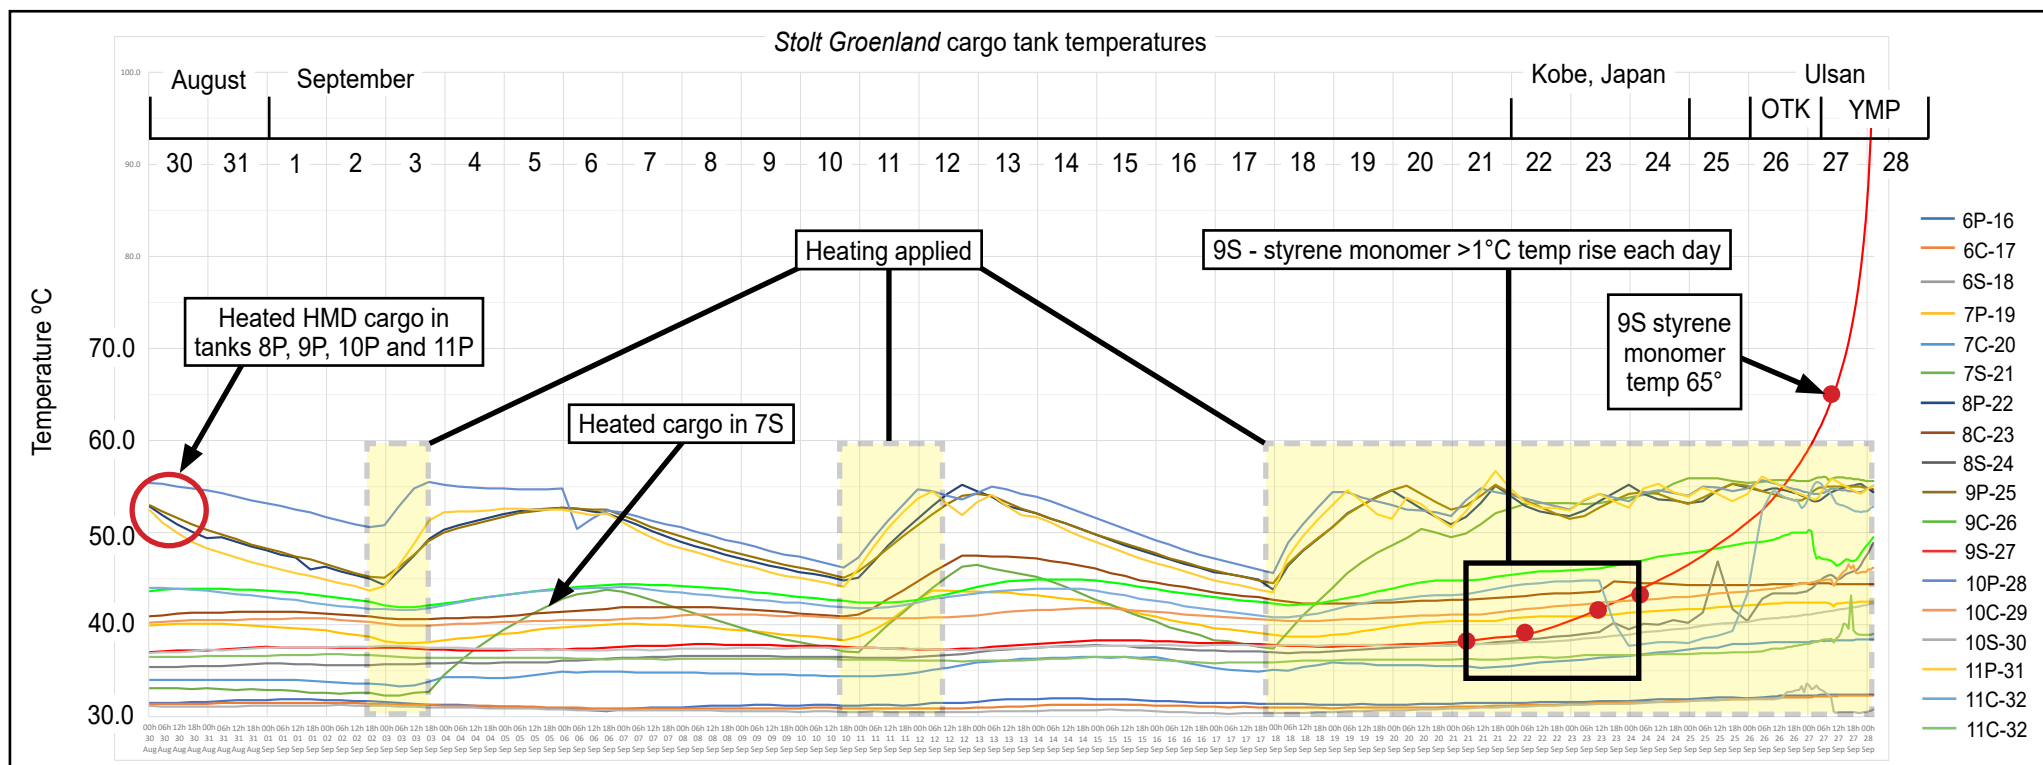
**Figure 17: Cargo temperatures recorded on the VDR**
