## Marine Notice 03/2022

## Pilot transfer arrangements

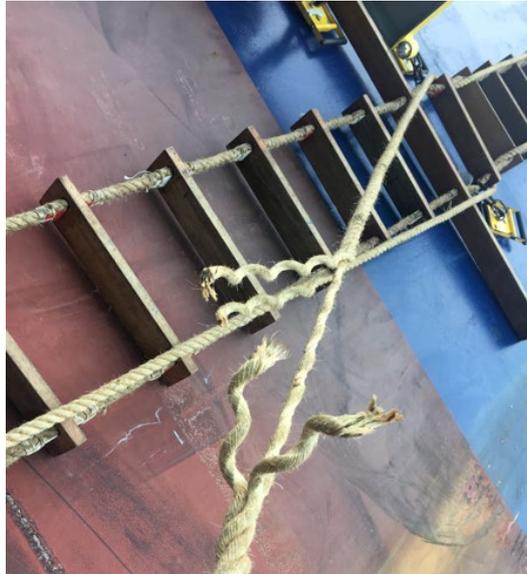
AMSA notes with concern that since November 2017 several pilots' lives have been placed at risk, in six separate incidents where man ropes have parted, or its securing point has failed. In addition, AMSA regularly receives reports and complaints about non-compliant pilot transfer arrangements

*Example of an unsafe man rope*

Paragraph 10.1 of Part A of the International Safety Management Code (ISM) requires vessel operators establish procedures to ensure a ship is maintained in conformity with the relevant rules and regulations, including pilot transfer arrangements. Such procedures should include regular inspections of the pilot transfer arrangement and storage of such equipment when not in use.

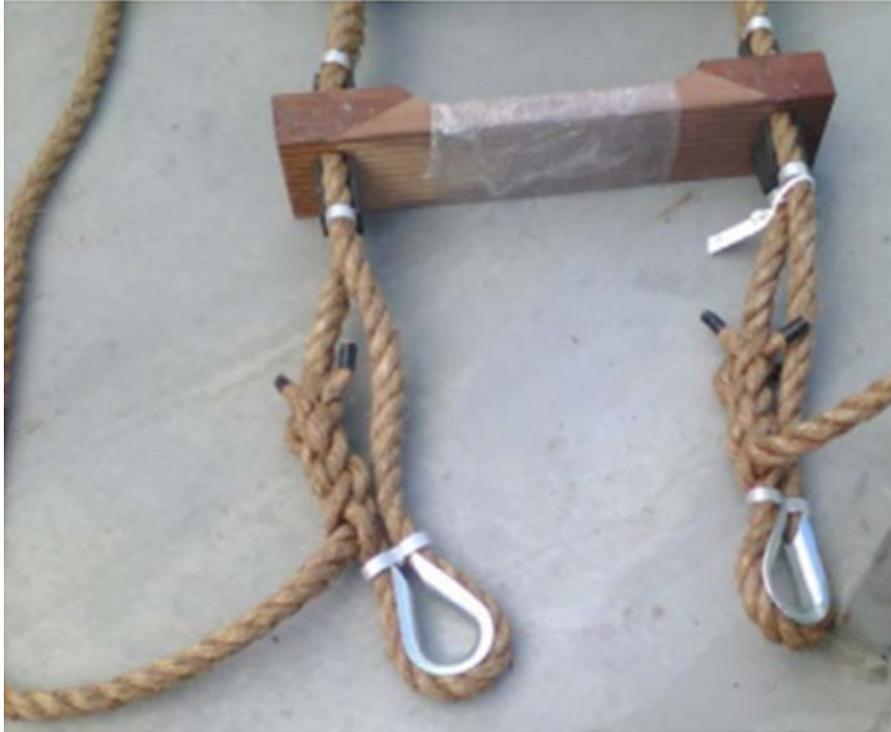
During recent PSC inspections AMSA surveyors have noted pilot ladders which have been constructed with splices in the side ropes.

Pilot ladders constructed like this are considered non-compliant by AMSA. Vessel operators and vessel masters are recommended to check their pilot ladders for splices in side ropes.
