## SAFETY INVESTIGATION REPORT

REPORT NO.: 01/2021

### **MV STARA PLANINA** **Two manoverboards** **in position 66° 05.0' N 005° 26.3' E,** **02 January 2020**

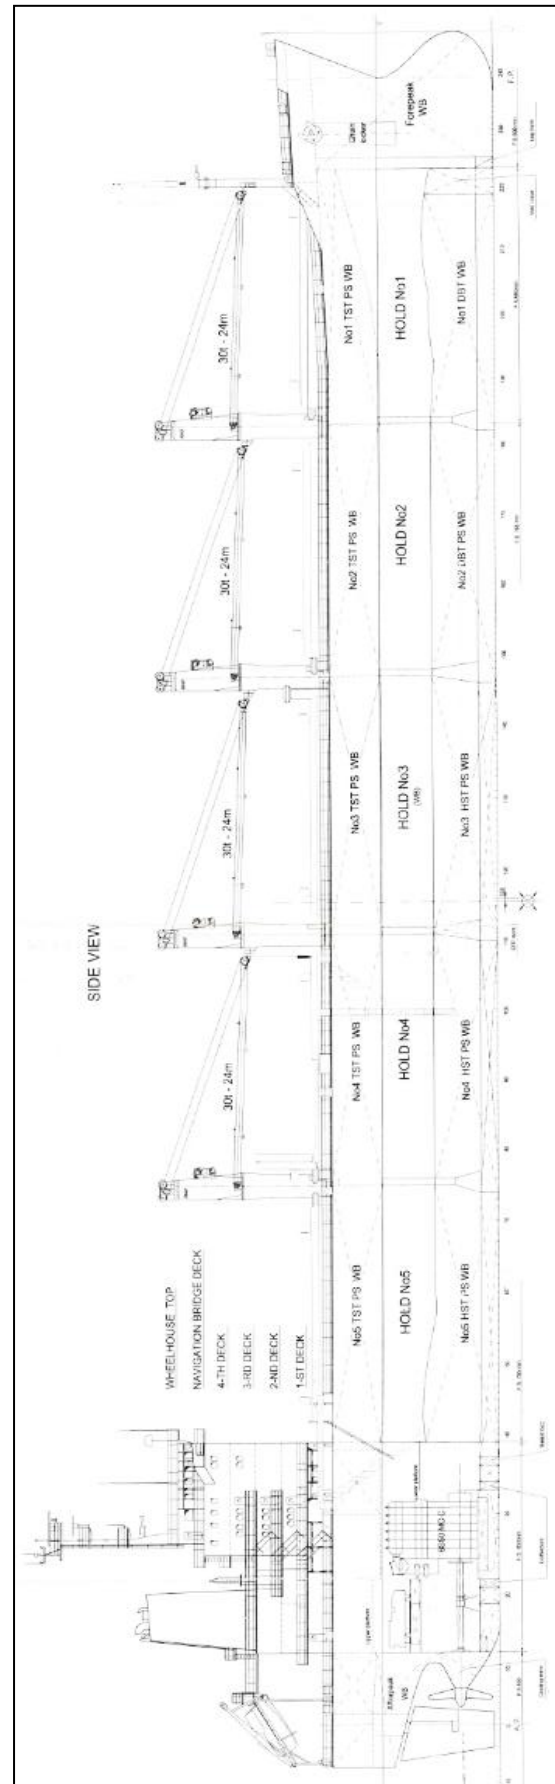
Figure 1: General arrangement of *Stara Planina*

*Stara Planina* (Figure 1) was a bulk carrier of 25,327 gross tonnage, owned by Stara Planina Shipping Limited and operated by Navigation Maritime Bulgare of Bulgaria. The vessel was built by Bulyard Shipbuilding Industry E.A.D., Bulgaria, in 2007 and was classed with Det Norske Veritas – Germanischer Lloyd (DNV-GL). The vessel had a length overall of 186.45 m and a moulded breadth of 30.00 m. *Stara Planina*'s summer draft was 11.81 m, corresponding to a summer deadweight of 42,704 metric tonnes. At the time of the occurrence, the vessel was drawing a maximum draft of 11.10 m.
