SAFETY INVESTIGATION REPORT

REPORT NO.: 18/2019

MV MAERSK JAIPUR Fatal accident in the Engine-room in position 54° 18.9' N 164° 26.9' W 08 October 2018

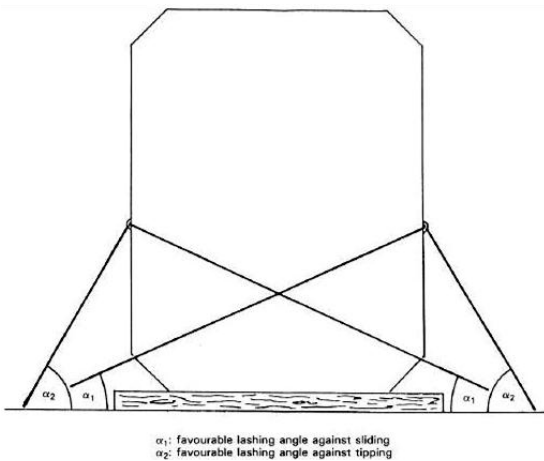
- the securing devices should be arranged in a way to withstand transverse and longitudinal forces which may give rise to sliding or tipping;
- the optimum lashing angle against sliding is about 25° , while the optimum lashing angle against tipping is generally found between 45° and 60° (figure 8); and
- if, owing to circumstances, lashings can be set at large angles only, sliding must be prevented by timber shoring, welded fittings or other appropriate means.

Figure 8: Extract from the CSS code - Principles of securing heavy items against sliding and tipping

The blowers were secured with wires fastened using turnbuckles, at angles of more than 60° to the horizontal. This did not provide any opposing force to prevent them from sliding in adverse weather conditions. The safety investigation hypothesizes that the blowers broke off from their lashings, during one of the violent rolling motions experienced by the vessel, as the lashing in use at the time did not prevent them from sliding. The turnbuckle, shown in Figure 9,
