## SAFETY INVESTIGATION REPORT

REPORT NO.: 22/2020

### **MV ALMA** **Fatal fall from the** **accommodation stairway** **in position 47° 38.1' N 008° 51.8' W,** **22 November 2019**

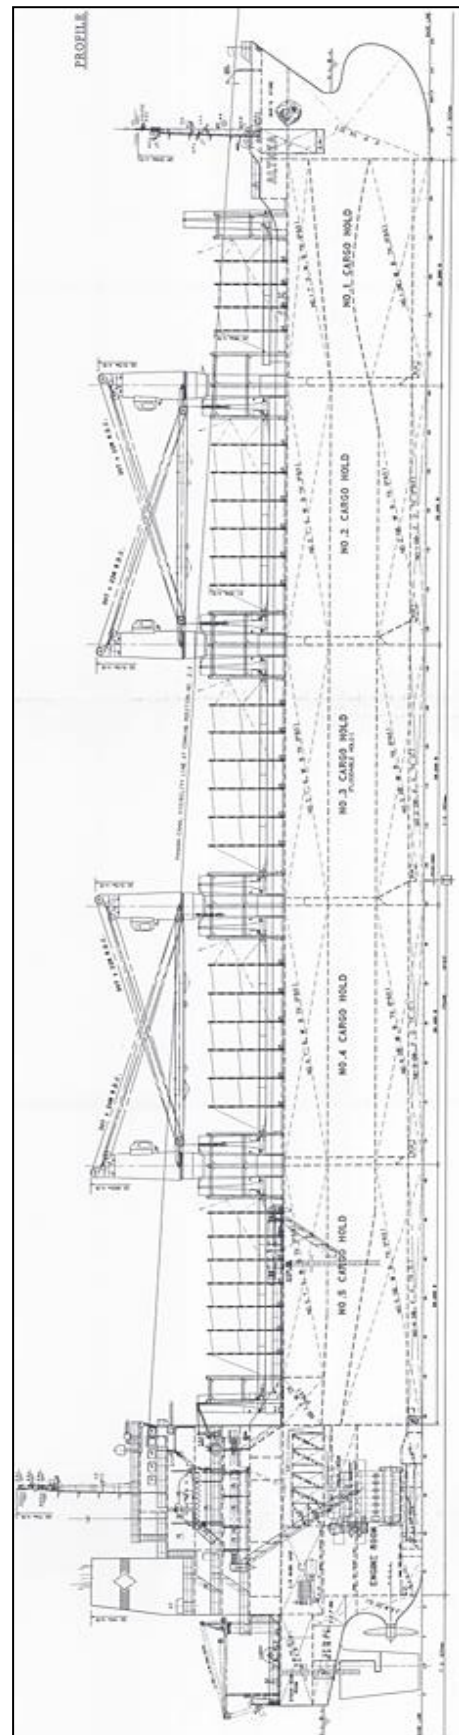
Figure 1: MV *Alma* General Arrangement

*Alma* (Figure 1) was a 17,697 gt bulk carrier, owned by Thalia Maritime Co. Ltd. and managed by Alloceans Shipping Co., Greece. The vessel was built in 2002, by Shina Shipbuilding Co. Ltd. and was classed with the American Bureau of Shipping (ABS). The vessel had a length overall of 169.61 m and a moulded breadth of 27.20 m. At the time of the occurrence, she was drawing a maximum draught of 10.00 m.
