Report on the investigation of  
wave damage to the  
passenger cruise ship  
***Oriana***  
in the North Atlantic Ocean  
28 September 2000

**Report No 36/2002  
November 2002**

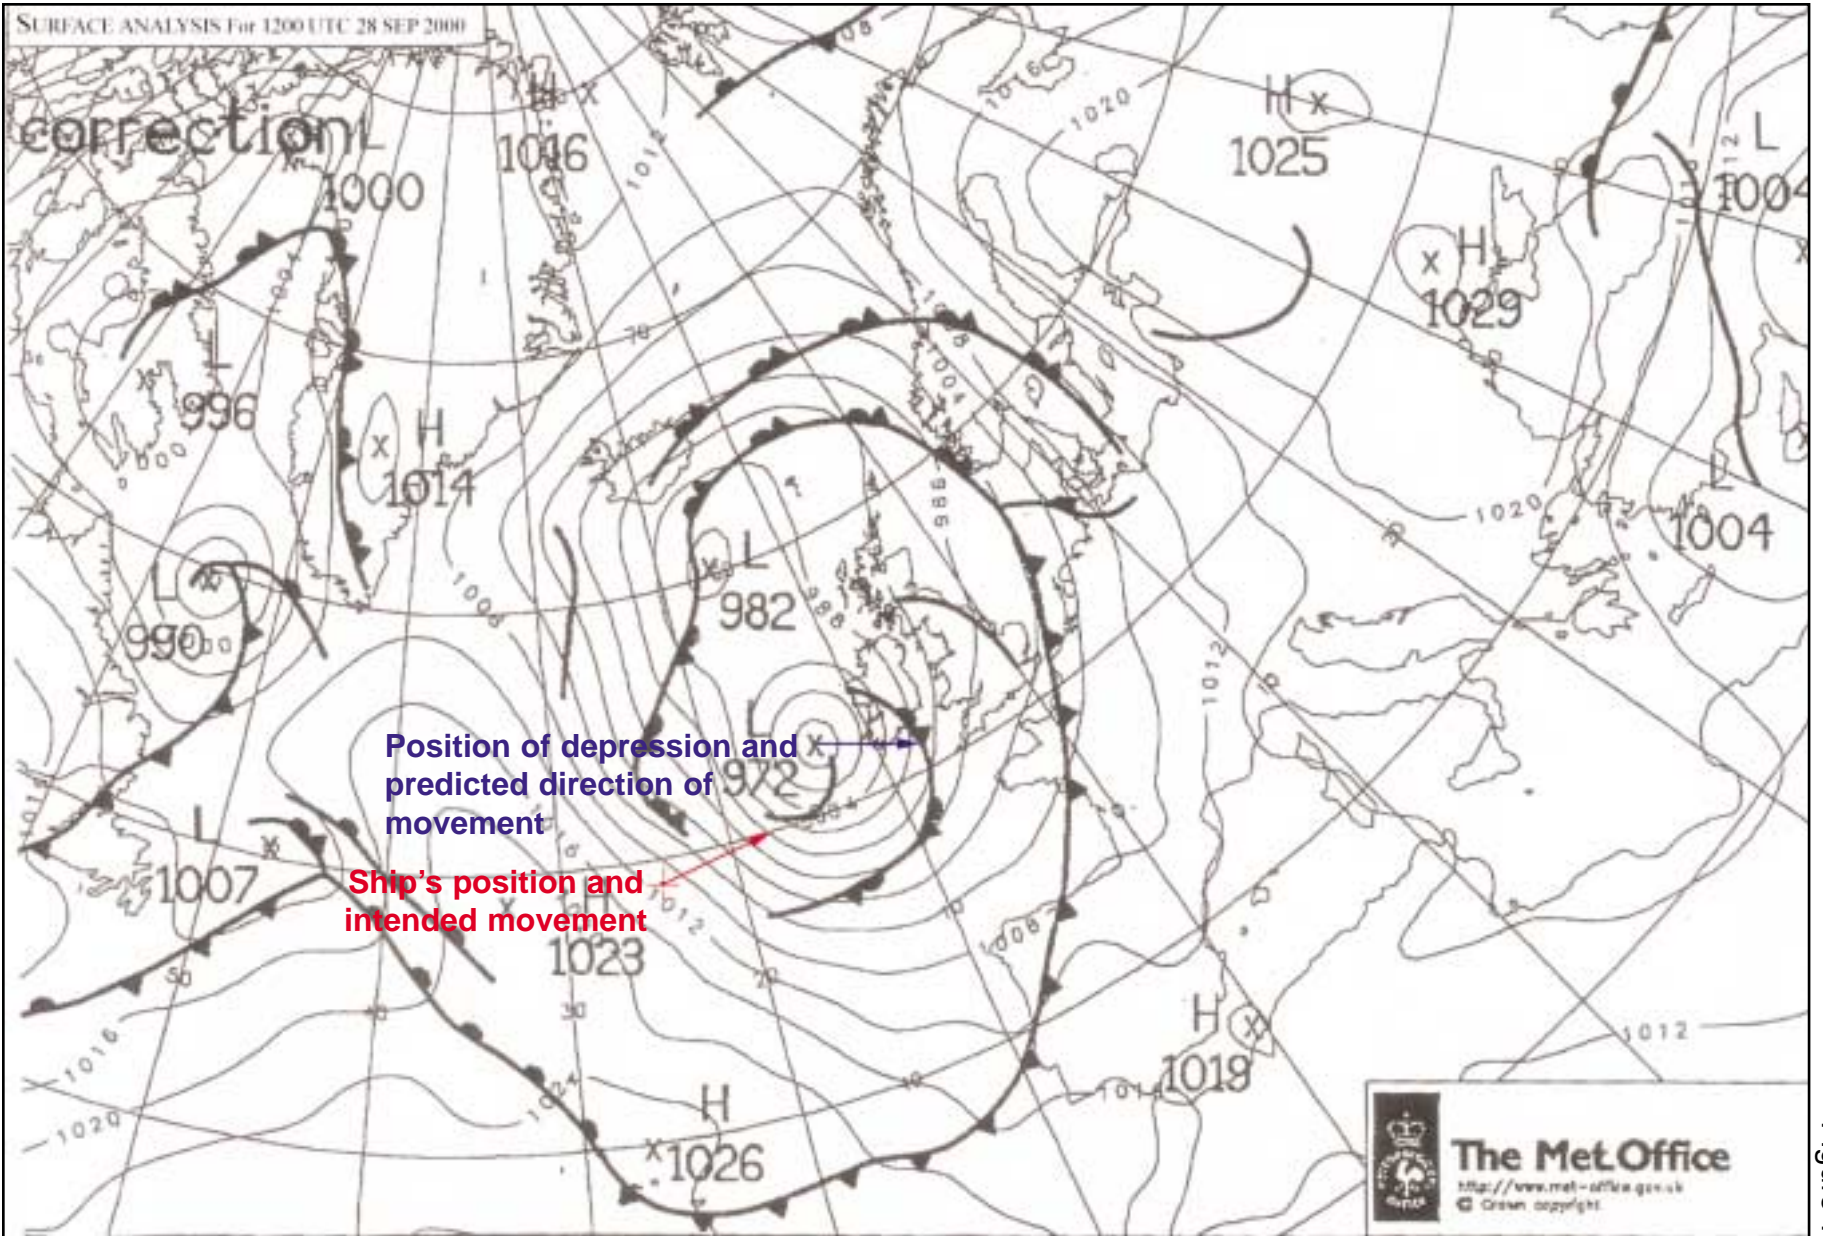
Figure 7

It is evident from the above distances that, from the morning of 28 September, *Oriana* was on the edge of the south-west sector in which the force 10 winds were forecast by NWS. This is supported by the distances between the isobars in **Figure 7**, which indicate a wind strength of about 50 knots in the vicinity of the ship's positions, at 1200 on 28 September, and the recorded barometric pressure and wind speed and direction.

Based on the information and forecasts available on 27 September, the captain assessed that, if the ship continued on her planned route at a reduced speed of 19.5 knots, she would remain clear of the worst of the storm conditions. **Figures 7 and 13** support his assessment, showing conditions to have been marginally more severe towards the centre of the depression. Nevertheless, although the ship remained on the south-western edge of the depression, she continued to close sufficiently to encounter storm force winds and very high seas.

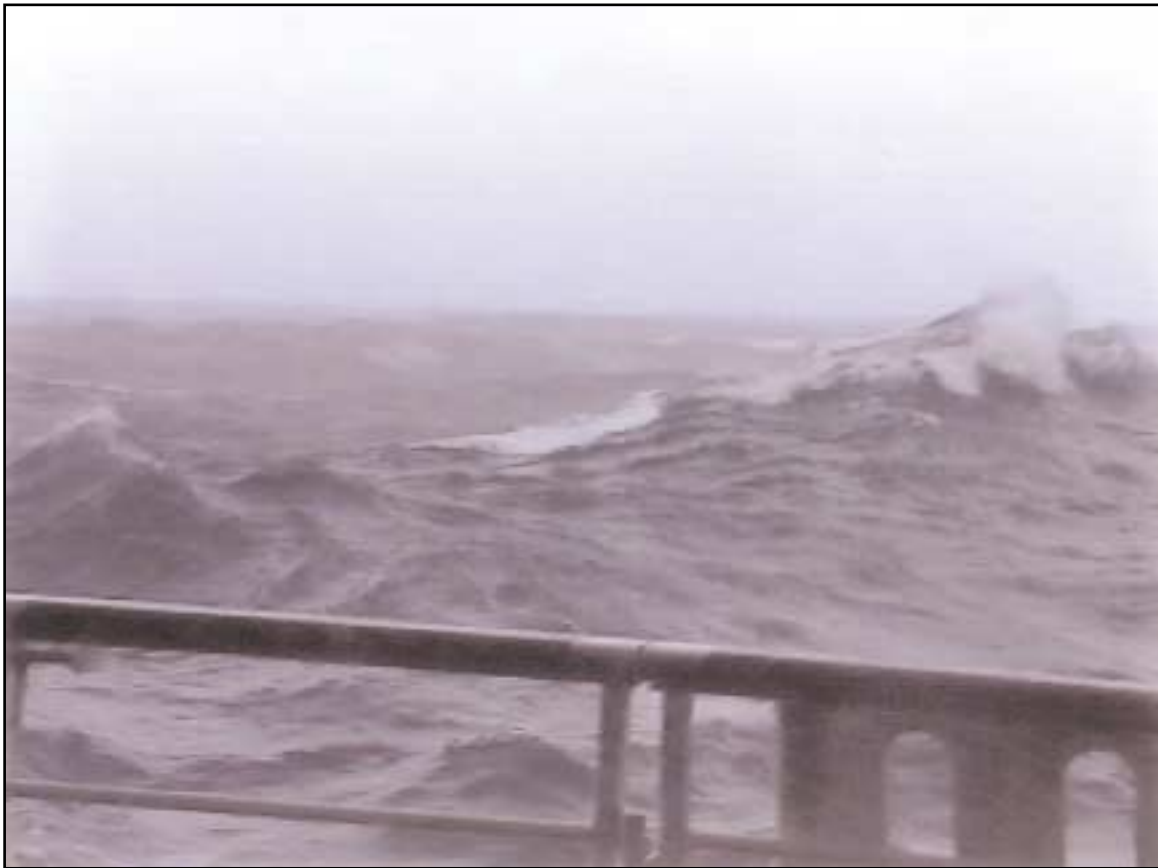
Figure 8

Video recordings taken by passengers on 27 September, and at about midday on 28 September show that the sea conditions worsened during this period. One of the latter recordings, taken from deck 7 on the port side at a height of about 13m above the static waterline, from which **Figures 8, 9, 10 and 11** were taken, confirms that the sea and swell were generally from the port quarter.

Photograph of waves from the port quarter

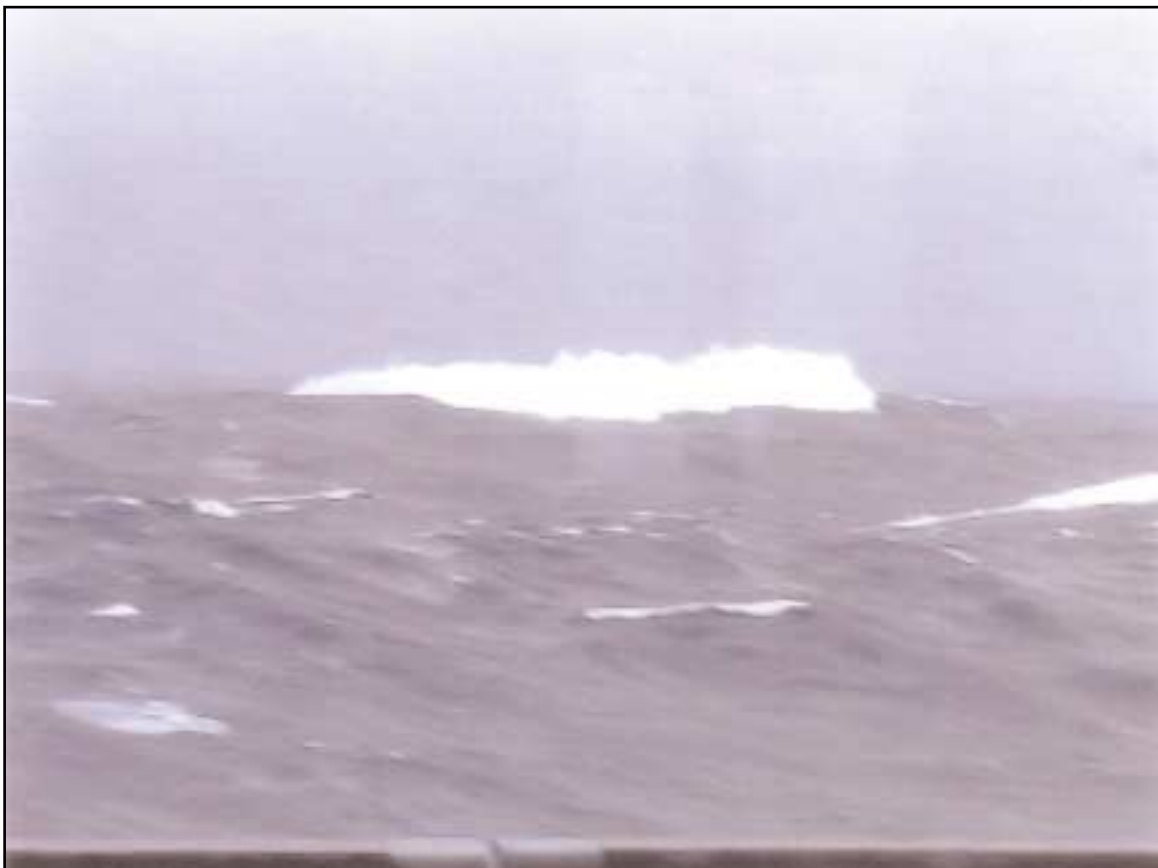
Figure 9

**Figure 9** shows that some of the waves were breaking and **Figure 10** shows a plume of spray at deck 7, which probably resulted from a wave impacting against the port side. Although it is not possible to determine accurately the height of the waves from this video, and there is no evidence to suggest that waves were breaking over deck 7, **Figure 11** possibly indicates that some waves could have been as high as deck 7.

Photograph of a wave breaking

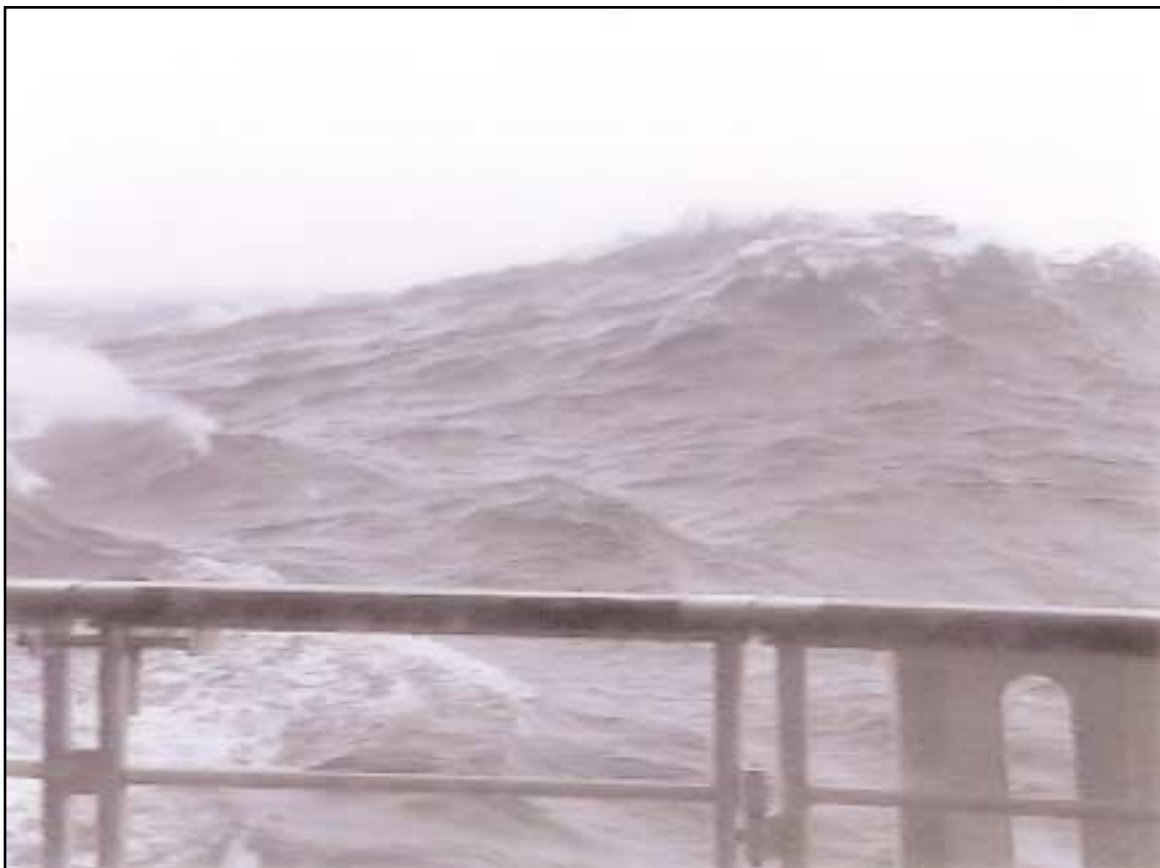
Figure 11

Photograph of wave of a similar height to deck 7

To have breached the windows on deck 6 and damaged the cabin interiors to the extent illustrated in **Figures 3, 4 and 5**, the wave must have been at least 10m high and must have impacted with force. As waves possibly as high as 13m were observed shortly before the window breach (**Figure 11**), it is feasible that *Oriana* was struck by a wave with a force exceeding the designed window strengths. This might have been particularly so if *Oriana* was struck by a breaking wave, which exerts a greater force than a static wave of the same length.

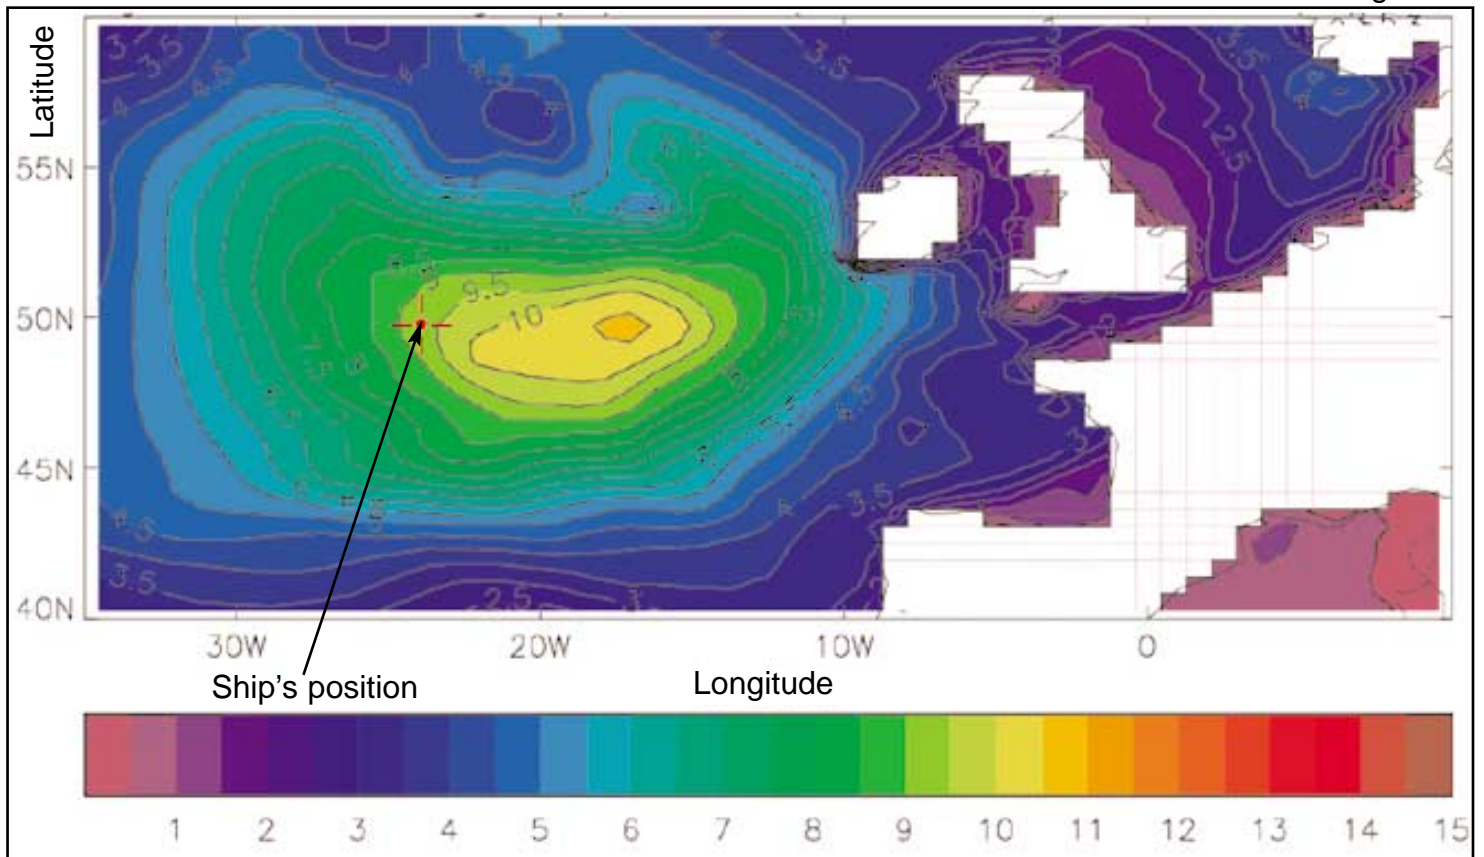
Figure 13

Diagram showing Significant Wave Heights for 12Z on 28 September 2000

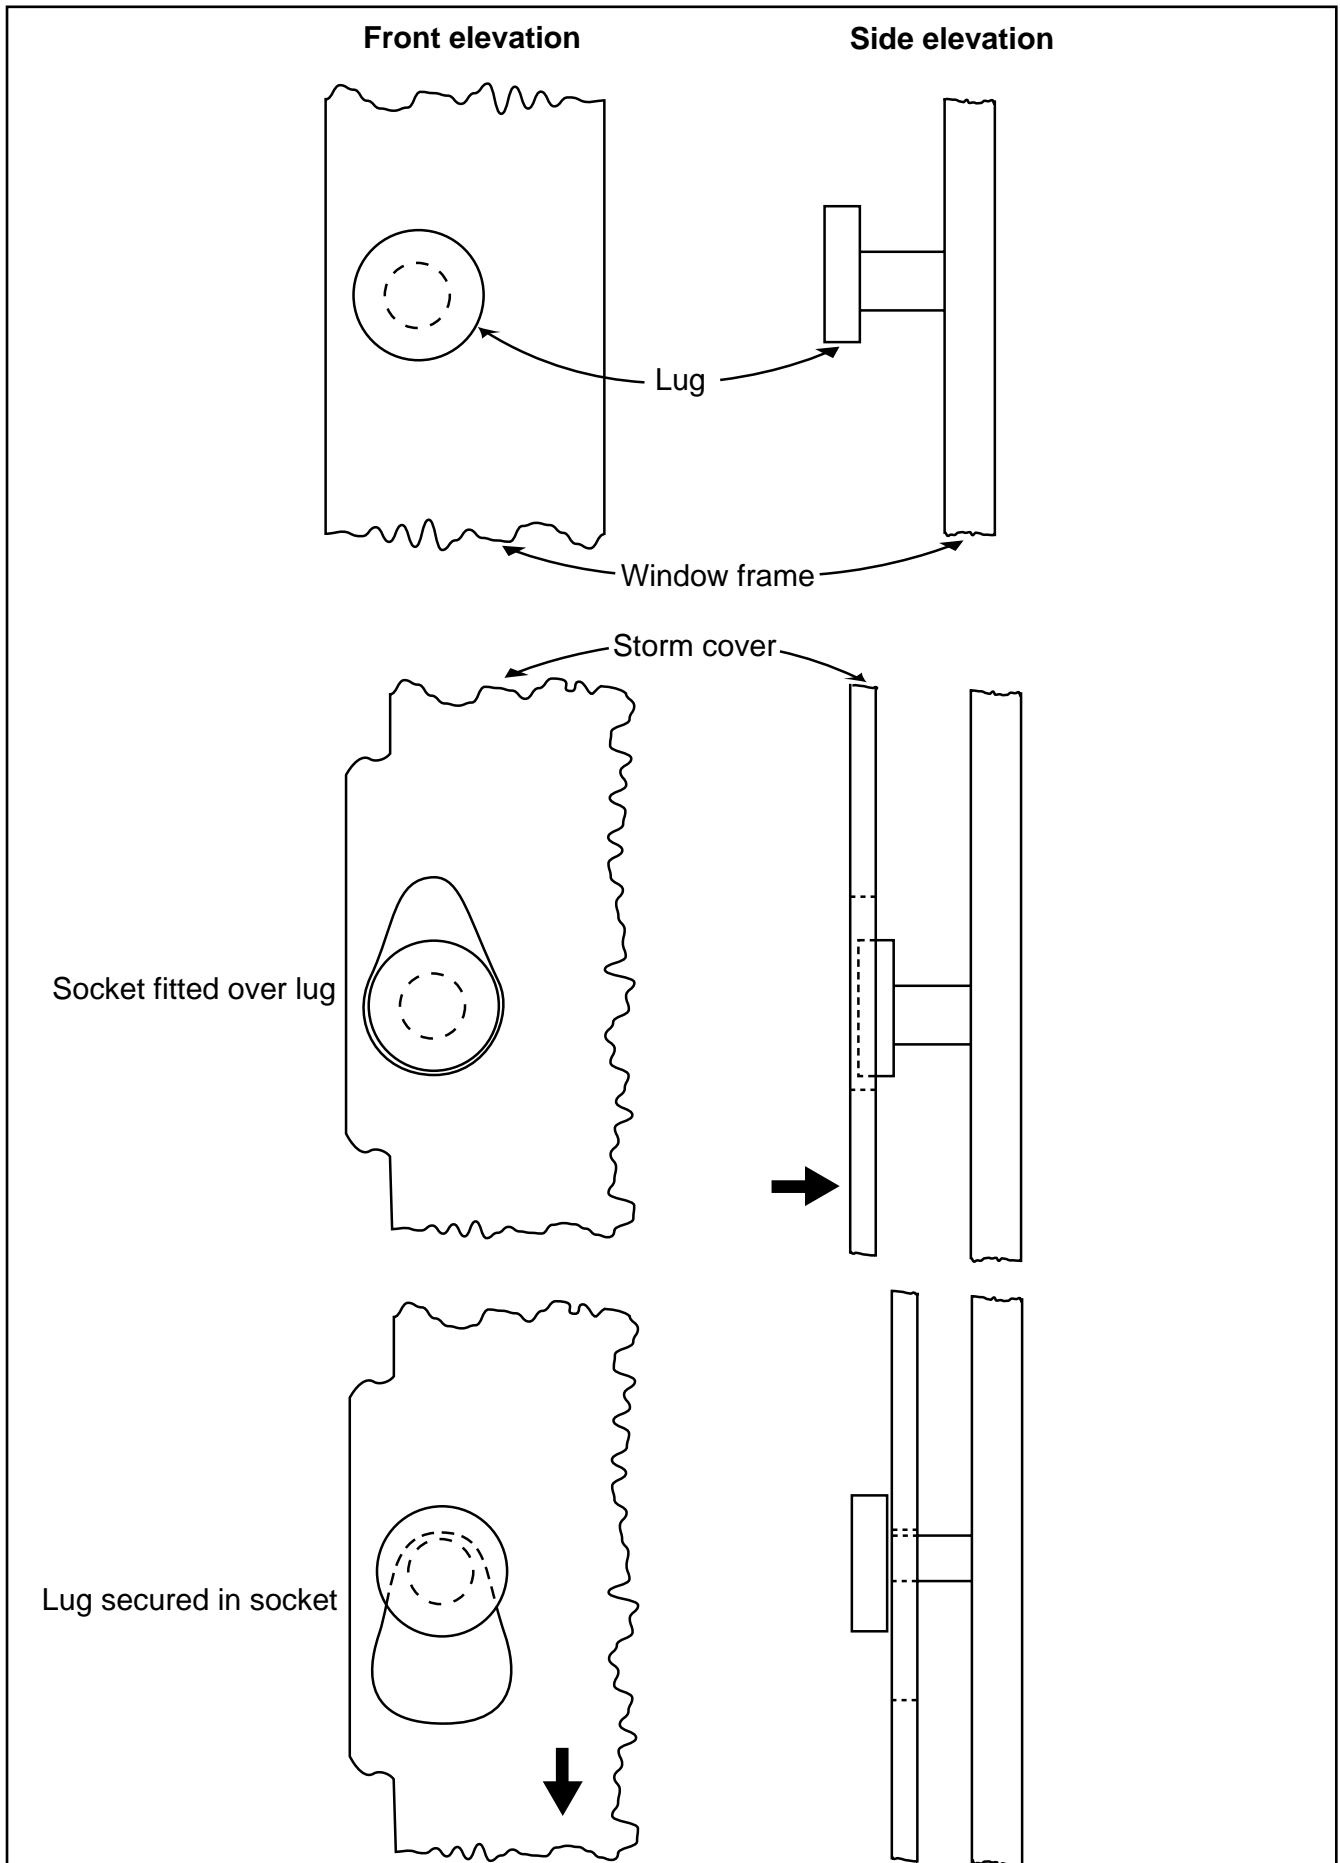
Figure 24

When the windows fitted with storm covers on deck 5 were breached, the storm covers were forced off their mountings by the pressure of the water. The sockets cut in the sides of the storm covers were ruptured as they were pushed off the lugs (**Figure 24**). The storm covers were also bowed.

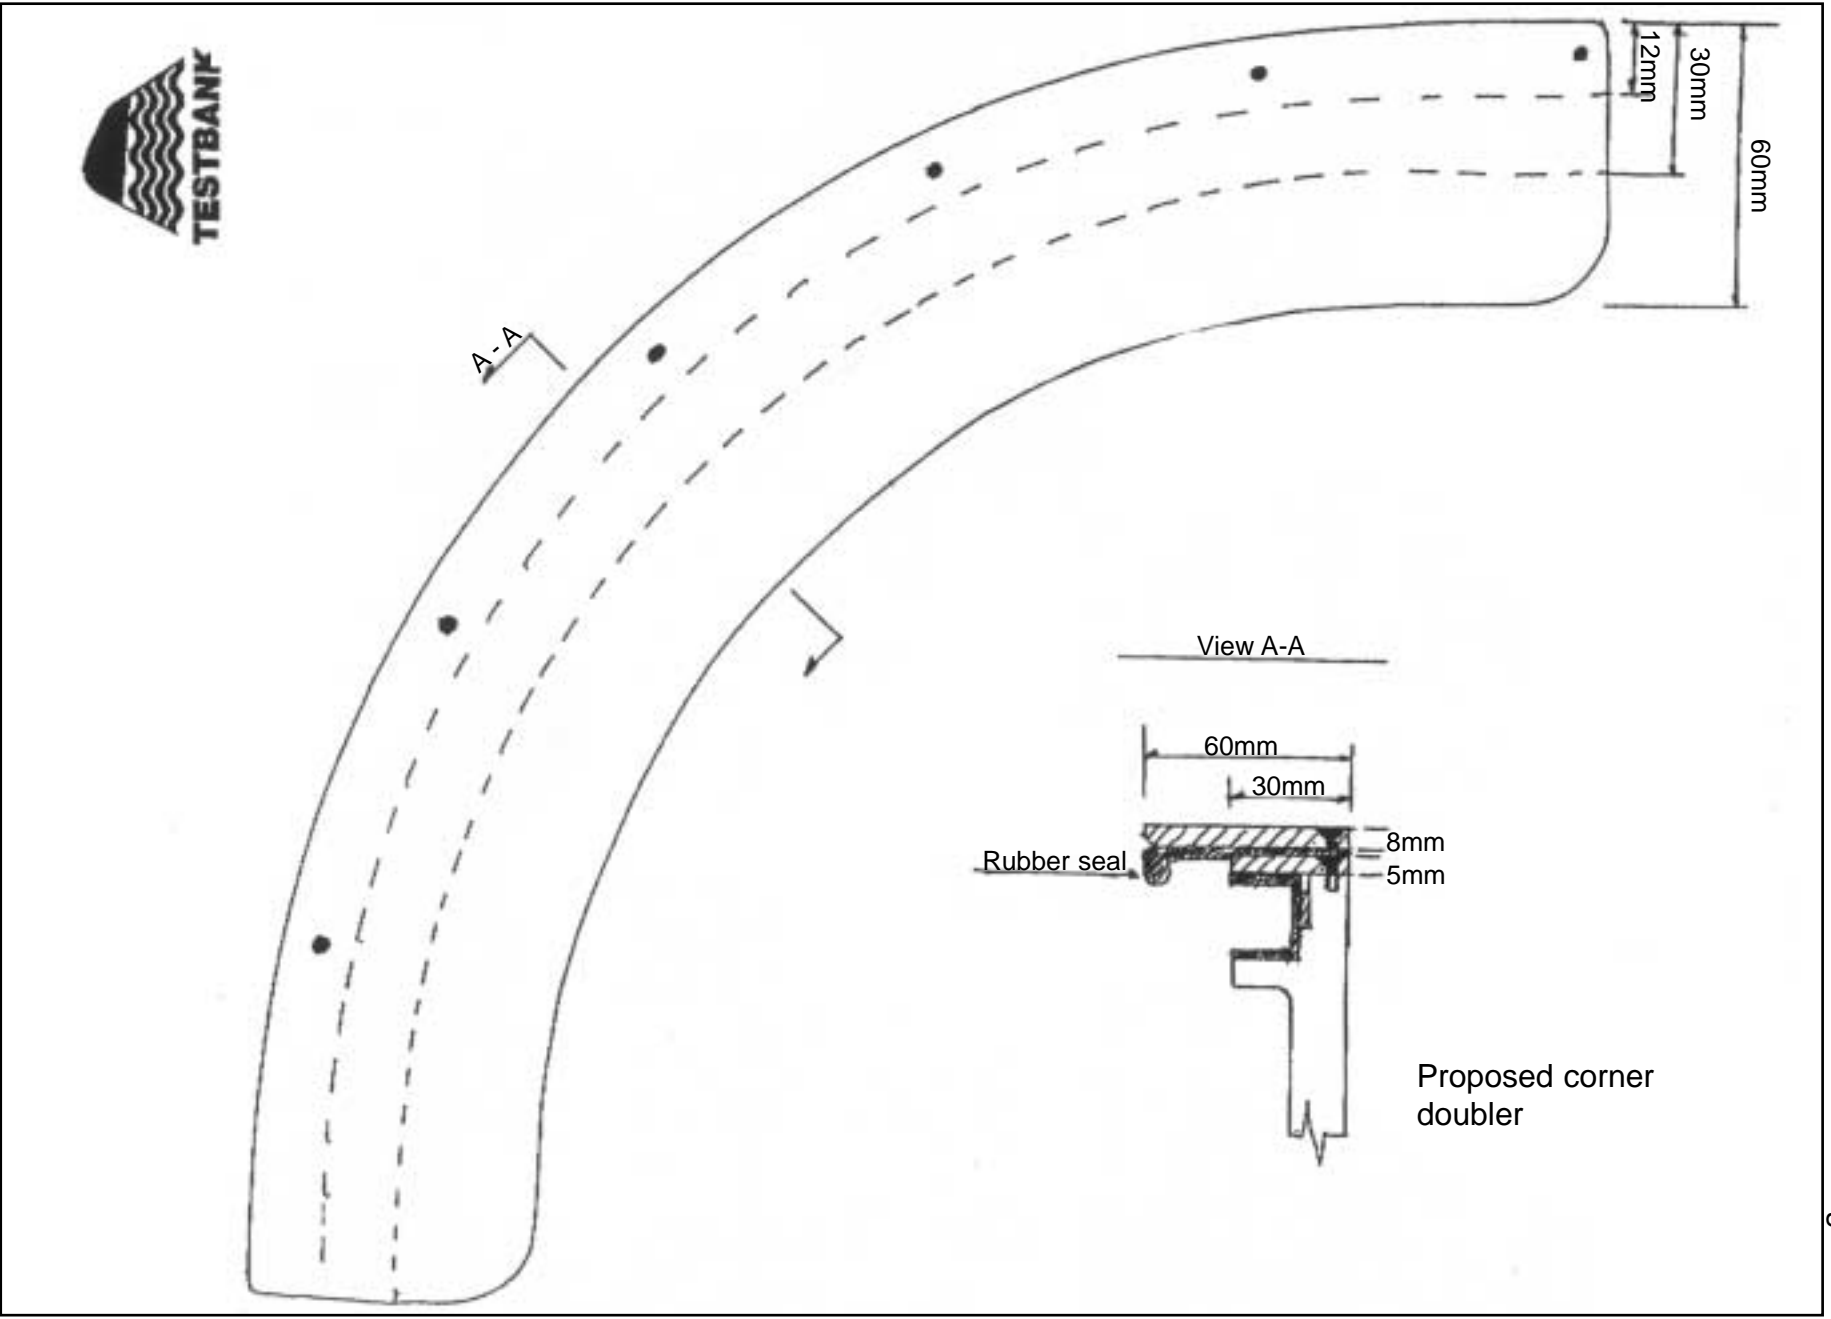
Figure 25

Diagram of retaining plate

After the accident, P&O repositioned all window-panes on decks 5 and 6 which were not properly centred, and fitted steel retaining plates to the corners of all windows on decks 5 and 6 (**Figures 25 and 26**). These plates were fitted on top of the existing glazing strip, with the intention of increasing the overlap and the grip of the frame on the glass. No retaining plates were fitted at the junctions between the mullion and the main part of the frame. This work was proposed by Lloyd's Register as a temporary measure, and carried out by P&O to standards approved by Lloyd's Register.
