Report on the investigation of heavy weather
encountered by the cruise ship

Pacific Sun

resulting in injuries to 77 passengers and crew

Report No 14/2009
June 2009

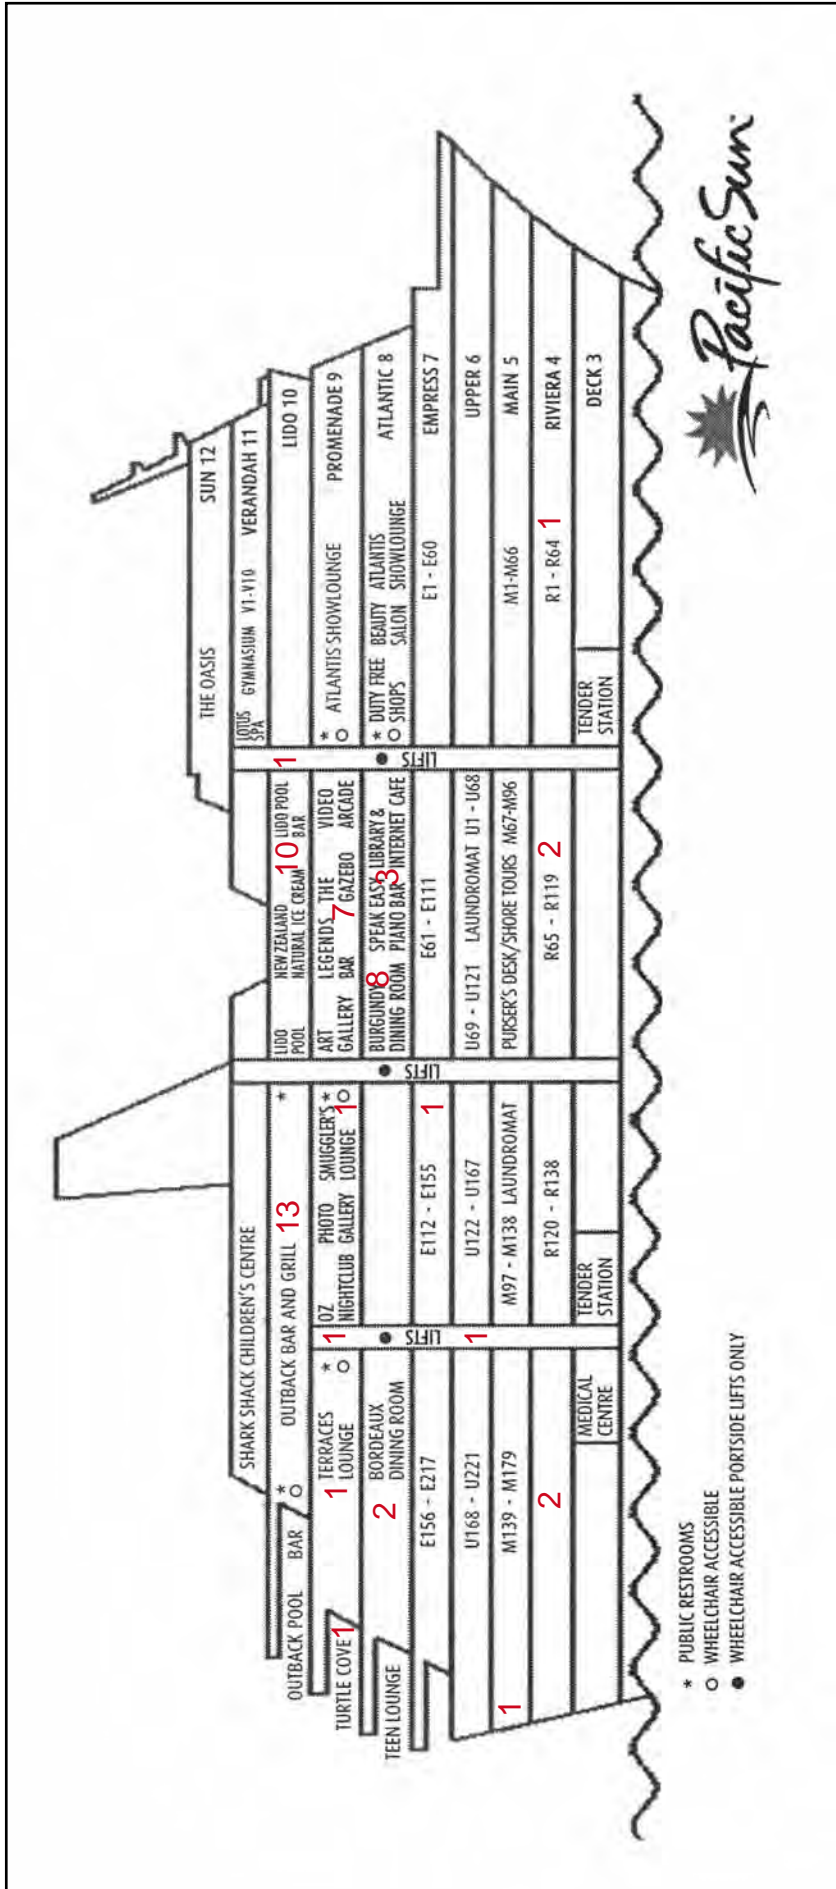
Figure 7

The locations where passengers sustained injuries, in so far as these could be identified, are shown at **Figure 7**. The majority of injuries occurred on the busy upper decks, in the public spaces, bars and restaurants with all the serious injuries occurring on decks 8, 9 and 10.

Location of injuries to passengers and crew - where known

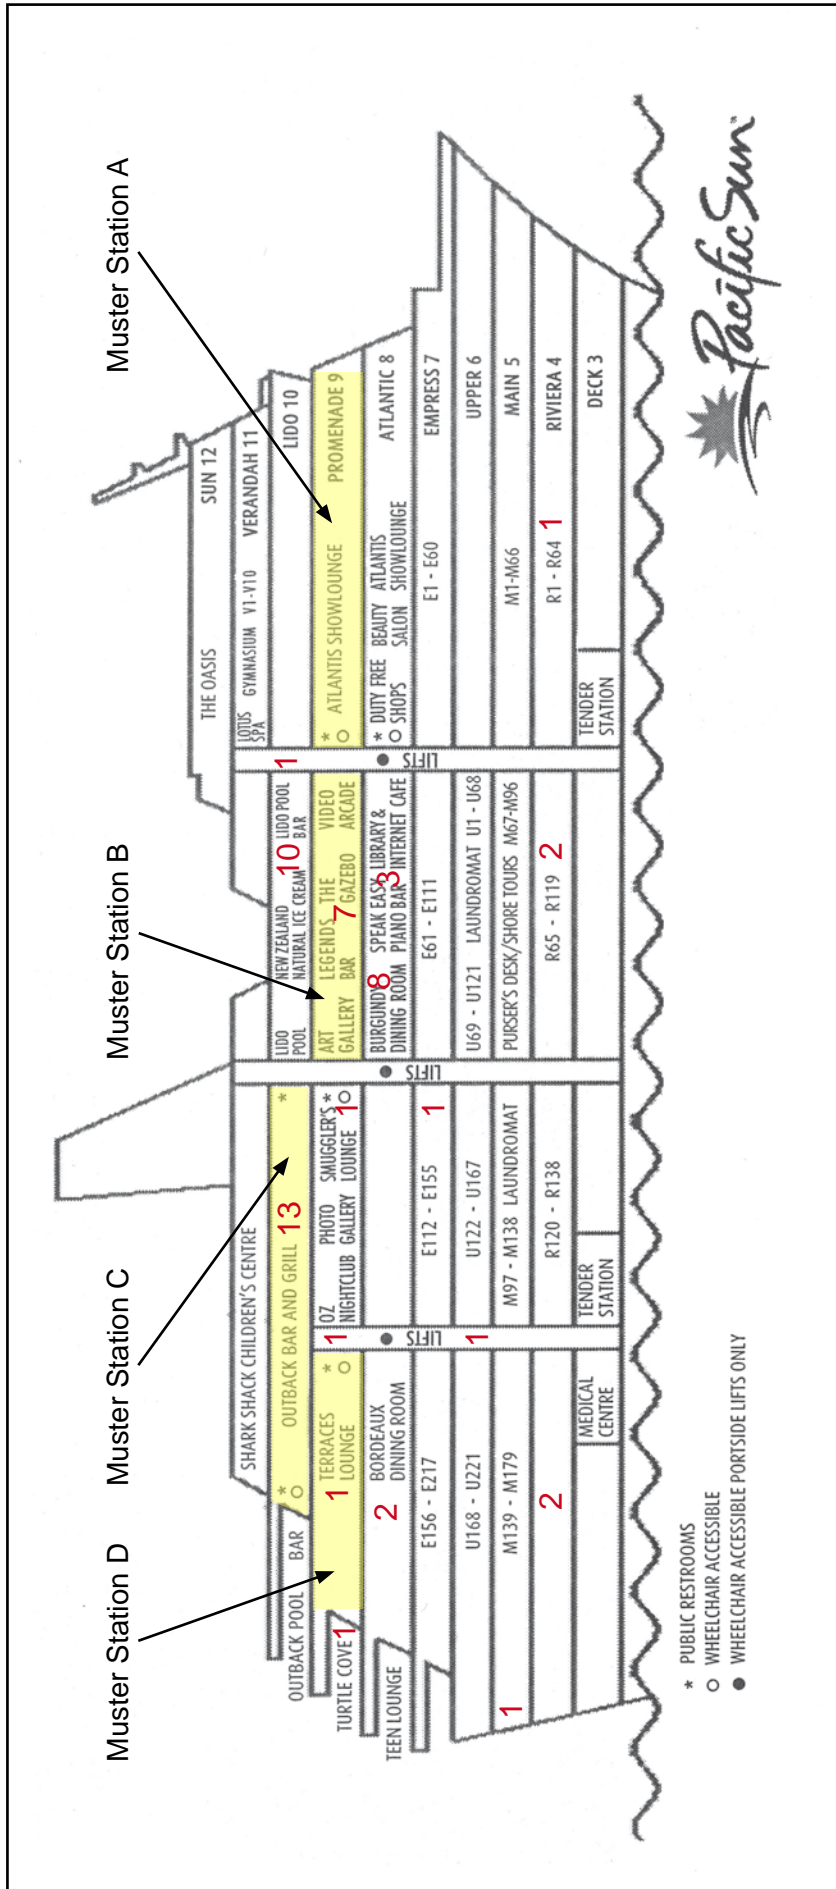
Location of injuries, where known, and Muster Station locations
