Securing of RORO Cargo

Introduction

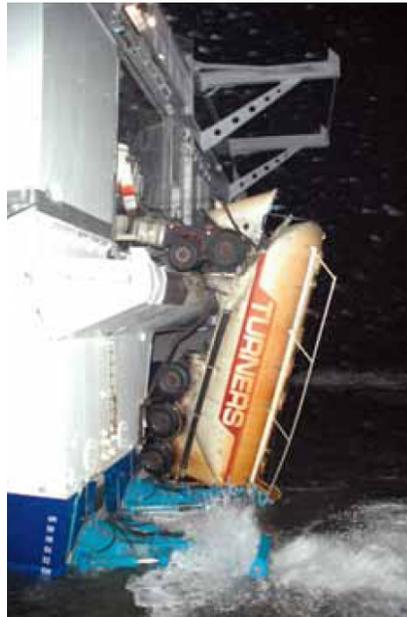
shell door was missing, a HGV tractor unit was wedged up against the internal insulation at the top of the door opening, and the trailer unit was hanging vertically over the stern. The tractor unit subsequently returned towards deck level where it was secured in position, and the trailer unit rested vertically on top of no.2 waterjet.

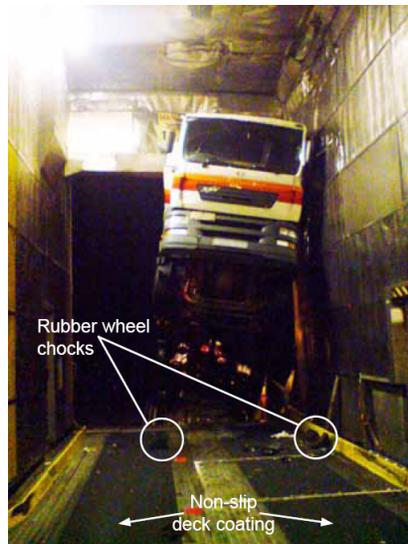
Simultaneously a loud crashing noise was heard from the vicinity of the port aft vehicle deck, which was immediately investigated by the deck crew. They found that the port aft
